Technical Service Bulletin

GROUP	NUMBER
CAMPAIGN	24-01-061G-1
DATE	MODEL(S)
SEPTEMBER 2024	G70 (IK)

SUBJECT: REAR COMBINATION LAMP GARNISH GAP INSPECTION AND REPLACEMENT (SERVICE CAMPAIGN T48G)

This TSB supersedes TSB # 24-01-061G to include 2 part numbers for Verbier White on page 2 (see yellow highlights).

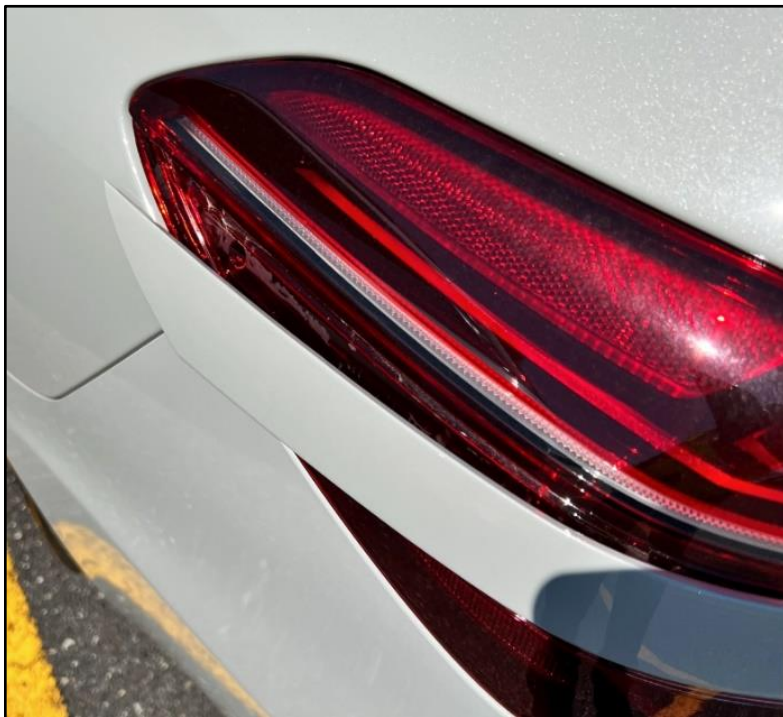
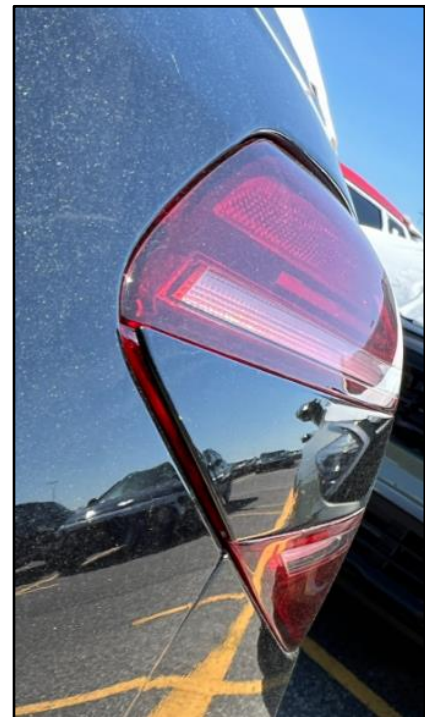
Description: This bulletin describes the procedure to inspect and replace the rear combination lamp garnishes that may begin to detach from the vehicle. The inspection and repair procedure involves confirming if the garnishes have separated and if necessary, removing the garnish and replacing with new parts.

NOTE: If it is found during inspection that one of the garnishes needs to be replaced, replace both garnishes.
