## Field campaign

<b>Topic</b>	Software update to 0042 / 07D2 (Driver door control module) and 0052 / 07D3 (Passenger door control module) - SC24/16
<b>Market area</b>	Australia E04 Bentley rest Asia and Australia (6E04),China 796 VW Import Comp. Ltd (Vico), Beijing (6796),Germany E02 Bentley rest Europe (6E02),Japan E03 Bentley Japan (6E03),United Arab Emirates E06 Bentley Middle East and Africa (6E06),United Kingdom E01 Bentley UK (6E01),United States E05 Bentley USA and rest America (6E05)
<b>Brand</b>	Bentley
<b>Transaction No.</b>	2074063/2
<b>Campaign number</b>	ED09
<b>Note</b>	
<b>Type</b>	
<b>US code</b>

### Bentayga Extended Wheel Base

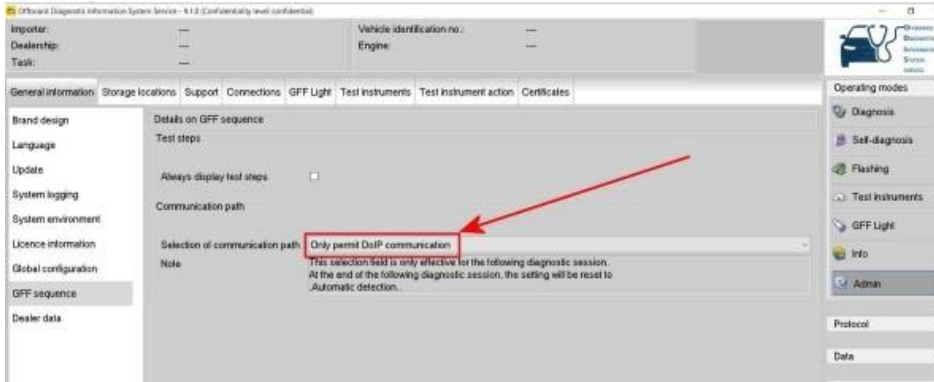
Figure 5

**VERY IMPORTANT: Before conducting the onward instructions / entering the SVM code, the operative MUST recheck the DoIP set up in ODIS and ensure that DoIP is selected (Figure 5) before proceeding**

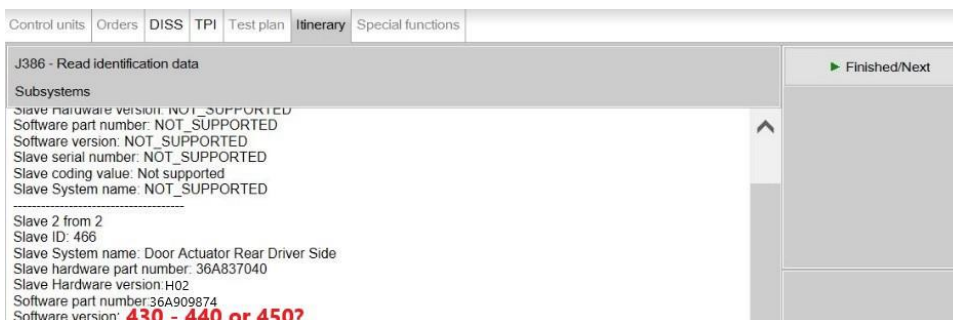
- 1) Select and run Guided Fault Finding
- 2) Referring to the example shown in Figure 6 - Navigate to the front driver door module (0042 / J386) > Guided Functions > Read identification data
  - Repeat for the front passenger door module (0052 / J387)

**In the event the Software version is 0430 or 0440 please raise a technical DISS query ensuring a current ODIS log is attached / saved online, the operative MUST await feedback before conducting any further work**

**Should the Software version already be 0450, the software is at the latest level, in this scenario the operative should conduct the instructions within the Work section from Step 8 to completion**

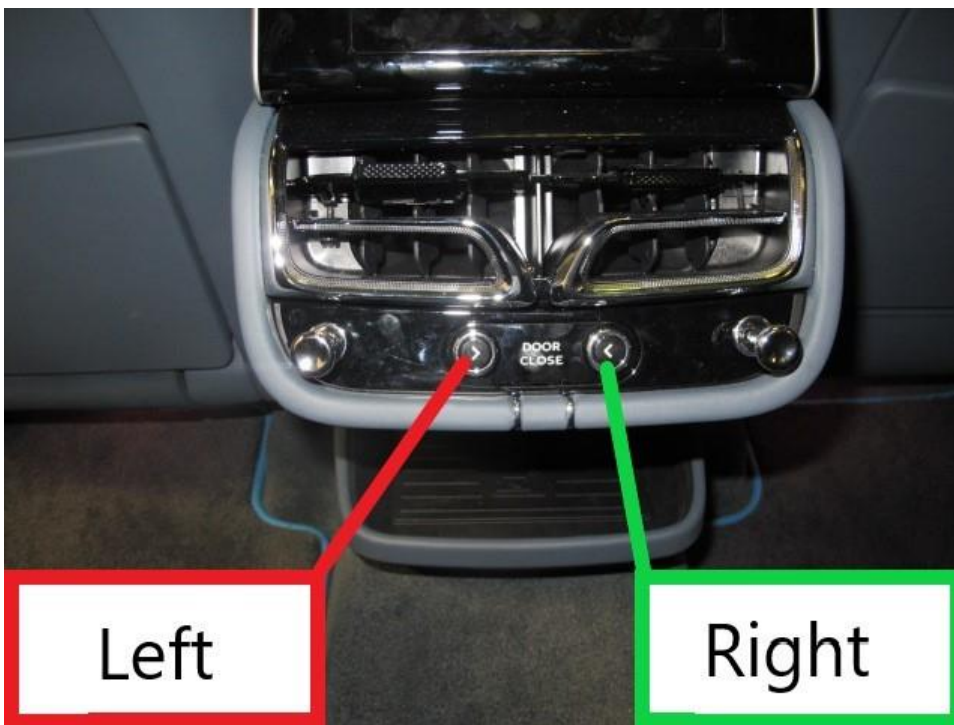
- Check the LHR door fully closes and latches (including soft close operation) without the requirement to press the button a second time
- Once fully closed/latched - Fully reopen the LHR door
- Repeat the power close operation (x2) times (x3 in total)

In the event the door close / latch operation fails at any point the operative must raise a DISS query and await feedback before conducting any further work

- The RHF - LHF and RHR doors must all be closed
- The tailgate must be closed
- All windows must be closed
- Referring to Figure 9 - Press and hold the left DOOR CLOSE button

- The RHF - LHF and LHR doors must be closed
- The tailgate must be closed
- All windows must be closed
- Referring to Figure 9 - Press and hold the right DOOR CLOSE button Check the RHR door fully closes and latches (including soft close operation) without the requirement to press the button a second time
- Once closed/latched - Fully reopen the RHR door
- Repeat the power close operation (x2) times (x3 in total)
