Rear Camera Foggy Or Missing Image

DATE: September 9, 2024

MODELS: M161 Levante (All MY).

SECTION: 08.71 – 1 CAMERA

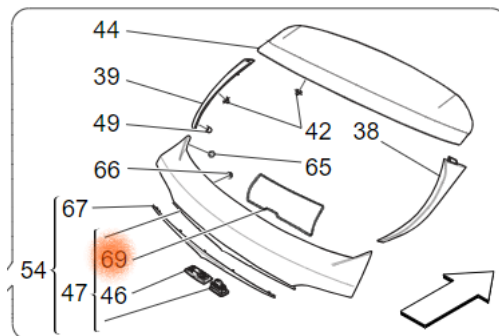
to investigate the cause of water infiltration and define the correct repair, it is necessary to disassemble the lower spoiler (ref. Modis 09.15 - 1, position 47) and to check the integrity of the gaskets indicated in picture 4. Check the electrical connection of the camera and look for any signs of corrosion / contamination.

In case of confirmed water infiltration in the rear camera, we suggest to replace it along with the lower spoiler gasket, now separately available (Component #69 in table 09.15 -1).

Note: Following the release of this notice and the availability of the gasket, replacements of the entire lower spoiler due to this anomaly can no longer be authorized.
