GROUP	MODEL
CLI	2021-2022MY K5 (DL3a)
NUMBER	DATE
056 (Rev 1, 9/17/2024)	August 2024

TECHNICAL SERVICE BULLETIN

HEATING, VENTILATION, AND AIR CONDITIONING (HVAC) BLOWER MOTOR FUSE RELOCATION (WTY037)

This bulletin provides information associated with the 'Warranty Extension Program' (WTY037) to inspect, and if necessary, relocate the Heating, Ventilation, and Air Conditioning (HVAC) blower motor 40-ampere fuse on certain 2021-2022MY K5 (DL3a) vehicles produced from March 27, 2020 through July 20, 2022. The HVAC system provides cooling and heating to help maintain a comfortable environment inside the vehicle. The blower motor provides primary airflow for the HVAC system. Extended use of the HVAC at high fan speeds may cause damage to the multi-fuse terminals for the HVAC blower motor circuit, which can cause the blower motor to become inoperative, resulting in reduced heat and air conditioning. The warranty coverage for repairs related to the HVAC blower motor have been extended from 5 years / 60,000 miles to 15 years / 180,000 miles, whichever comes first, starting from the date the vehicle was first put into service. Follow the procedure outlined in this publication to relocate

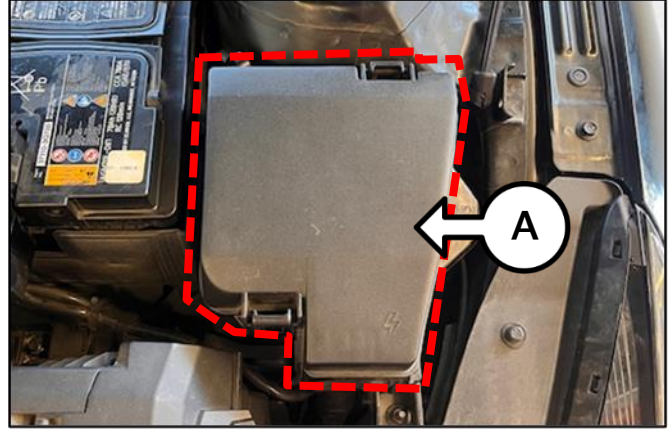
1. Release the two (2) locking tabs to remove the junction box fuse cover (A).

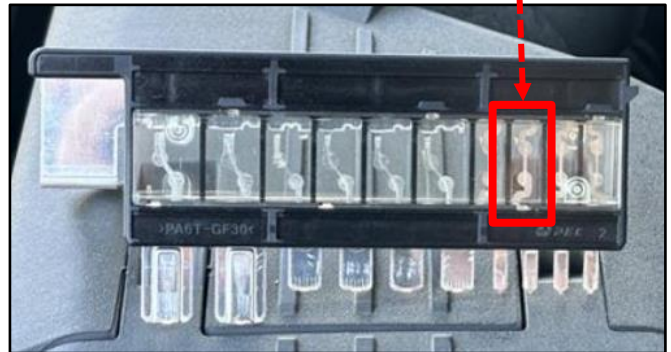
2. Using a flashlight, visually inspect if the multi-fuse (B) location #3 is blown.

- If the multi-fuse (B) location #3 is NOT blown, no further action required.
Claim inspection only labor op.
- If the multi-fuse (B) location #3 IS blown, proceed to the 'Repair Procedure' on page 3.

If the multi-fuse location #3 is blown, the multi-fuse does NOT need to be replaced.
