## Product Update: 2023 HR-V Rear Window Inspection

Supersedes 24-017, dated July 17, 2024, to update the parts information in **yellow**.

### BACKGROUND

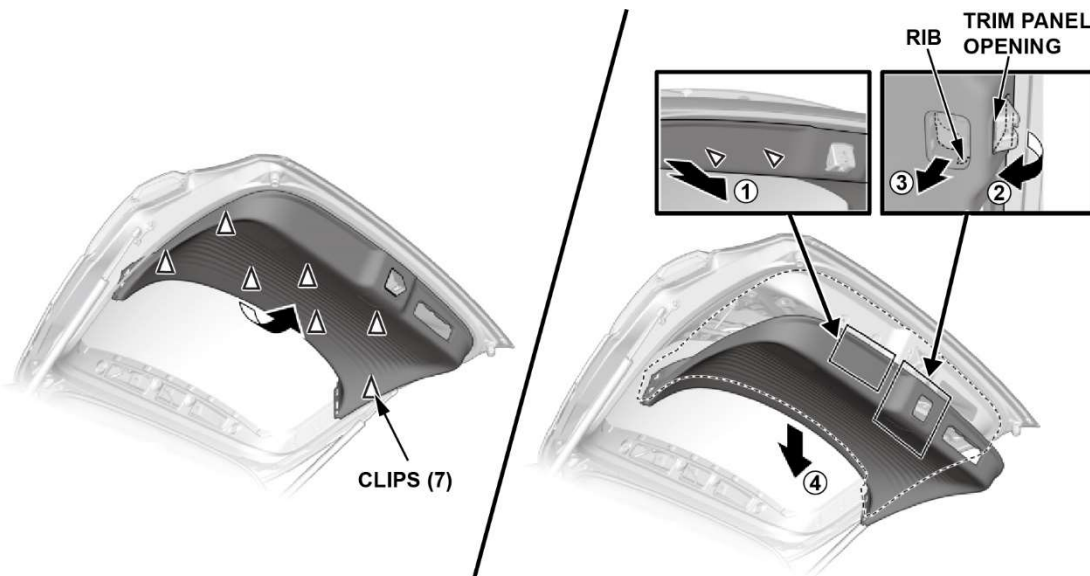
2. Remove the tailgate trim panel.

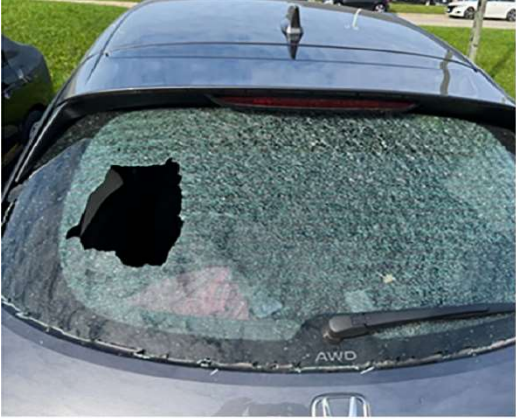
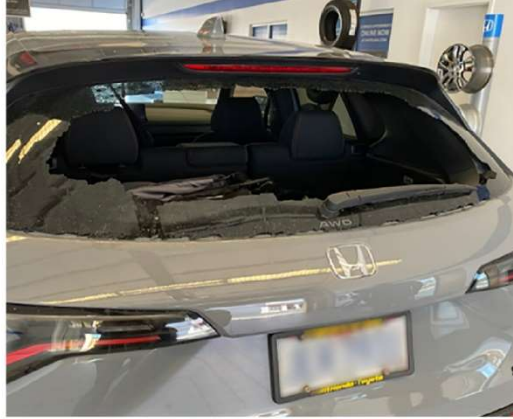
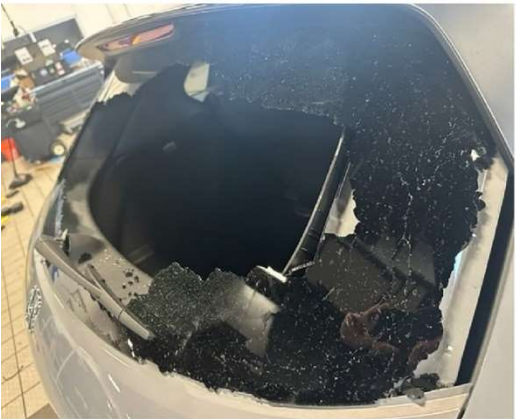
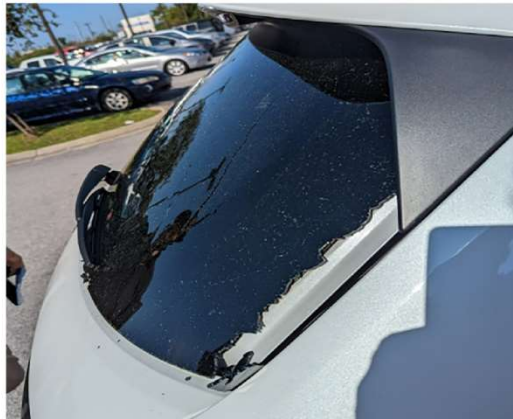
NOTE: Make sure that the vehicle does not have any visual body damage that could have caused the rear glass to shatter.

1. Take a photo of the **VIN plate** plus **two photos** of the broken windshield and upload to the warranty claim.
2. Clean any debris in the rear cargo area, and inside of the rear tailgate, caused by the shattered glass.
3. If there are no signs of damage to the bumpers, tailgate, wiper, or body alignment issues, and the tailgate opens and closes properly, go to the **REPAIR PROCEDURE** and replace the rear windshield glass.

If there are signs of visible body damage (from a vehicle accident), refer to the **DPSM** for evaluation.

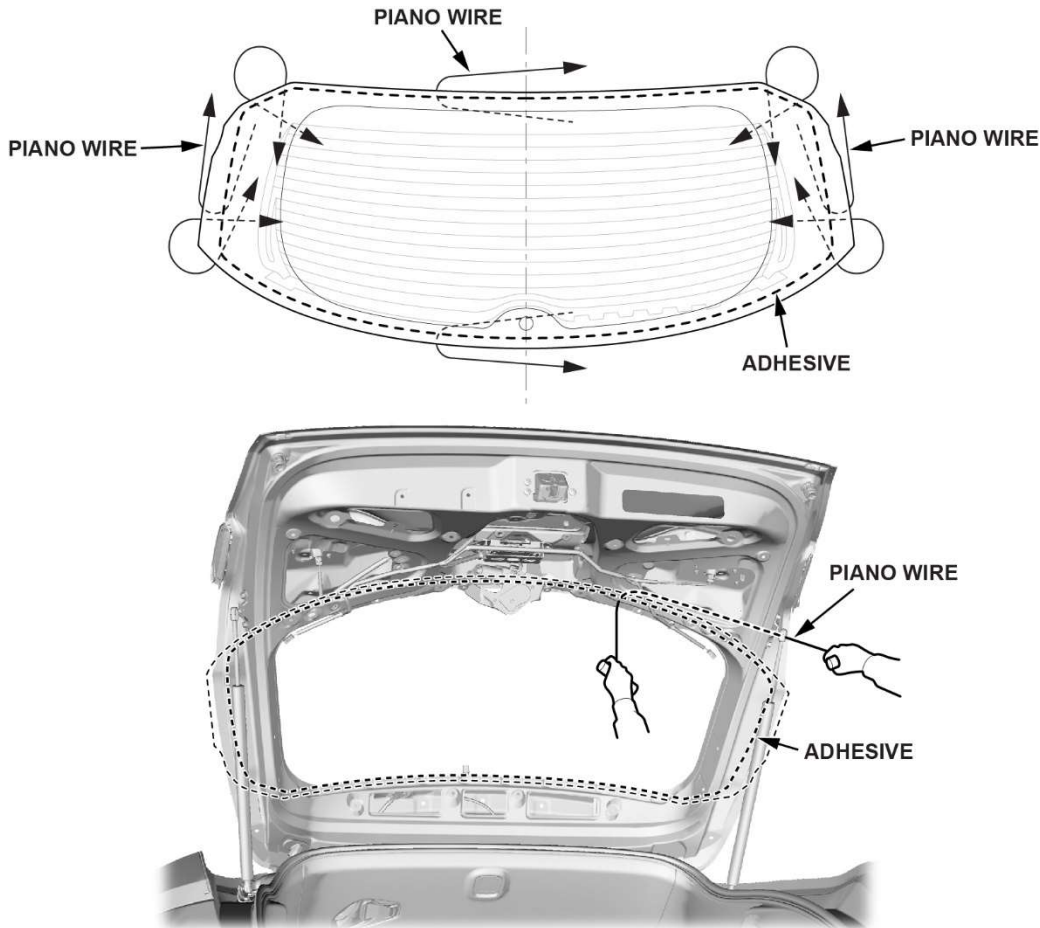
10. Make a hole through the adhesive (from inside the vehicle) at a corner of the rear window, then separate the adhesive.  
NOTE: Hold the piano wire as close to the rear window as possible to prevent damage to the tailgate.

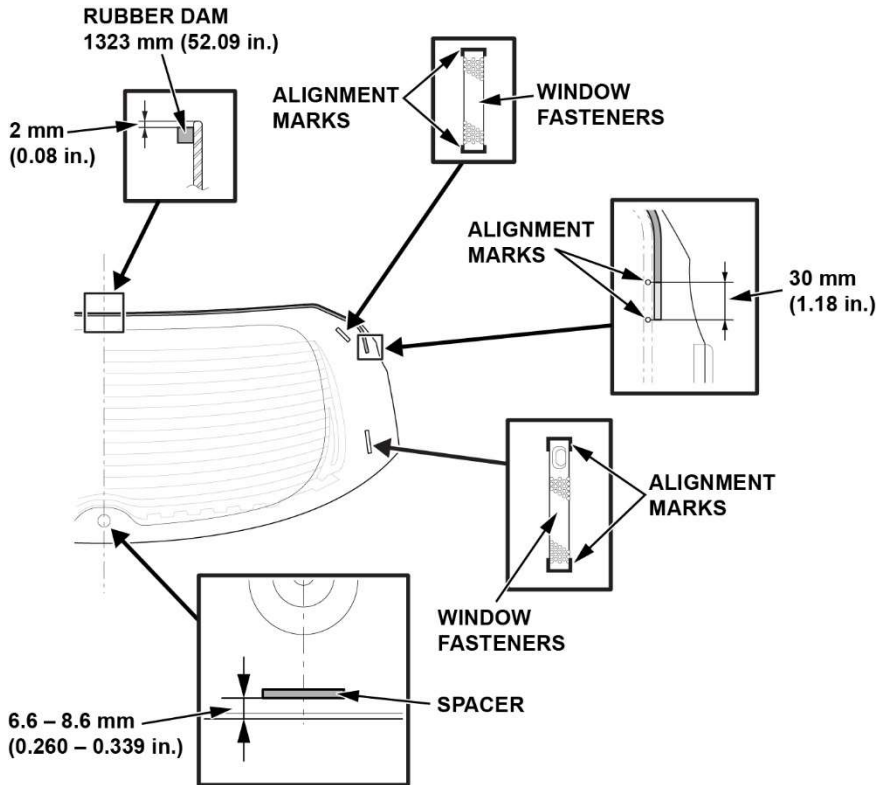
14. Install the following on the new glass:

- Before installing the fasteners and spacer, apply glass primer to the area where the adhesive tape will be applied.
- **Do not** touch the rear window where the adhesive will be applied.
- Make sure all fasteners line up with the alignment marks.

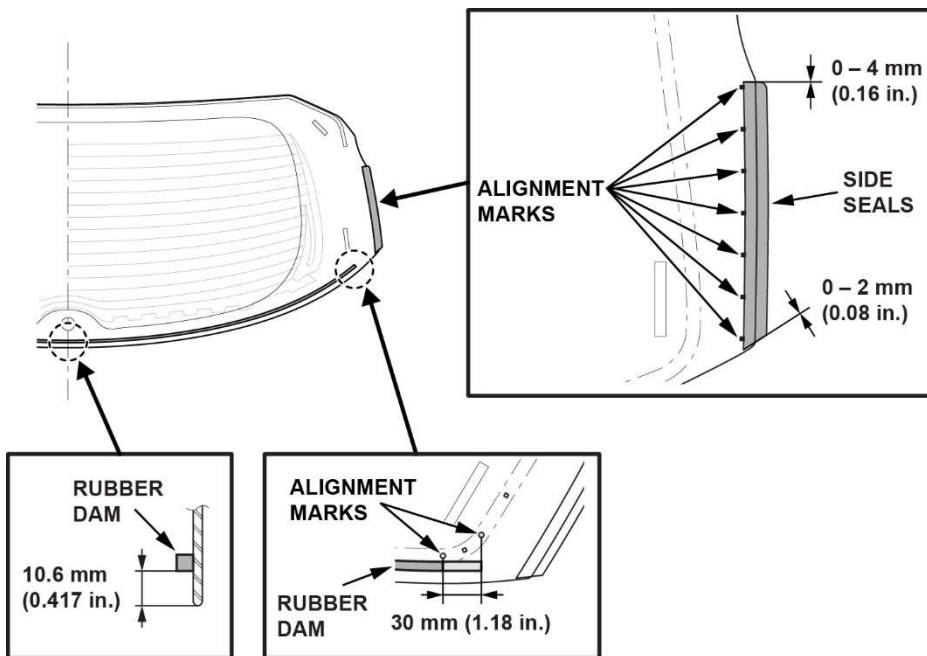
15. Install the rubber dams and side seals with adhesive tape on the inside facing of the rear window.

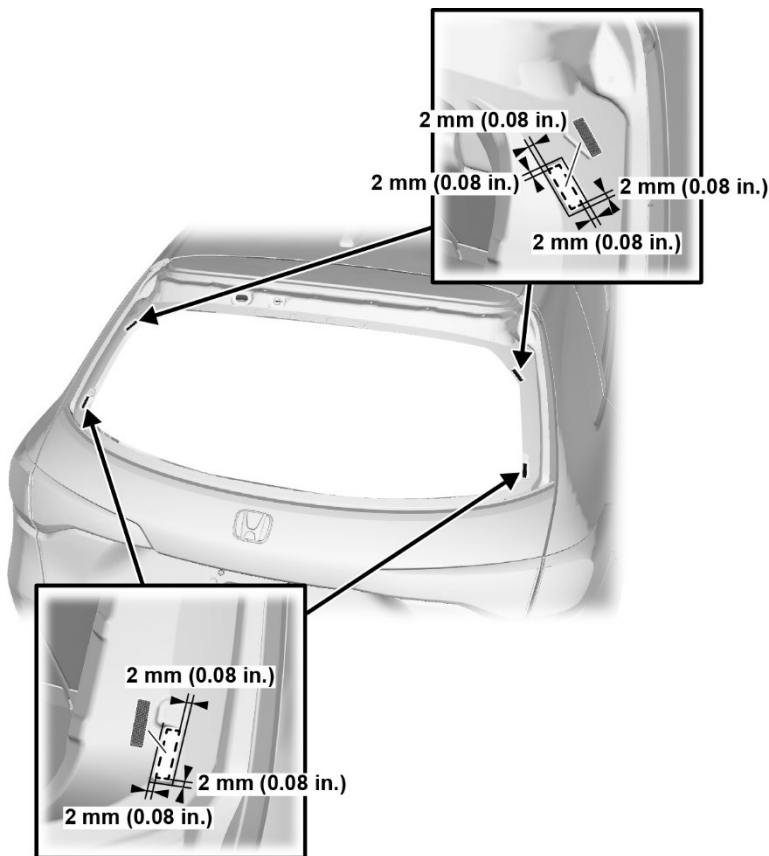
16. Attach the new fasteners with the adhesive tape to the rear window opening flange of the tailgate.

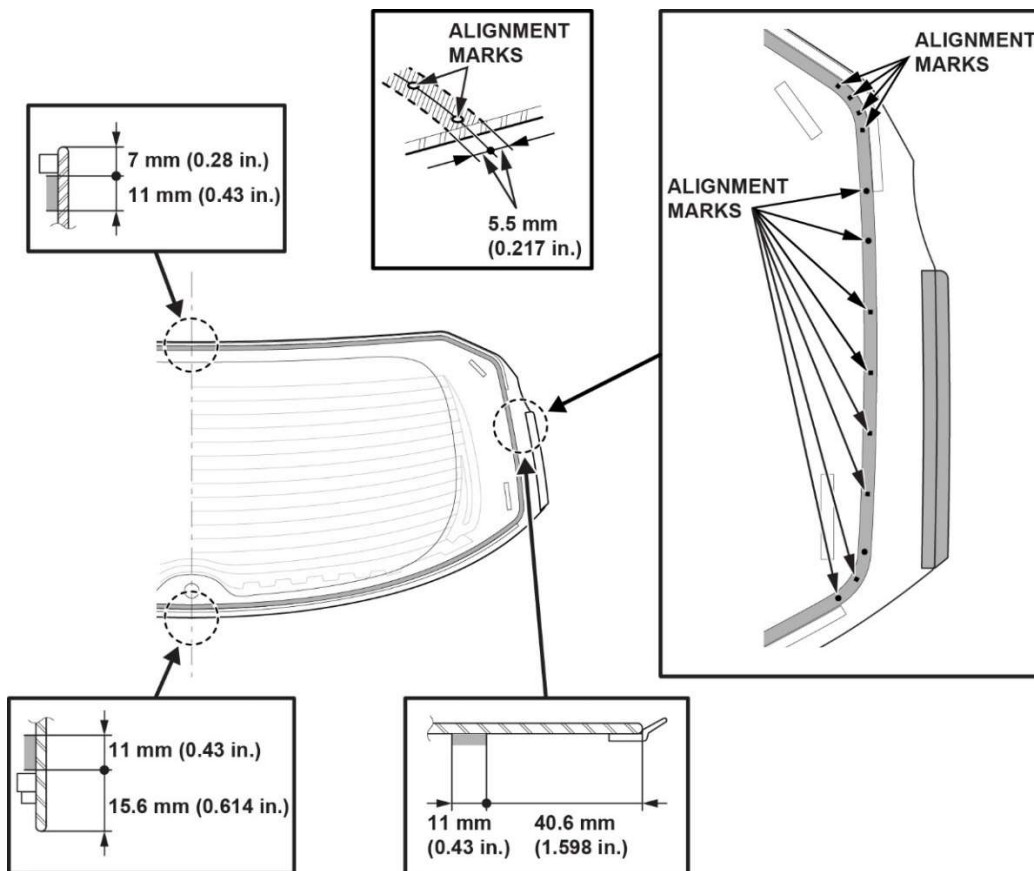
17. Apply a light coat of primer, then lightly wipe it off with a gauze or cheesecloth.

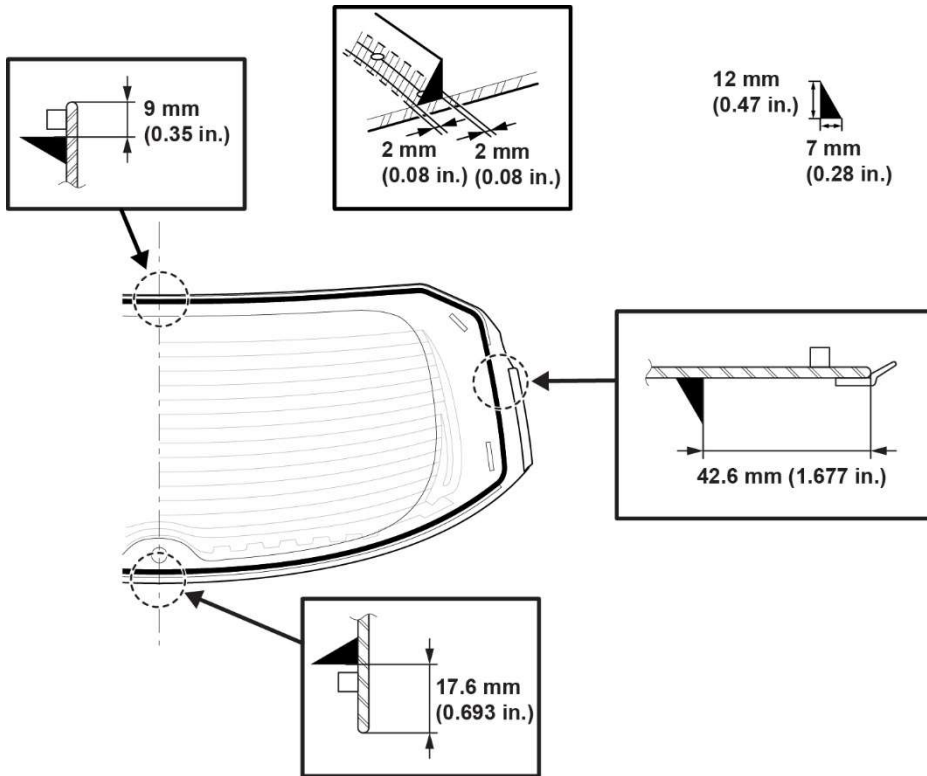
18. Apply a light coat of body primer to any exposed paint or metal around the flange where the new adhesive will be applied. Let primer dry for at least **10 minutes**.
