This Service Information Bulletin (Revision 7) replaces SI B54 11 19 **dated January 2024**.

F95 (X5 M Sports Activity Vehicle)	F96 (X6 M Sports Activity Coupe)	F97 (X3 M Sports Activity Vehicle)	F98 (X4 M Sports Activity Coupe)
G01 (X3 Sports Activity Vehicle)	G02 (X4 Sports Activity Coupe)	X5 (Sports Activity Vehicle)	X6 (Sports Activity Coupe)
X7 (Sports Activity Vehicle)

This bulletin outlines known areas of possible water entry, operational noise, or wind noise for the vehicles listed above. It serves only as a diagnostic resource in troubleshooting complaints from the roof area.

SUNROOF DIAGNOSIS

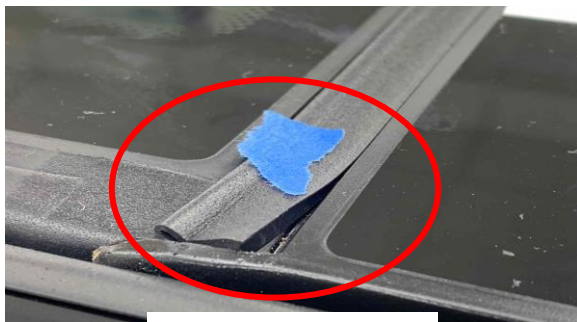
Defect: separated

Situation: Excessive water enters through the sunroof seals.

Repair: Look for gap near end of the seal on front glass. If found, replace seal according to ISTA/AIR instructions REP 54 13 052. Also refer to B54 04 21.

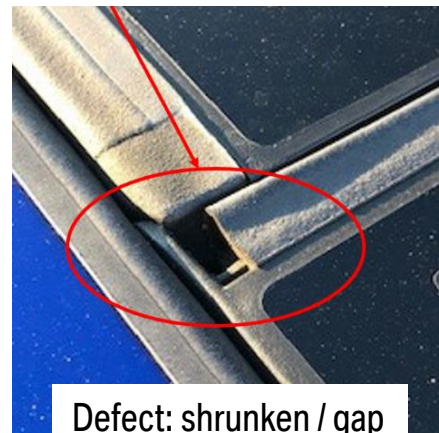
Defect: shrunken / gap

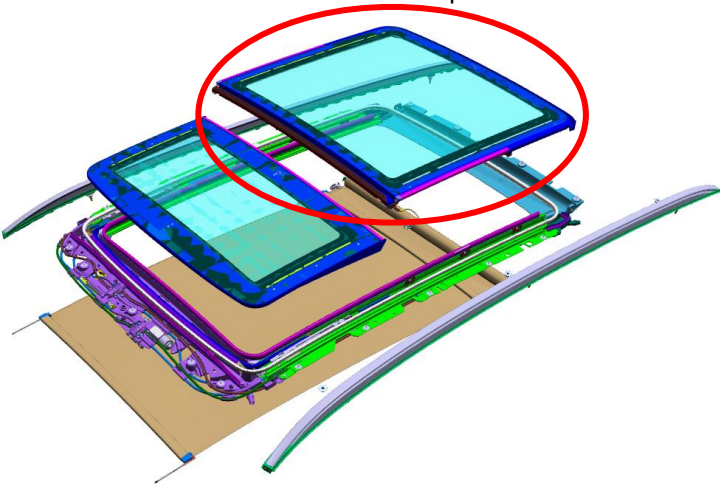
Situation : Excessive water enters through the sunroof seals. (see pictures)

Repair: Look for gap near ends or twist in seal. If found, replace seal according to ISTA/AIR instructions.
REP 54 13 050

If gap is greater than 0.5 mm. Ensure that the locking tab is present on the glass panel

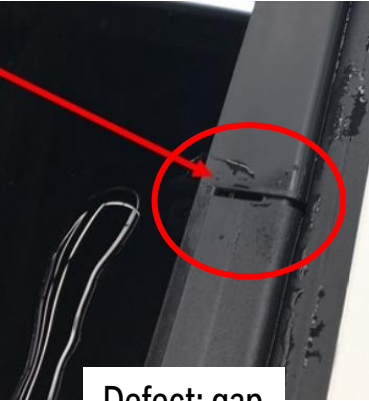
Defect: gap

Seal not engaged over the locking tab. Vent the glass and reattach.

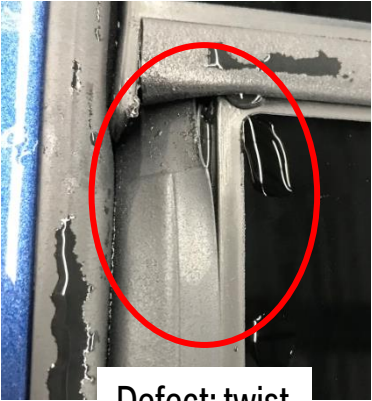
Defect: twist

Reattach for repair

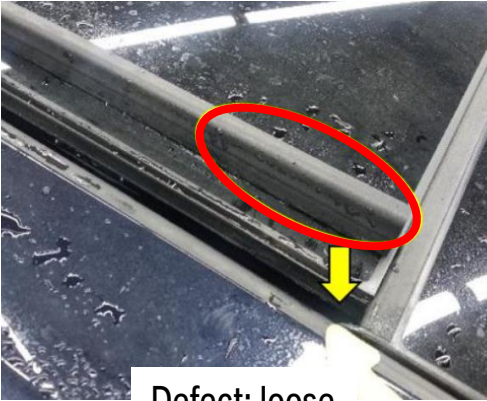
Defect: loose

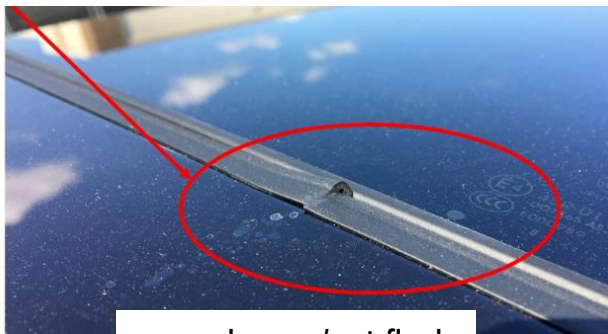
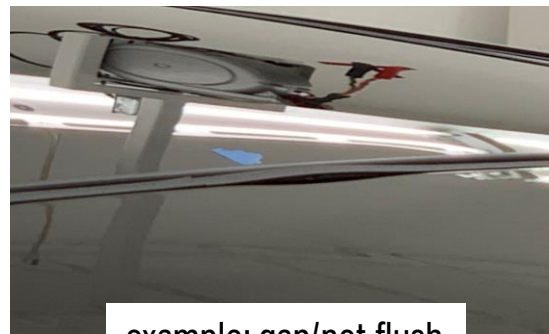
Situation : Excessive water enters through the sunroof seals.

example: gap/not flush

Repair: Inspect the sunroof perimeter seal for defects. Replace body seal according to ISTA/AIR instructions REP 54 13 055.

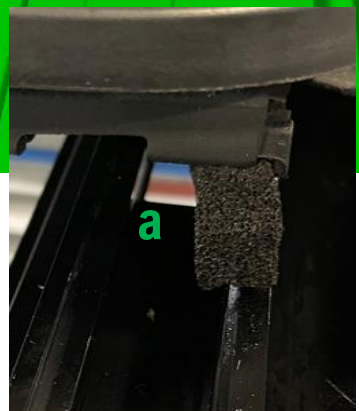
Correct foam position (a)

Repair: Check position of the seal/ foam. Remove foam/ seal if deformed or damaged. Refer to SIB 54 01 23.

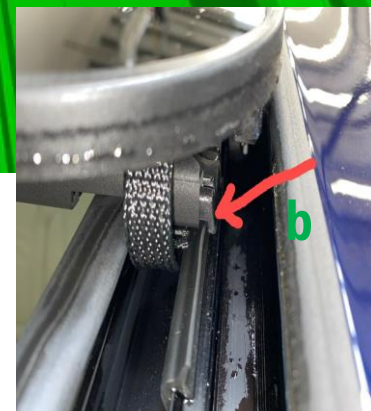
Correct seal position (b)

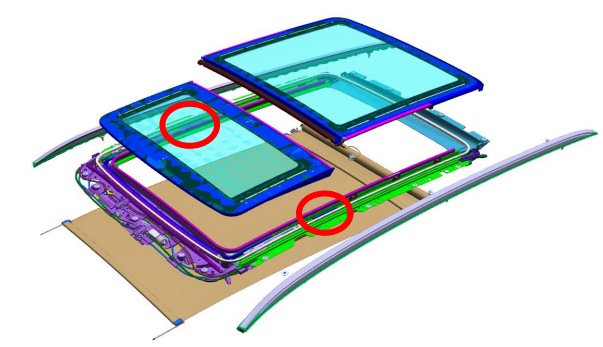
Check the position of the Dyko seal. It should be tucked under the outer edge of the rear glass encapsulation. In the photo above it is not in the correct position. This can cause water ingress to the pano roof.

Use a tool to ensure the Dyko seal is positioned behind the edge of the rear glass encapsulation. Use care when moving the seal as to not dislodge the seal from the frame.

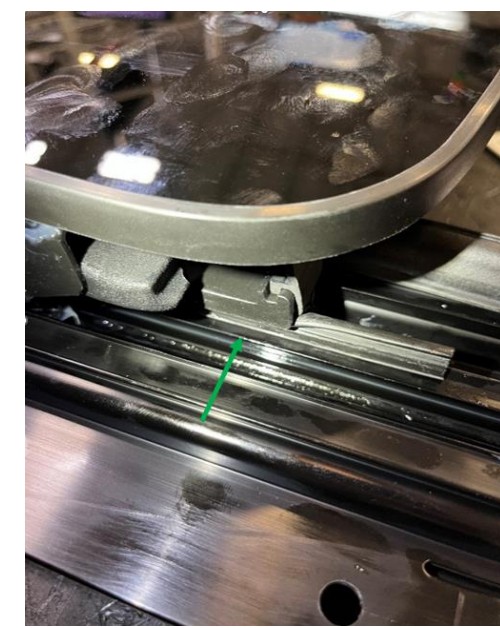
After the correction to the Dyko seal is made, it should look like the photo above. Completely behind the rear glass encapsulation.

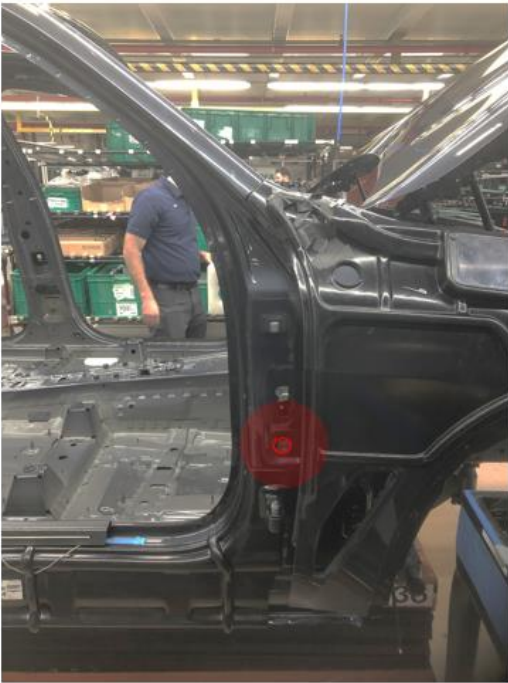
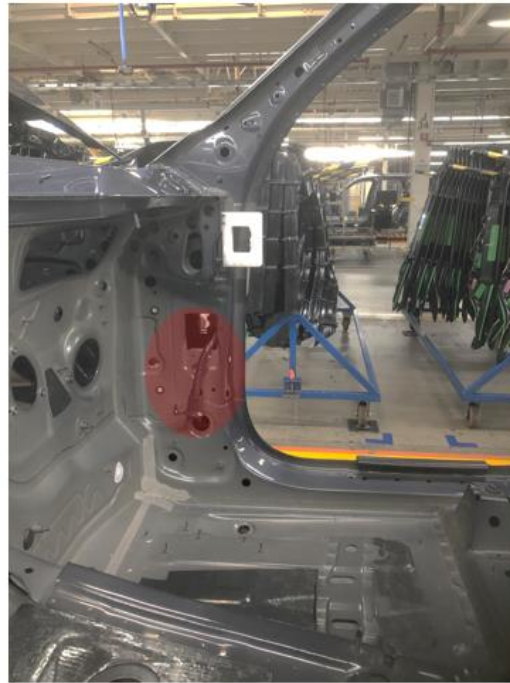
Situation: There is a water leak near the front or rear carpets. The drain tubes may be twisted. Remove A-pillar kick panels to check if front drain tube is twisted/kinked. Use borescope if needed.

!!This situation is one of the more common issues. Investigate thoroughly!!

Repair: Reposition hose to remove kink. If kink can't be removed, refer to B54 11 19 Attachment 1 for repair instructions.

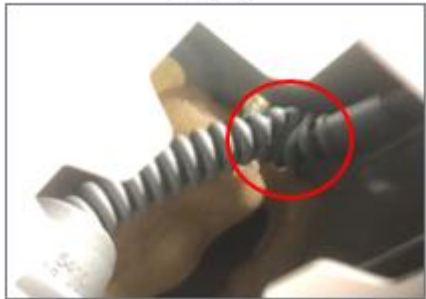
kinked

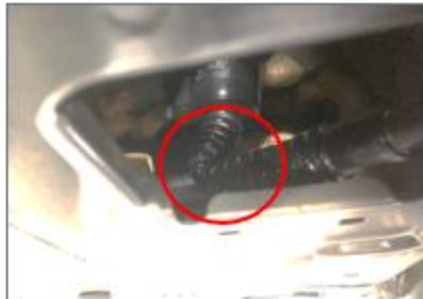
Slightly kinked

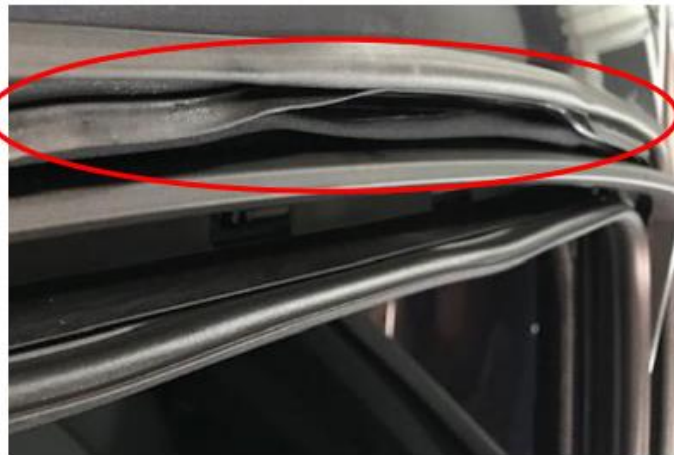
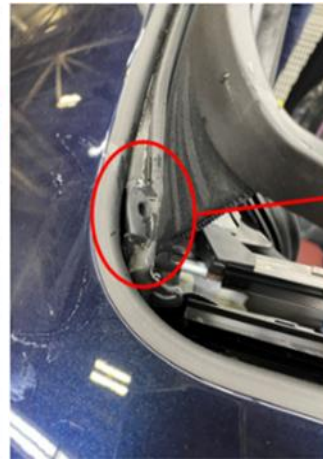
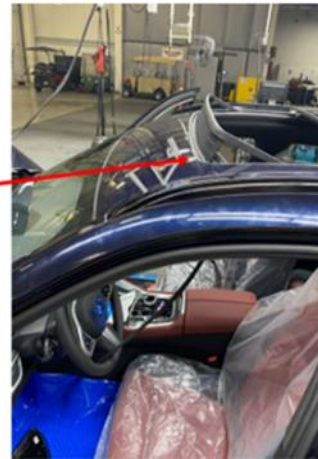
Solution: There is a water leak in the front. The aero-acoustic seal may be incorrectly installed or deformed.

Repair: Check if the seal is properly seated and in good condition. If not, then reset or replace the aero-acoustic seal and replace the body seal according to the ISTA/AIR instructions REP 54 13 055.

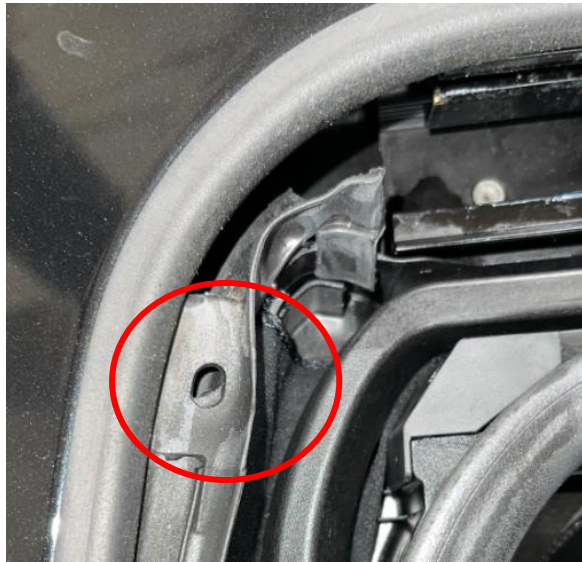
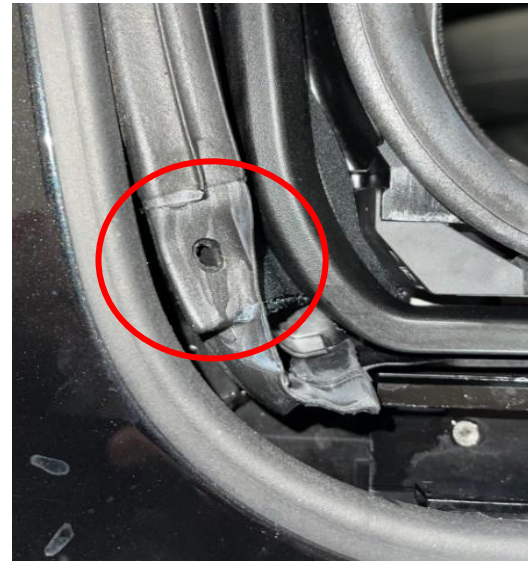
Solution: There is a water leak in the front. The aero-acoustic seal may have flash or blockage at the front vent/ drain holes.

Repair: Check if the seal is blocked at the front corners. If the holes are block by flash then replace the aero-acoustic seal.

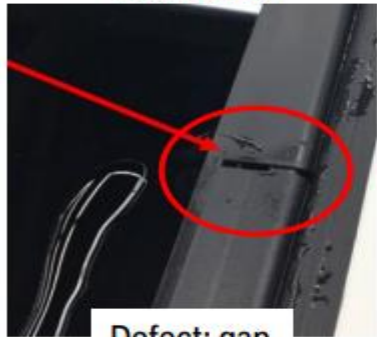
Defect: gap

Situation: Heard on fast track (50kph). Run water on top of car and look for leak. Look for gap near end of the seal on front glass. Excess water enters through the sunroof seals. (see photos)

Repair: Look for gap near the ends or twist in the seal(s). If found, replace seal according to ISTA/AIR instructions REP 54 13 050. If the knob or locking feature is missing on the rear glass panel replace the rear glass panel.

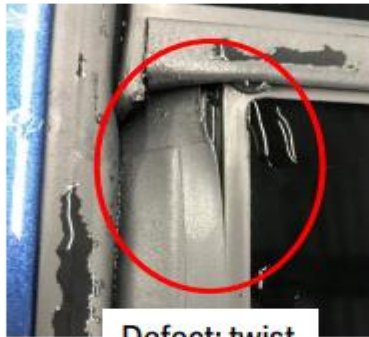
Defect: twist

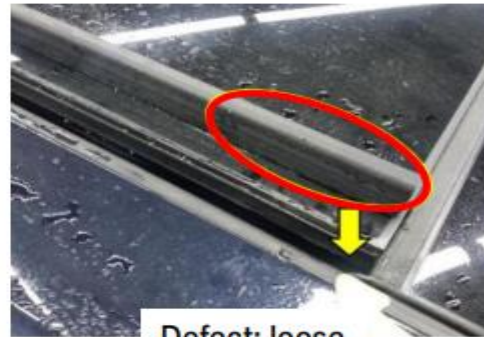
Defect: loose

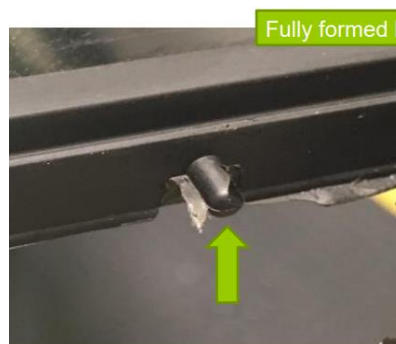
Fully formed knob

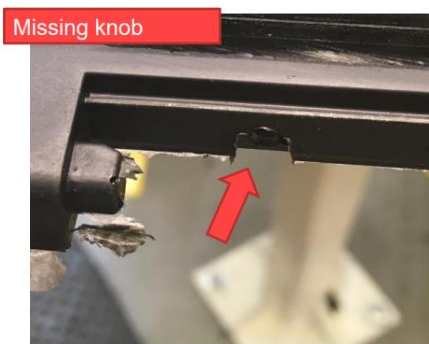
Missing knob

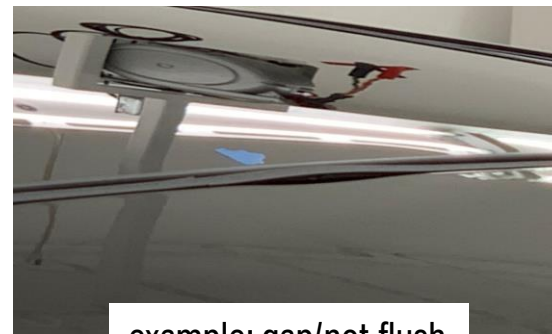
Situation: The body seal may be detached or improperly installed.

example: gap/not flush

Repair: Check body seal to see if it is flush to vehicle. (no loose areas/wrinkles)

If damaged, replace body seal according to ISTA/AIR instructions REP 54 13 055.

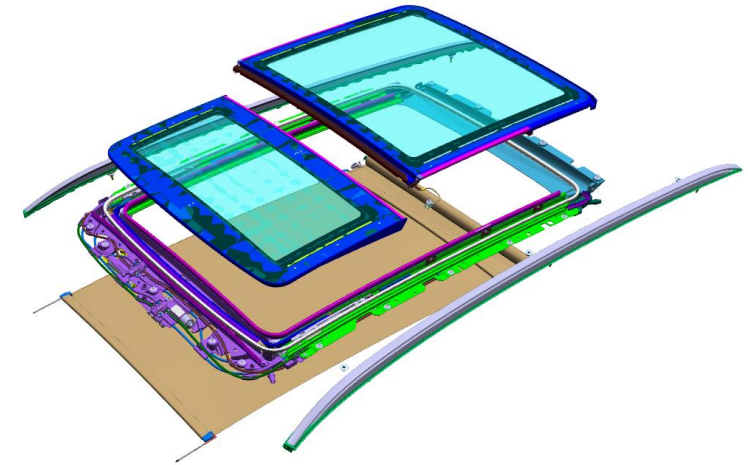
Situation: Rushing wind noise is heard from center of the glass.

Repair: Tape can be used to isolate noise and find where glass is not flush.

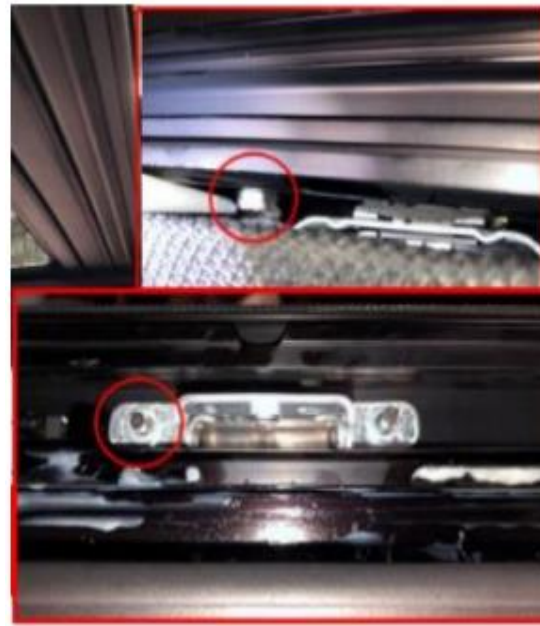
REAR GLASS BRACKET LOOSE

Situation: Metallic noise heard while driving over rough road surfaces.

Repair: Inspect bracket screws (**bracket to frame**, not glass to bracket). Check for any screws with thread lock interference. If excess thread lock is on the screws then replace screws. Tighten loose screw(s) to 6.1 Nm to fully seat. If the screws can't be tightened correctly, the frame would need replacement.

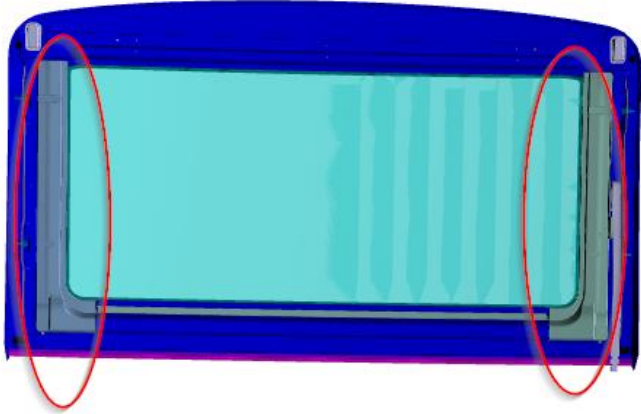
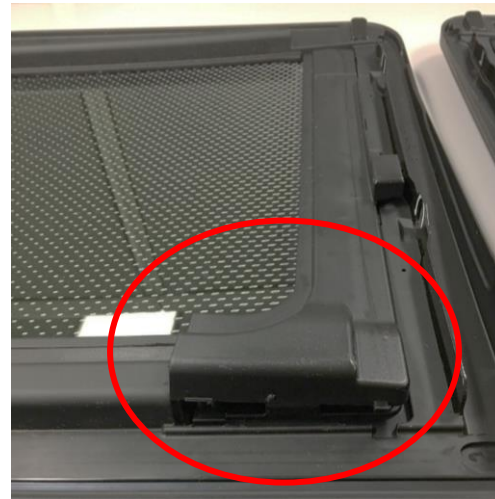
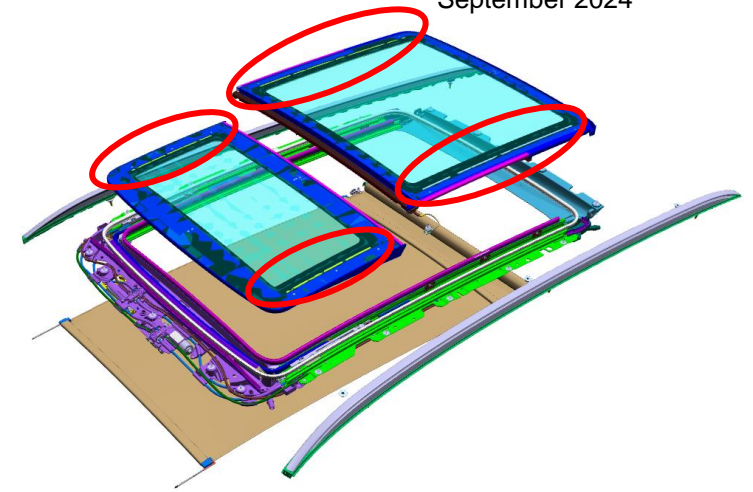
Situation: Rattle is heard from plastic cover tapping on glass panel (front or rear glass) when driving on rough road surfaces.

This situation only affects vehicles with SA407 (Panoramic Sky Lounge LED Roof)

Repair: Attempt to insulate with felt tape is visually appropriate. Replace glass panel according to ISTA/AIR instructions REP 54 13 250 if insulation is not possible.

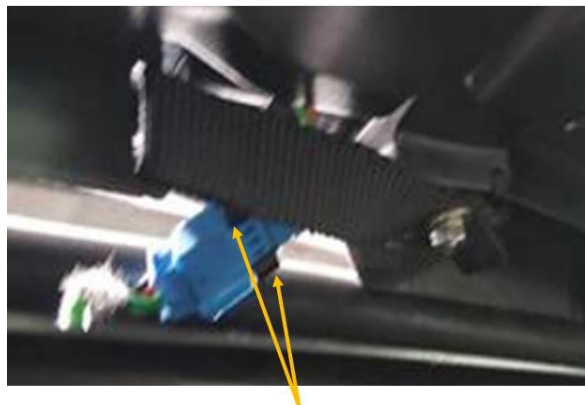
Clip loose with prongs attached to connector

Solution: A loose clip for the ambient light harness is tapping on the glass or contacting the sunroof mechanism. Only affects vehicle with SA407 (Panormaic Sky Lounge LED Roof).

Repair: Correctly install the harness clip.

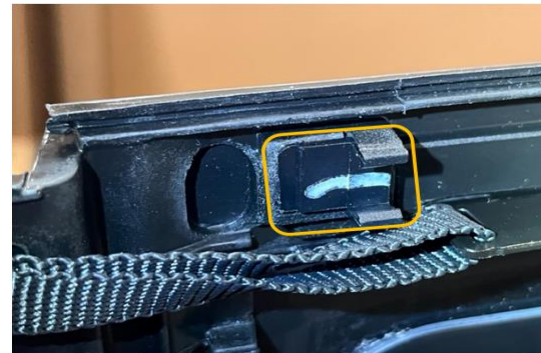
Clip attached to panel with a press fit rib on the back into a slot on the panel. Glass supplier glues the rib with cyanoacrylate glue.

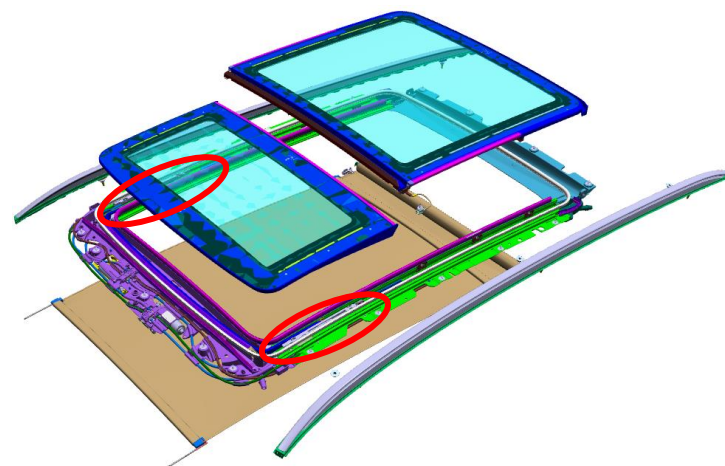
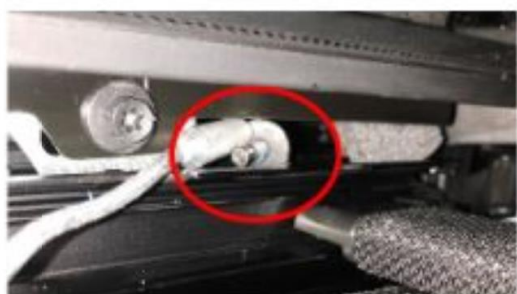
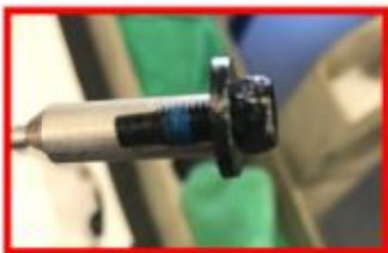
EXTRA SCREW

Situation: A metallic “rolling” noise is heard during acceleration/deceleration. An extra screw may have fallen into the track during production. The screw is not missing from any location.

Repair: Remove the extra screw. Additional repairs are not necessary, all other screws are correctly installed.

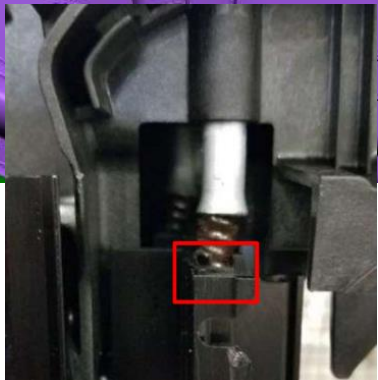
Defect: misaligned or burr

Repair: Inspect the sunroof frame for misalignment or a burr on the cable guide as shown. If damage is found, replace the frame according to ISTA/AIR instructions REP 54 13 261.

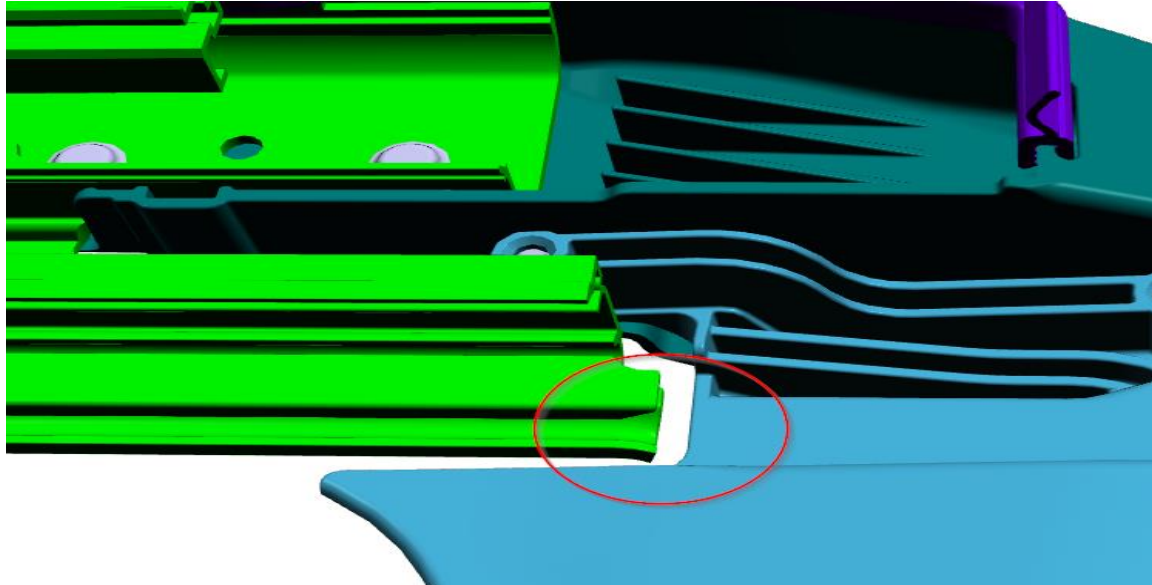
Sharp/Burr on Rollo entry at rear of guide

Repair: Remove the burr on the edge of the PDF rail to break the edges. If the noise is still present then replace cassette frame according to ISTA/AIR instructions REP 54 13 261.

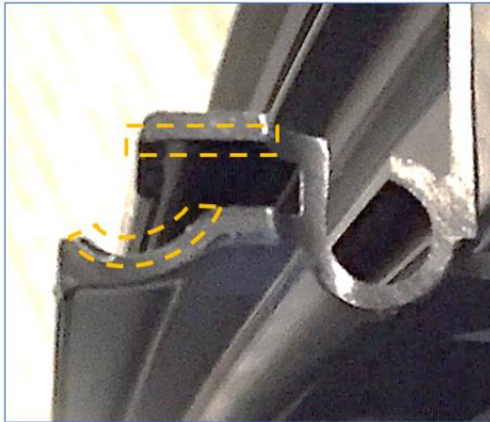
Burr on PDF lip on guide

Run a round pick across these two edges to break the edge.

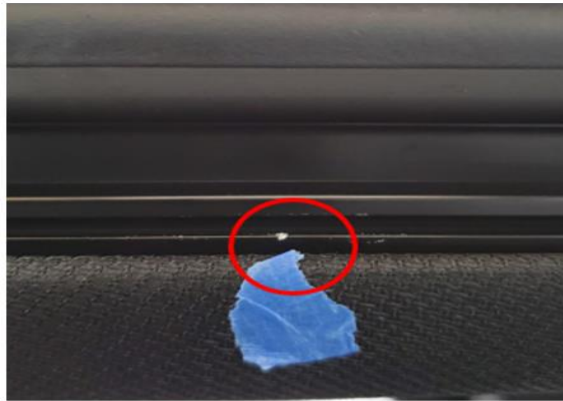
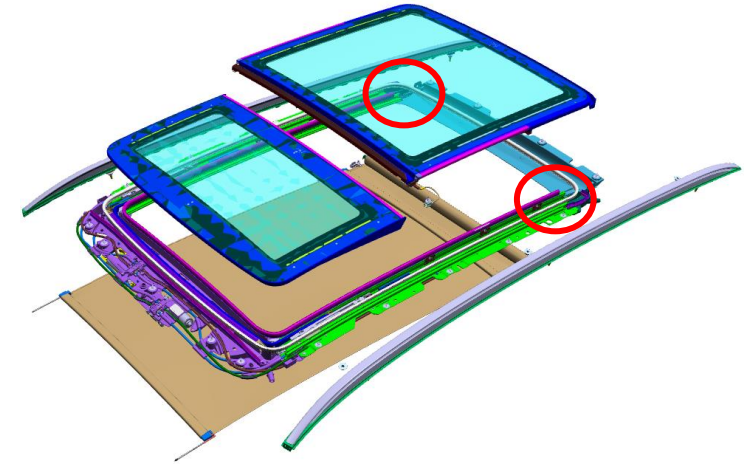
Situation: If scratching/catching noise is heard while shade is moving.

Knock off any vertical burr on horizontal surface and touch up with a black paint pen or permanent marker.

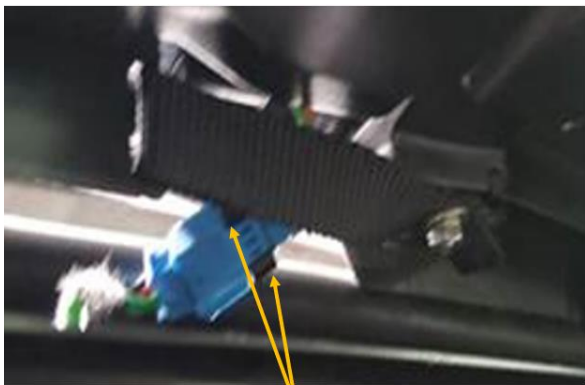
Clip loose with prongs attached to connector

Solution: A loose clip for the ambient light harness is tapping on the glass or contacting the sunroof mechanism. Only affects vehicle with SA407 (Panormaic Sky Lounge LED Roof).

Repair: Correctly install the harness clip.

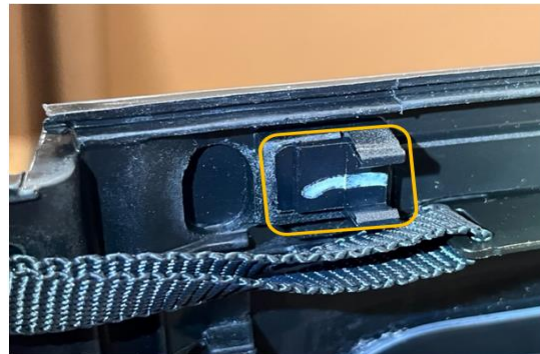
Clip attached to panel with a press fit rib on the back into a slot on the panel. Glass supplier glues the rib with cyanoacrylate glue.

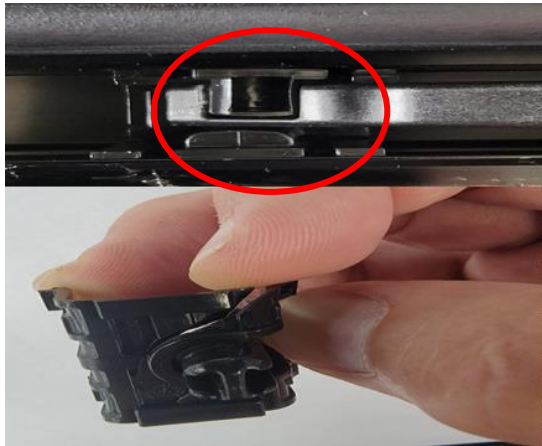
WIND DEFLECTOR PIVOT POINT LOOSE/BROKEN

Situation: A creaking noise is present while the wind deflector raises/lowers. Sunroof may reverse due to anti-trap when closing.

Repair: Replace pivot point and wind deflector according to ISTA/AIR instructions REP 54 13 090

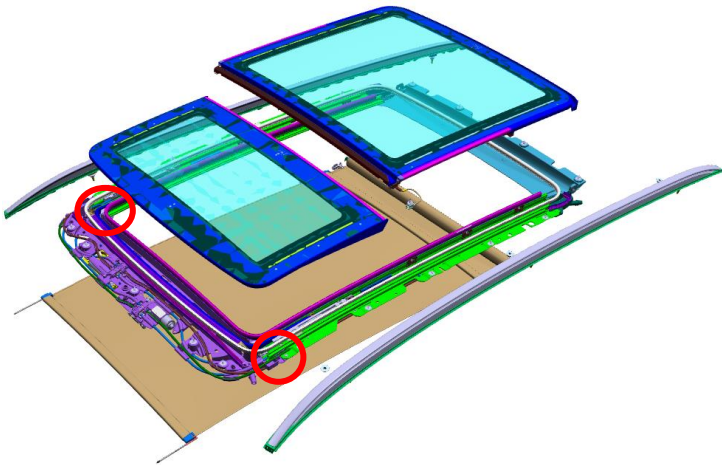
Picture of NOK (Before adjustment)

Situation: A popping noise is heard when the wind deflector raises/lowers.

Repair: Remove excess butyl to allow the wind deflector to move freely.

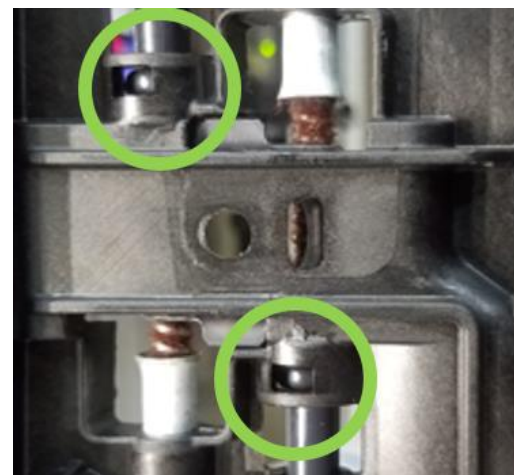
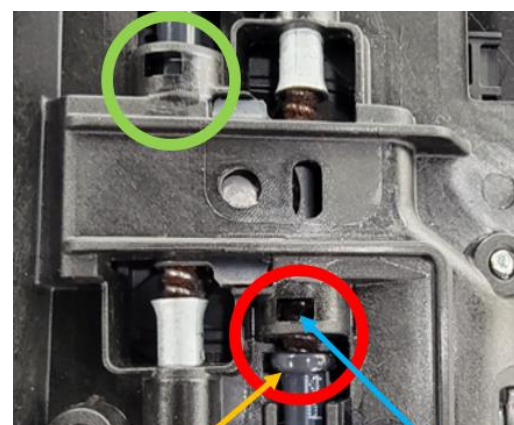
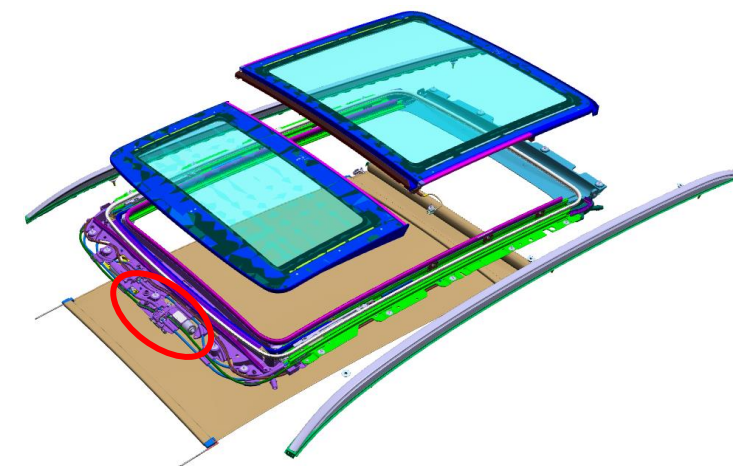
RELIEF CABLE TUBE NOT INSTALLED/ LOCKED IN

Bead not visible in window

Situation: A humming/ crackling noise is present when the opening of the sunshade or the glass.

Repair: Replace frame according to ISTA/AIR instructions REP 54 13 261.

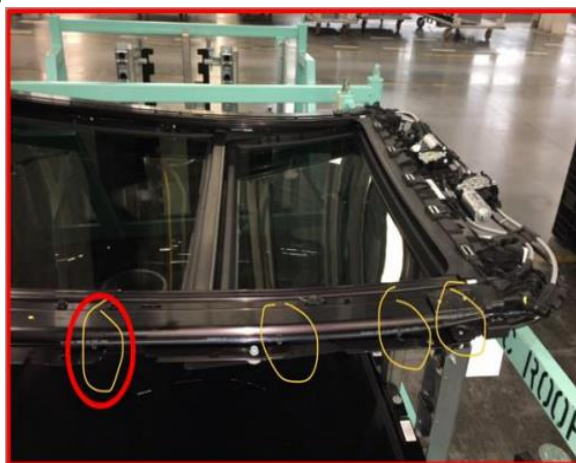
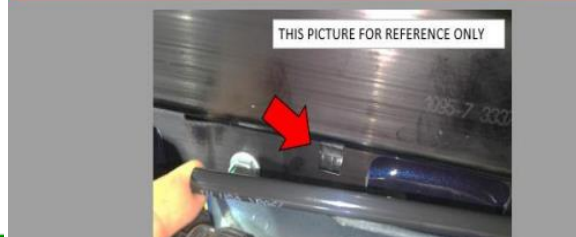
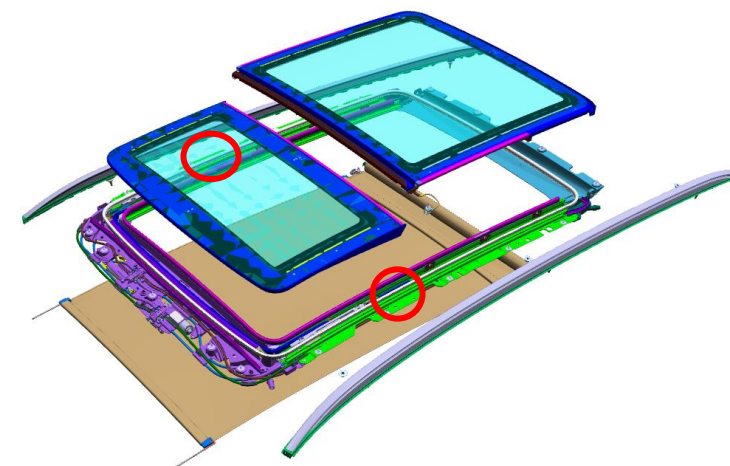
CABLE TUBE CLIP NOT INSTALLED

Identifier: If there is humming / crackling noise when opening of the sunshade. Or Plastic rattling while driving on bad track.

Repair: Engage/set clip correctly. If tube is damaged and noise persists then replace cassette according to rework instructions.

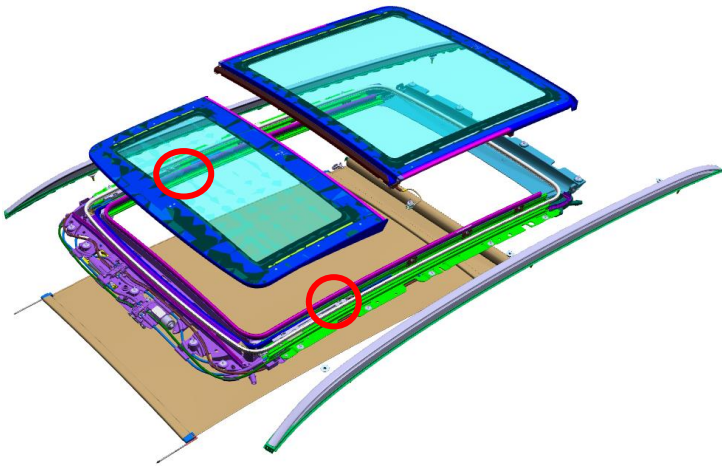
MECH ARM BURR

Scratching noise when glass is moving to full open position or early in close motion from a burr dragging along the rear glass seal or body seal. In addition to removing the burr from the mechanism, seals should be checked for degradation from the burr.

Repair: Inspect the pivot area for a burr and remove it if found. If the burr can't be found or it can't be repaired, replace the sunroof mechanisms according to ISTA/AIR instructions REP 54 13 515.
