SERVICE BULLETIN

NUMBER: 03-94-24

SUBJECT: Front Transverse Link Bushing Cracking

DATE: 09/04/24

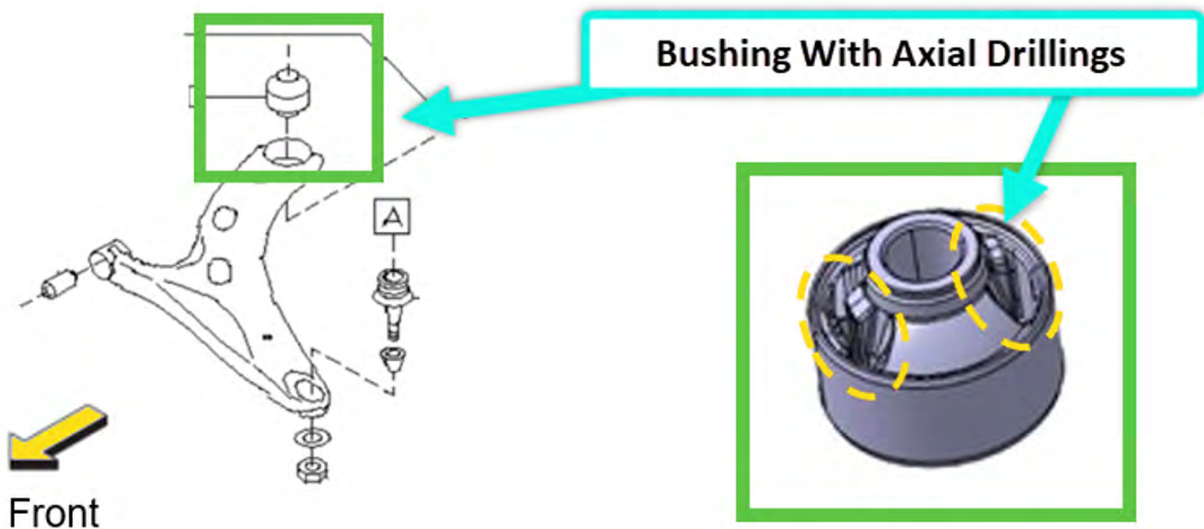
This bulletin outlines the judgment criteria to be used when inspecting front transverse link bushings. This information was developed to reduce unnecessary bushing replacement. Small surface cracks located on the rubber will not have any affect on the performance of the bushing. It is important to review the inspection information supplied in this bulletin prior to the replacement of front transverse link bushings.
