SERVICE BULLETIN

APPLICABILITY: 2019-24MY Forester

NUMBER: 12-255-24R

SUBJECT: Knocking Type Sound from Engine Compartment

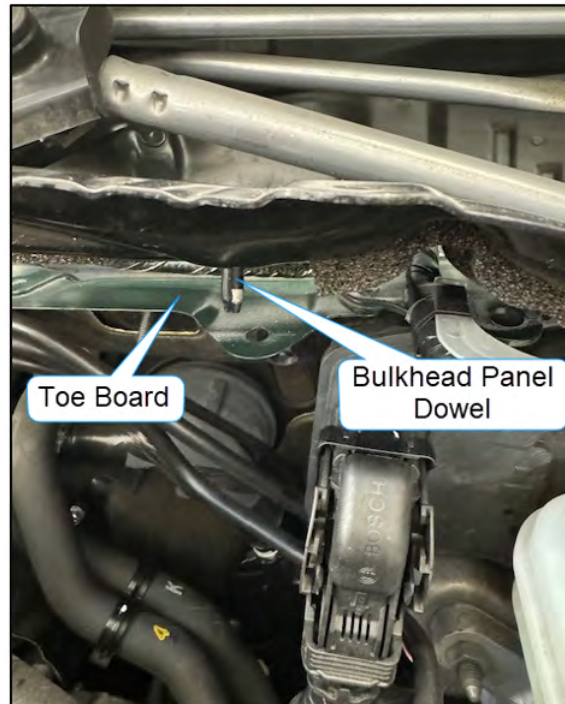
This bulletin announces the repair procedure developed to address cases of a knocking type sound emitting from the engine compartment. The front bulkhead panel dowel on the driver side can rub against the toe board causing a knocking sound when driving over small bumps. If this knocking sound from the engine compartment is duplicated, follow the service procedures outlined in this bulletin.
