## Preview Solution CBR-570-6

### **US17 GHG Common Rail Fuel System Component Electrical Faults - Model Year 2017 To 2024**

Published 20 September 2024

Valid for Volvo models VN,VAH,VHD Mack models AN,GR,GU,LR,CHU,CXU,PI,MRU,TE model years 2017 to 2024

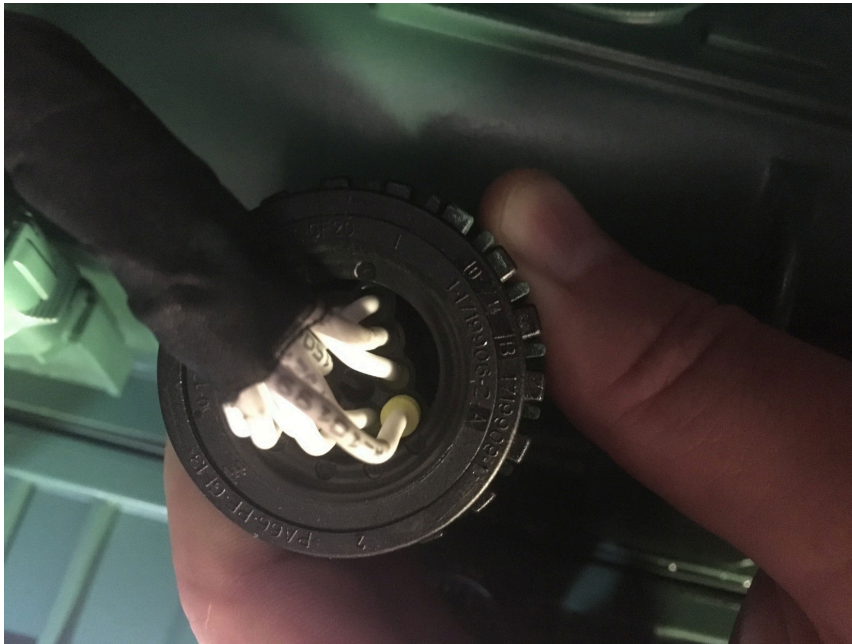
Follow Guided Diagnostics for any of these components with associated electrical faults. However, the cause for some of these faults has been identified with terminals not locked properly in place on the VCI 1 and VCI 2 connector. The VCI connectors are located on the lower valve cover base. The plastic wire cover on the connector should be removed for better visual inspection. This is an area where special attention should be taken to inspect for an issue.

Picture below of plastic wire cover on the VCI connectors.
