**Subject: Engine Wire Harness Chafing / IPC Gauges Sweep / IPC Warning Message / SES/Check Engine/MIL / No Start / No Crank / Runs Rough / Stalls / Reduced Engine Power / Various DTCs**

*This bulletin replaces PIT5677E, PIT5713A, PIT5751C and PIT5742. Please discard PIT5677E, PIT5713A, PIT5751C and PIT5742.*

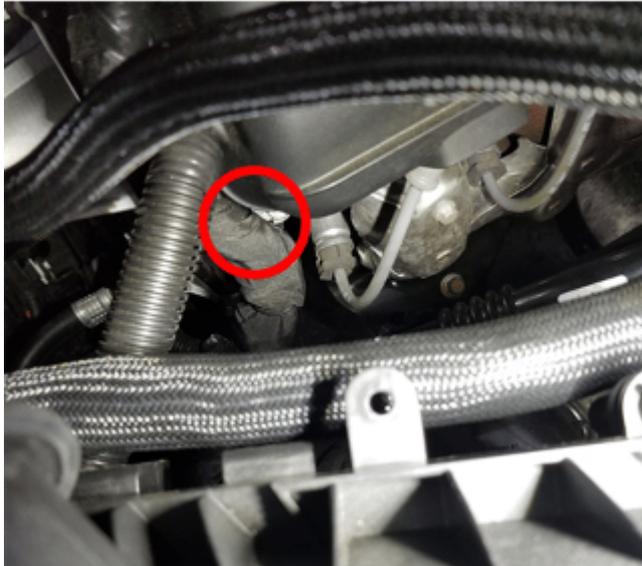
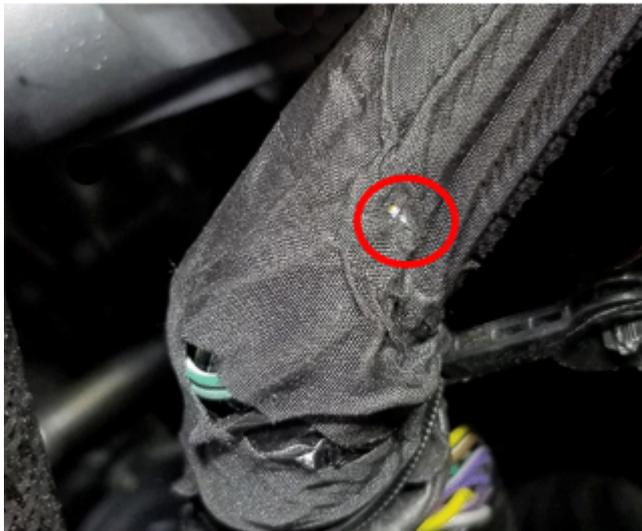
**Note:** The first graphic below is a before, and after (2), repair example of harness chaffing at the Oil Dipstick bracket.

To correct this concern, repair the damaged wiring following the SI wire-to-wire repair procedures. Once repaired, protect, and reposition the engine wiring harness to prevent future harness damage.

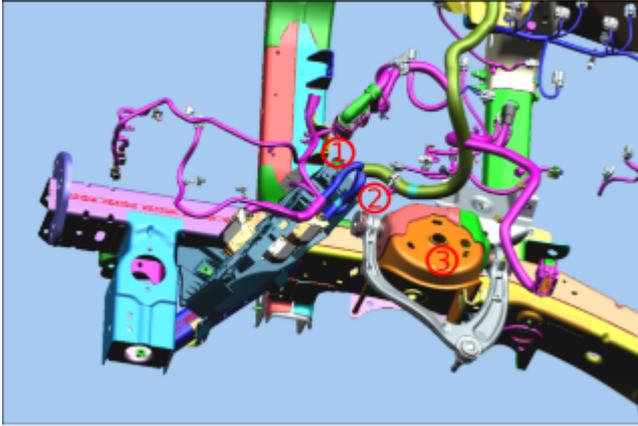
5868341

3. Locate the three contact points where the wire harness is chaffing, the ECM/TCM black bracket (1), the upper control arm (2), and the shock tower bolt (3).

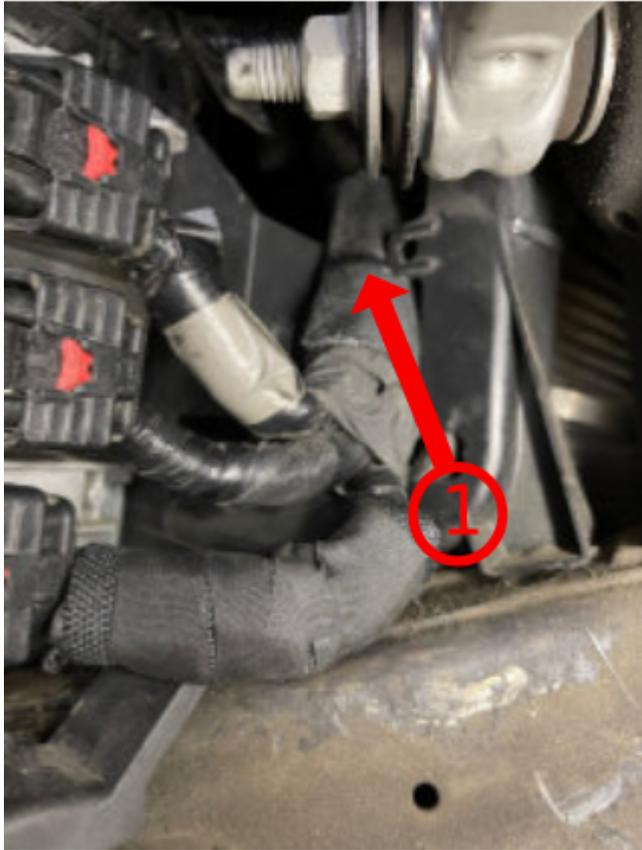
5868350

4. At the ECM/TCM bracket, locate the wire harness laying against the ledge (1).

5. Wrap the wire harness with the shorter Engine Harness Sleeve then utilizing zip ties and two small holes in the bracket (1).
