# HYUNDAI

## Technical Service Bulletin

GROUP <b>BODY</b>	NUMBER <b>24-BD-012H</b>
DATE <b>OCTOBER 2024</b>	MODEL(S) <b>IONIQ 5 (NE EV)</b>

**SUBJECT:** TAILGATE RATTLE & FRICTION NOISE REWORK

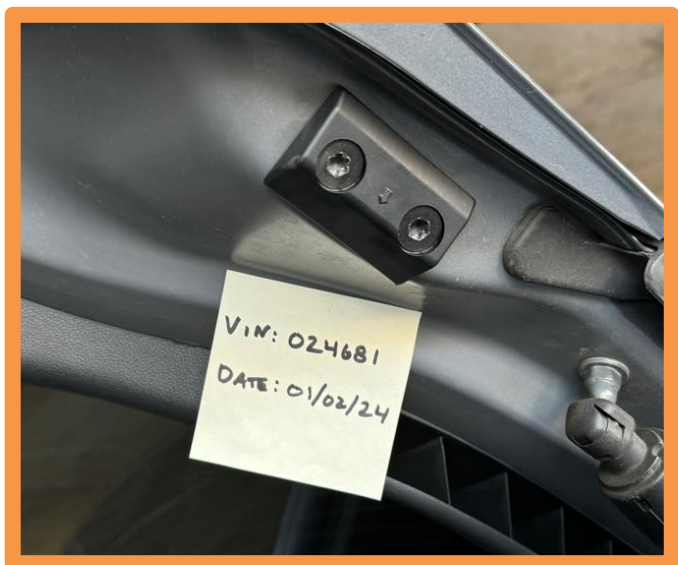
Using STUI, take a photo of the new tailgate side guide bumper installed with the last 6 digits of the VIN and the date of repair on a piece of paper.

7. Repeat Steps 1 – 6 for the opposite tailgate side guide bumper.

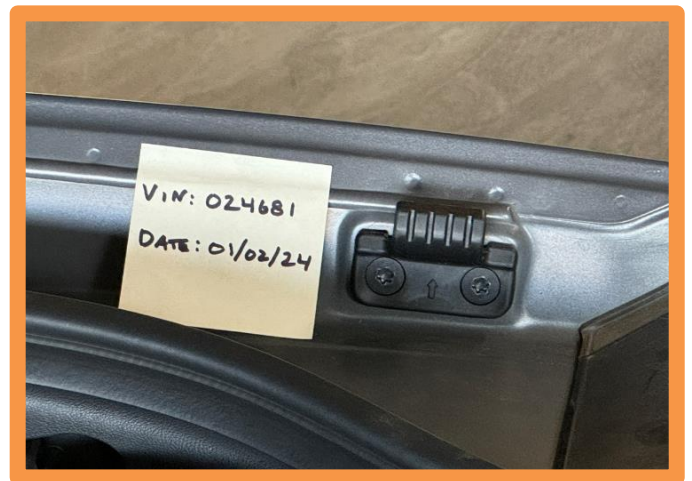
Using STUI, take a photo of the new outer side panel guide bumper with the last 6 digits of the VIN and the date of repair on a piece of paper.

5. Repeat Steps 1 – 4 for the opposite outer side panel guide bumper.
6. If further adjustment is required, proceed to the “Tailgate Striker & Overslam Bumpers Adjustment” section.
