Service Bulletin

Bulletin No.: 24-NA-166

Subject: DTC C1171 C1172 C1173 C1174 Tire Pressure Monitor Sensor Unable to Relearn Ethernet Cable Overlay for TCP OnStar Module

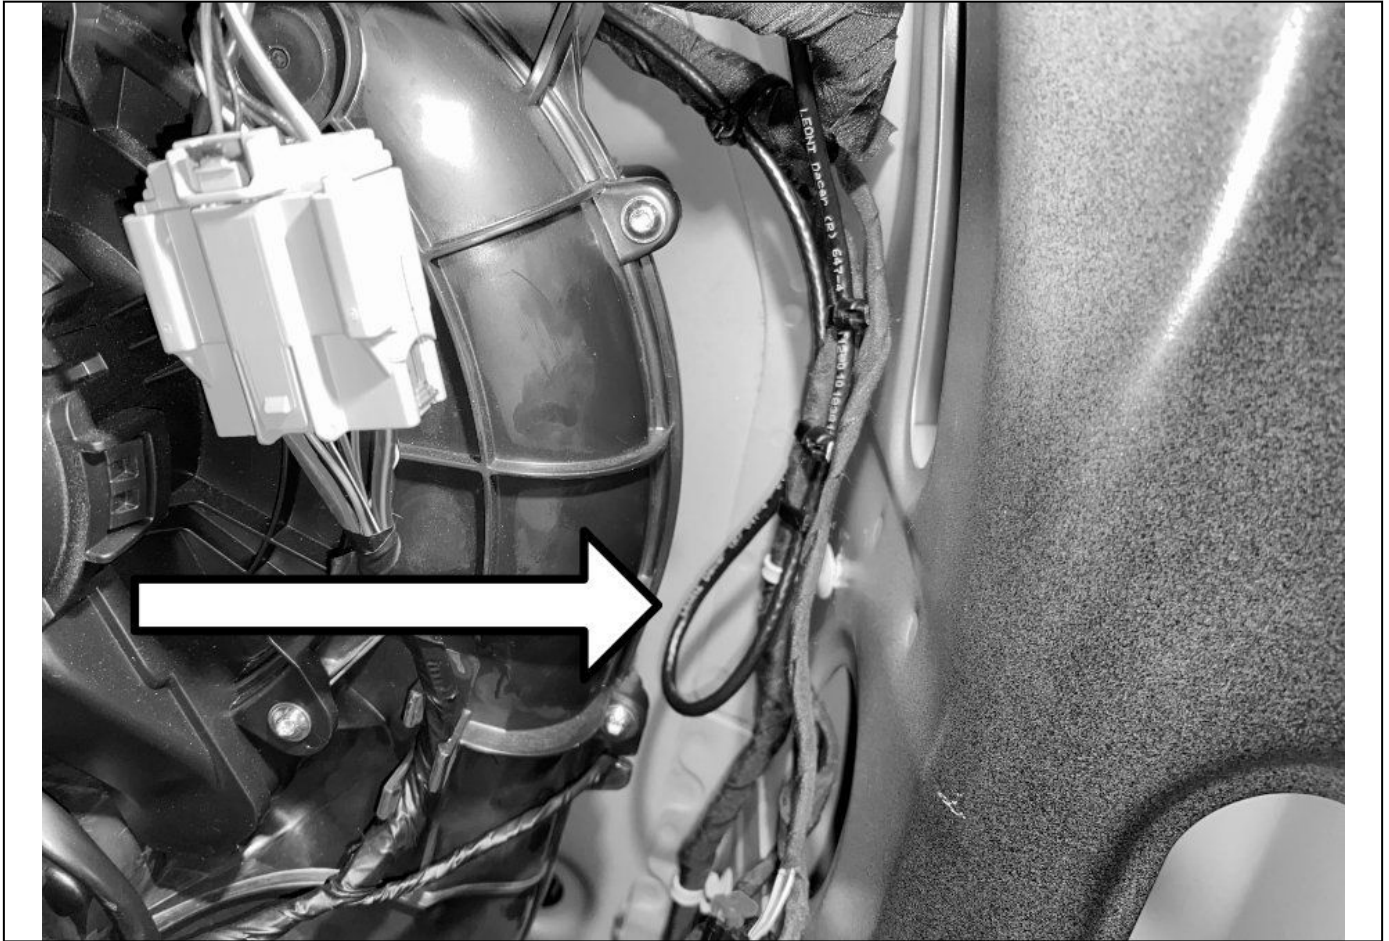
6706129

Important: Ensure the replacement Ethernet Cable will have enough slack so that it is not pulling on the connector at X7 of the Telematic Control Module. Failure to do so could damage the connector at the module.

22. Make a small loop to remove some of the excess cable and secure with a wire tie. Ensure to leave plenty of slack so that the cable will not pull on the connector at X7 of the Telematic Control Module.

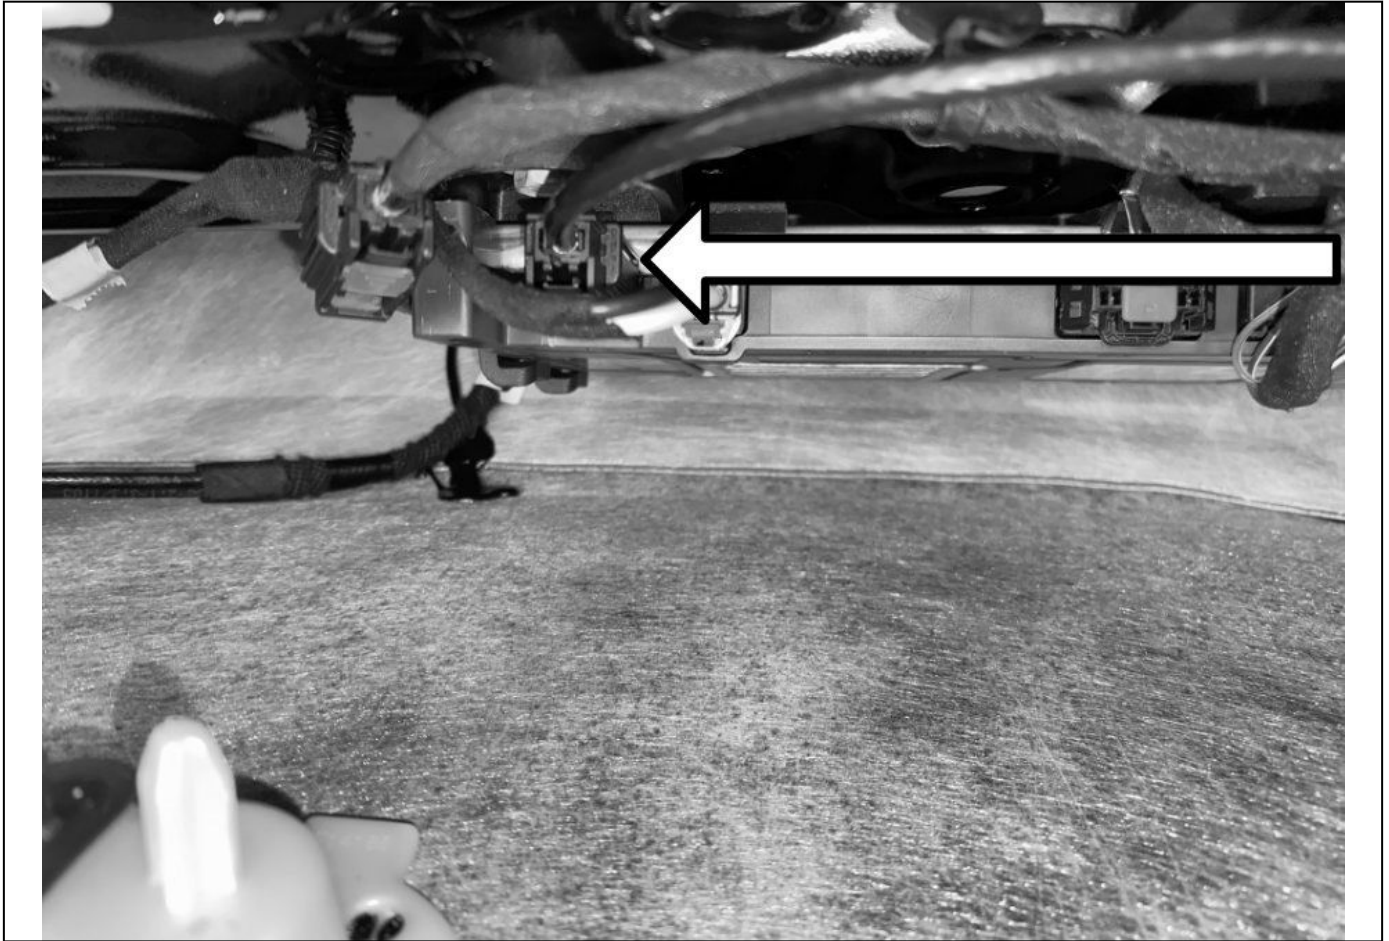
6706159

Important: Ensure the replacement cable has plenty of slack and is not pulling on the cable connector plug. Failure to do so could damage the connector at the module.

24. Connect the replacement cable into X7 of the Telematic Control Module. Ensure that the cable has enough slack left to not pull on the X7 connector.
