INFINITI

TECHNICAL SERVICE BULLETIN

ITB19-024D

DTC B00A0-00 STORED

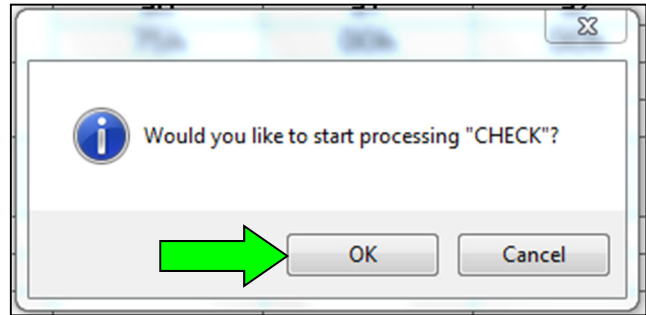
Figure 5

11. Check for code "75h" to show under **CURRENT FAILURE CODE**.

- If code "75h" shows under **CURRENT FAILURE CODE**, go to step 12.
- If code "75h" does not show under **CURRENT FAILURE CODE**, STOP HERE. This bulletin does not apply. Refer to ASIST and the ESM for further diagnostic assistance.

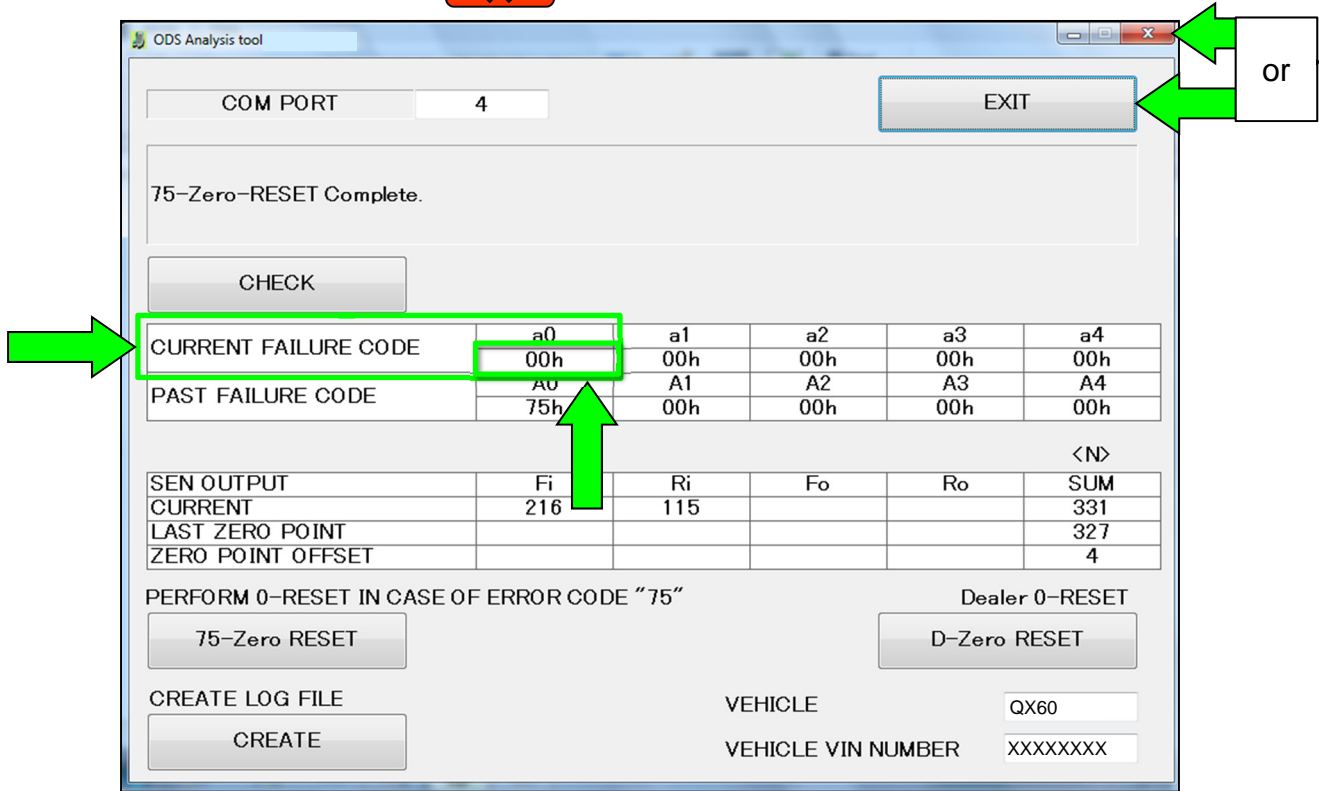
16. When the screen in Figure 9 displays, the 75-Zero reset process is complete.
 - Verify code “75h” is not displayed under **CURRENT FAILURE CODE**.
17. Select either **EXIT** or the

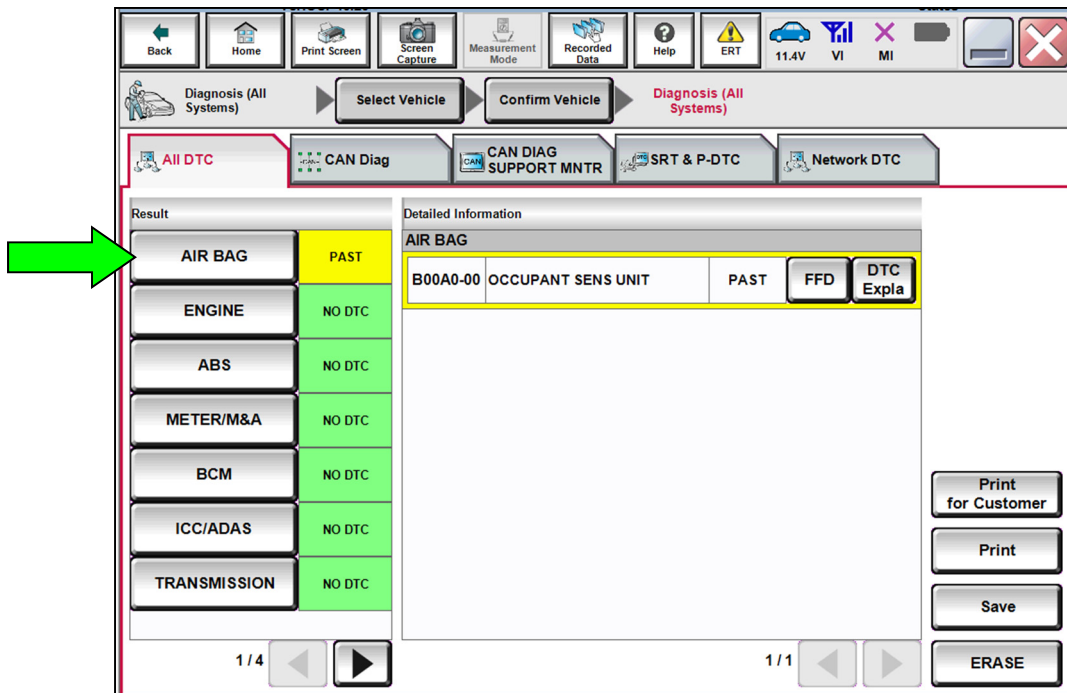
Figure 12

- DTC B00A0-00 should be the only DTC displayed.
- If DTC B00A0-00 is not the only DTC displayed, perform diagnosis and repairs as needed.
