Technical Service Bulletin

GROUP**CAMPAIGN****NUMBER****24-01-074G****DATE****OCTOBER 2024****MODEL(S)****SEE BELOW****SUBJECT:**

OUTER DOOR HANDLE TOUCH SENSOR REPAIR
(SERVICE CAMPAIGN T58G)

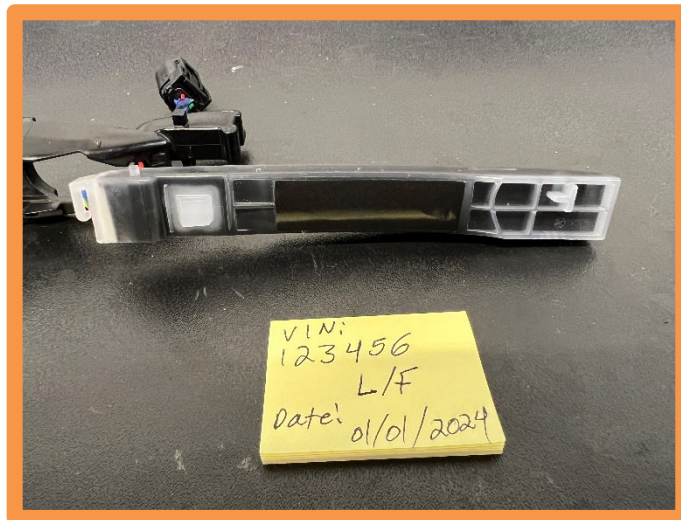
13.

Using STUI, take a photo of the applied double-sided tape with the specified door (left front, right front, left rear, right rear), last 6 digits of the VIN and date of repair on a piece of paper.

Upload the photo to STUI.
