Service Bulletin

Bulletin No.: 23-NA-072

Subject: Shudders or Shakes at Low Speeds

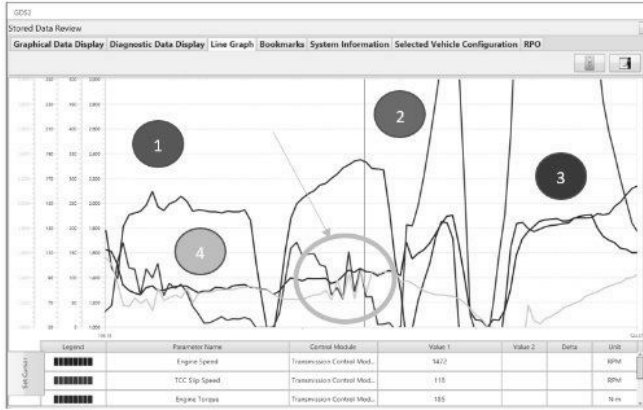
6325119

TCC Shudder: (Typically seen on 4th-5th Upshift as ISS Oscillation)

Record GDS2 Session Log and look for ISS oscillation when driveline disturbance occurs.

Diagnose by performing launch from 0 mph speed at 15-20% pedal up to 30 mph.

Condition present when TCC Slip less than 150 rpm maximum.

TCC Shudder	ISS (Peak-Peak)	Action	Comment
Normal	<50 rpm	Do Nothing	Not a Torque Converter/ATF Issue
Degraded	>50 rpm <200 rpm	Proceed with ATF Drain and Refill	ATF Degradation has occurred. Check Fluid Condition (Instructions below "Fluid Condition Check")
Damage	>200 rpm	Replace Torque Converter	Hardware damage has likely occurred.

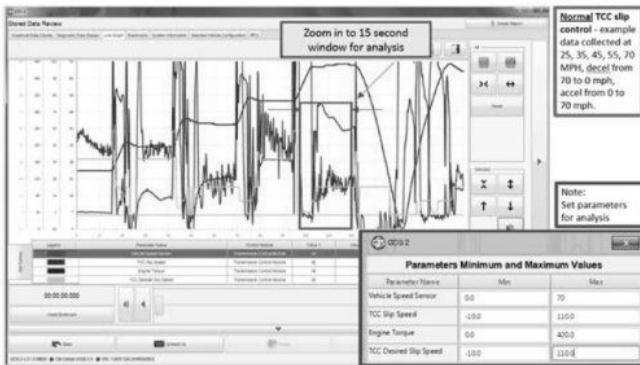
Figure 1 Parameter Minimum and Maximum Values

1. Utilize TIS2Web / GDS2 / MDI service tool
2. Select module diagnostics – TCM
3. Select TCC data for session log / data collection
4. Collect data between 89 and 113 km/h (30 and 50 mph) steady state / steady throttle with minimum 15 seconds.
5. For line graph evaluation, set parameter minimum and maximum to values stated for comparison: See Figure 1
6. Evaluate collected data with line graphs and compare data to each figure below:
 - Normal State: See Figure 2
 - Degraded State: See Figure 3
