Subject: MULTIPLE WARNING LIGHTS ON, VEHICLE ONLY STARTS WITH KEY TRANSMITTER NEAR START BUTTON DUE TO POOR CONTACT AT FUSE F1	Service Alert No.: SA-040/24
	Last Issued : 10/16/2024

2024-2025 CX-90
2025 CX-70

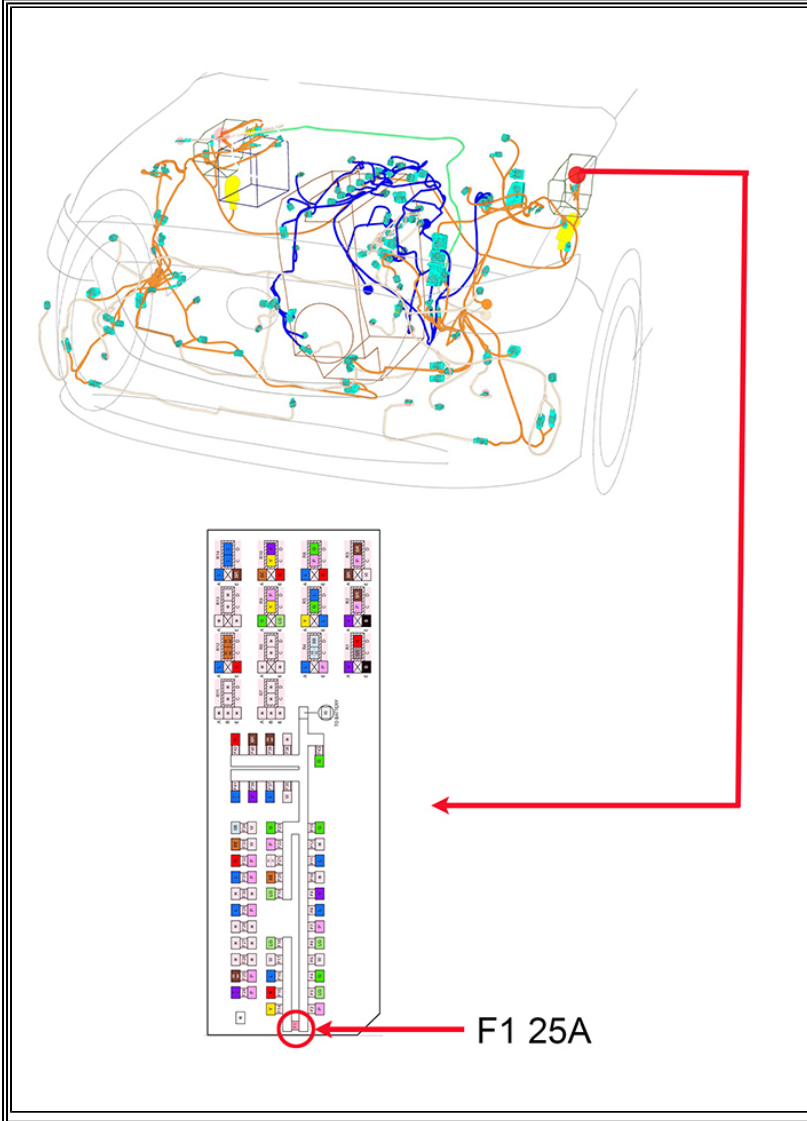
This may be caused by Fuse F1 not fully seated (poor terminal tension) or a poor ground connection at the front harness connector G03.

Good

No Good (not secured)

NOTE: The F1 25A fuse is removed during transportation. The F1 25A fuse must be inserted completely before the vehicles are delivered to customers.
