**SERVICE BULLETIN**

**APPLICABILITY:** 2020-22MY Legacy and Outback Models      **NUMBER:** 15-261-20R  
**SUBJECT:** Reprogramming File Availability for Optimization of Gen 4 Denso CP1 Infotainment Systems      **DATE:** 03/10/20  
**REVISED:** 10/01/24

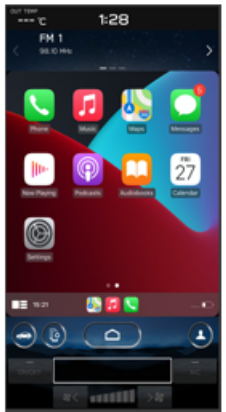
<p>Can't transition to CarPlay screen</p> </div>

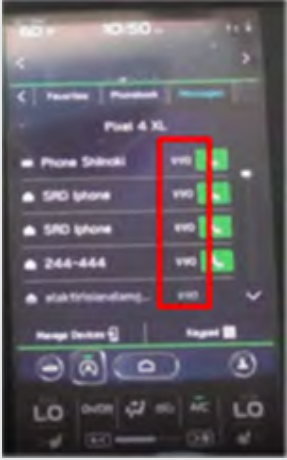
Number	Symptoms to be Improved:
16	<p>When selecting “Phone-&gt;”Message,” message received time is displayed incorrectly as “1/1/0.”</p> <p>It can occur with an Android phone with a specific Android OS (Pixel 6, Pixel4a, Pixel4XL, Xperia etc. ) in which time zone data is attached to the message receiving time.</p>

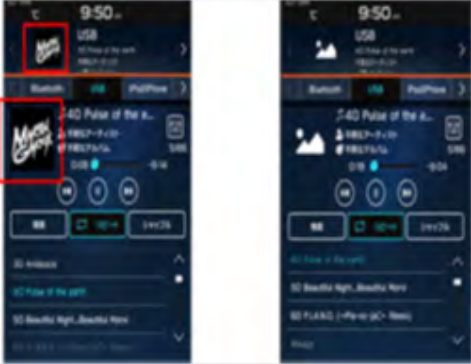
17	<p>Even when using the same mobile device that was paired previously, a message of “Are you sure you want to activate this profile?” is prompted and confirmation is needed to activate the device.</p>
18	<p>Cover art of previous music is displayed when playing music without cover art in USB audio. It can occur when music with and without cover art is mixed and stored together a single USB.</p>

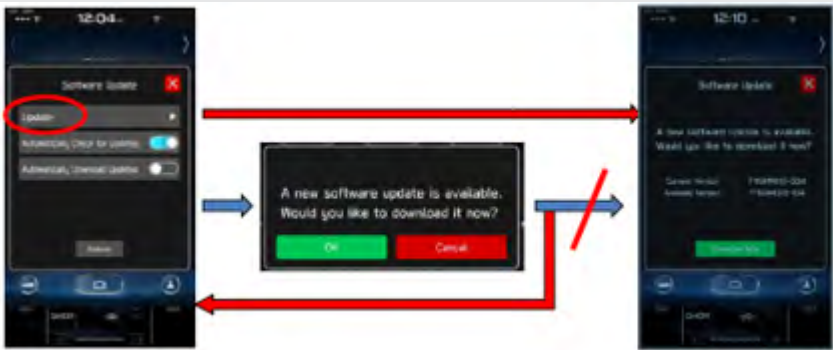
24	<p>When using FOTA service to update the software by selecting “Setting” &gt; “Software Update,” a message of “A new software update is available. Would you like to download it now?” is displayed but the downloading does not start after pressing “OK.” When this symptom occurs, it comes back to the “Software Update” screen. The downloading can be started by pressing the “Update” on the “Software Update” screen. (Temporary solution.)</p>

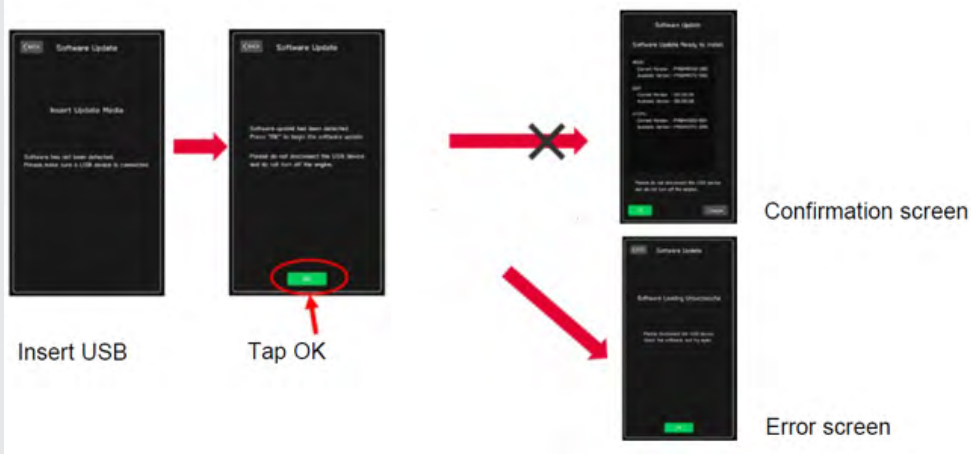
Number	Symptoms to be Improved:
12	<p>When conducting USB reprogramming, the screen transition to error screen instead of confirmation screen.</p>

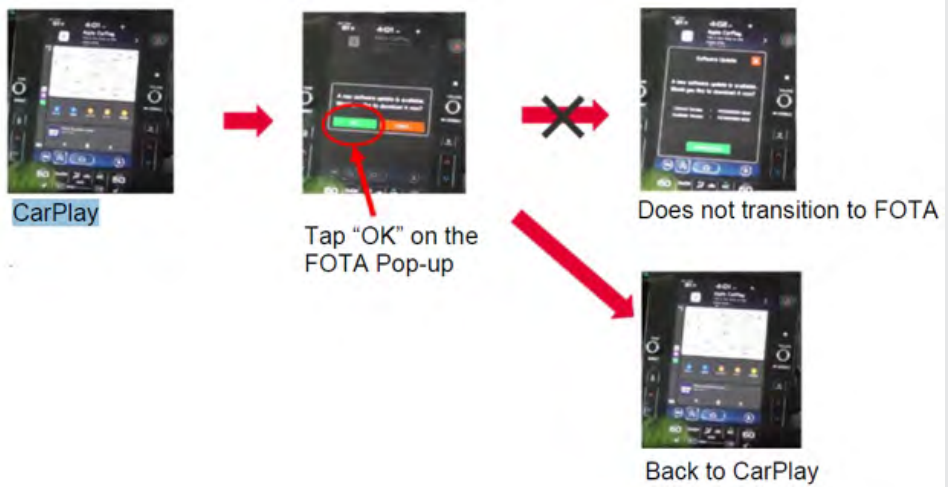
<p>Dealership Mode</p> <p>Software Update</p> <p>Software Update</p> <p>Software update setup is initializing...</p> <p>Vehicle internet is also required to complete the update.</p> <p><b>Note*</b> In case this USB update failure occurs, retry updating according to the instructions in “Appendix A”</p>
14	<p>When the FOTA pop-up (new software availability notification) is displayed while the CarPlay is being used, the display comes back to CarPlay screen even if the customer tries to get into the FOTA screen.</p>

<p>CarPlay</p> <p>Tap “OK” on the FOTA Pop-up</p> <p>Does not transition to FOTA</p> <p>Back to CarPlay</p>

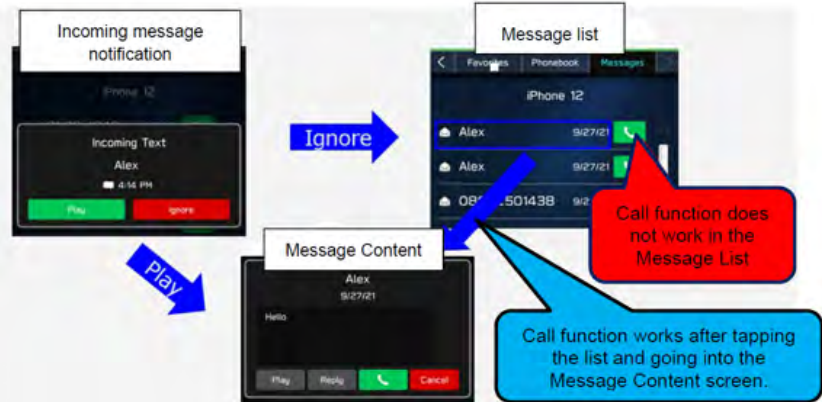
Number	Symptoms to be Improved:
15	<p>Call function does not work in the Message List (after ignoring the incoming message notification.). However, the call function can still be used after getting into the Message Content screen by tapping the message list.</p>

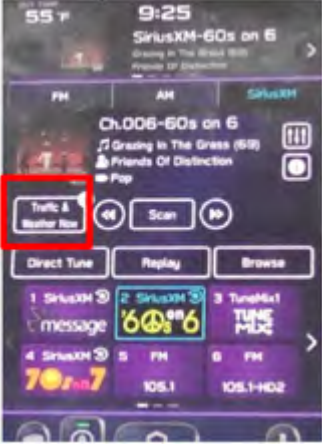
Number	Symptoms to be Improved:
25	<p>No response when touching “Traffic &amp; Weather Now (TWN)” on SMX screen.</p>

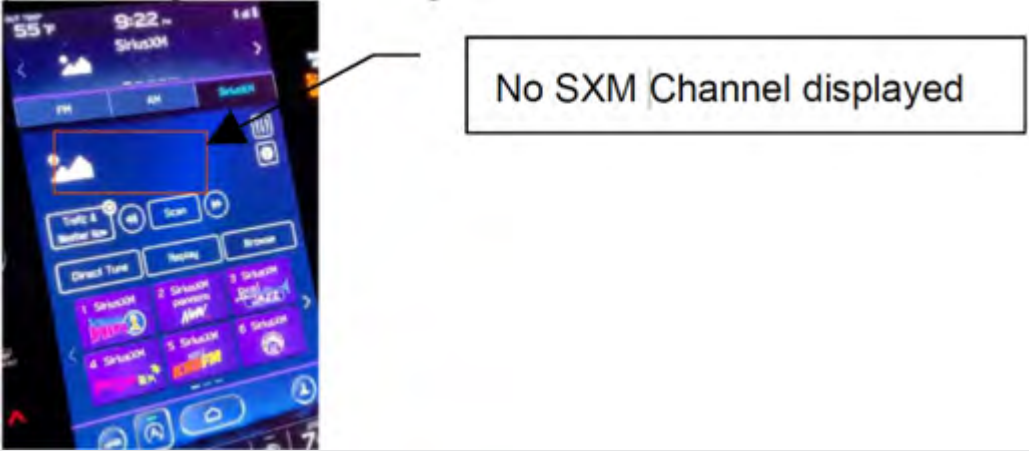
26	<p>SXM has blank screen and no sound when the SXM screen had been selected as audio source at the previous ignition off timing.</p>

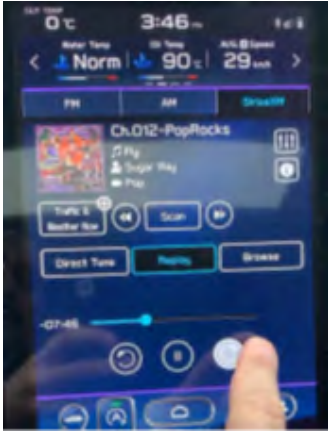
Number	Symptoms to be Improved:
28	SXM has blank screen and no sound when the audio source is change to SXM.
29	<p>“Fast forward” does not work in SXM replay function. (Fast Rewind works.)</p>

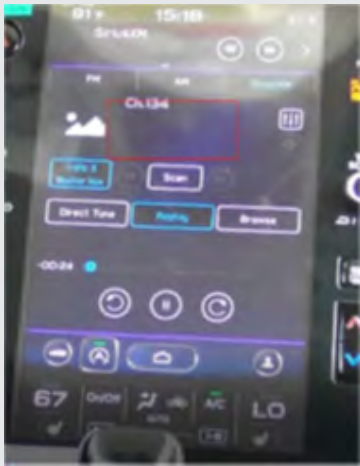
31	<p>The team logo is not displayed on Sports Flash screen when the SXM screen had been selected as audio source at the previous ignition off timing.</p>

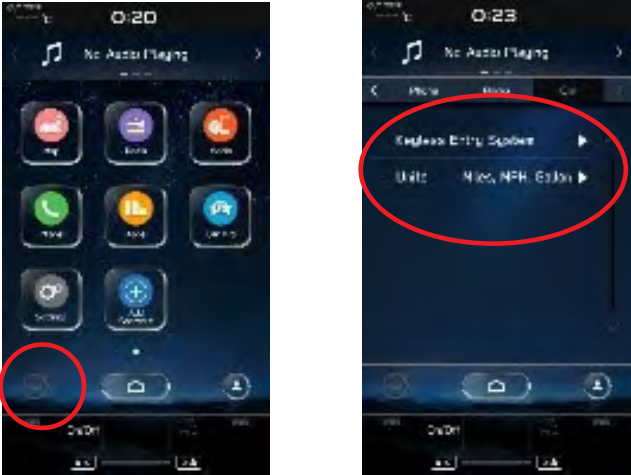
Number	Symptoms to be Improved:
4	<p>Vehicle Setting Icon in &lt;Home&gt; menu is grayed out. Menu list in the “Car” tab in the Setting Menu is not displayed.</p>

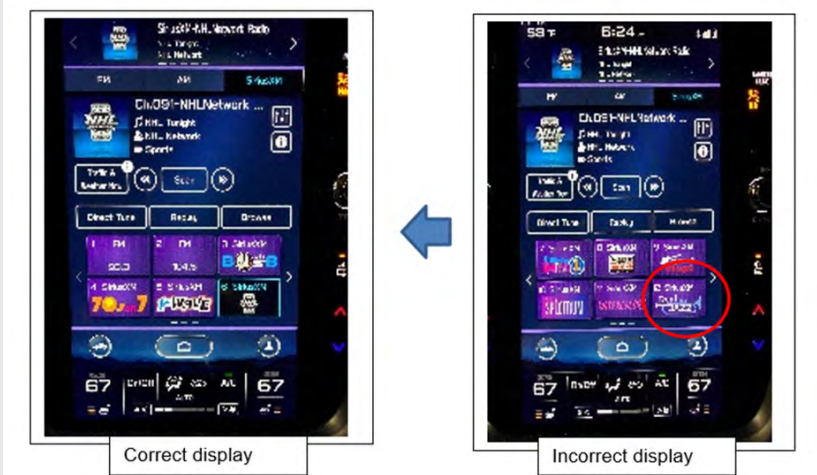
Number	Symptoms to be Improved:
18	Android Auto does not function. "Android Auto is Disconnected" is displayed with Launch Error message.
19	CarPlay does not function with USB connection.
20	Sound is muted after hanging up a hands-free phone call.
21	Ring tones and the voice from the other end on the hands-free phone call cannot be heard
22	No sound in SXM, following low or dead battery.
23	Navigation guidance directions are not spoken.
24	When iPhone phone book transfer fails, system repeats Bluetooth disconnection and connection.
25	<Media> button does not function in <Home> menu.
26	Vehicle location is not displayed correctly in Navigation screen.
27	Radio station moves unexpectedly due to momentary flick or brush of the touch screen.
28	Temperature setting cannot be controlled by Voice Recognition in Canadian (C*) specification.
29	Preset outline is not shown following station selection using steering switch <div style="text-align: center;">

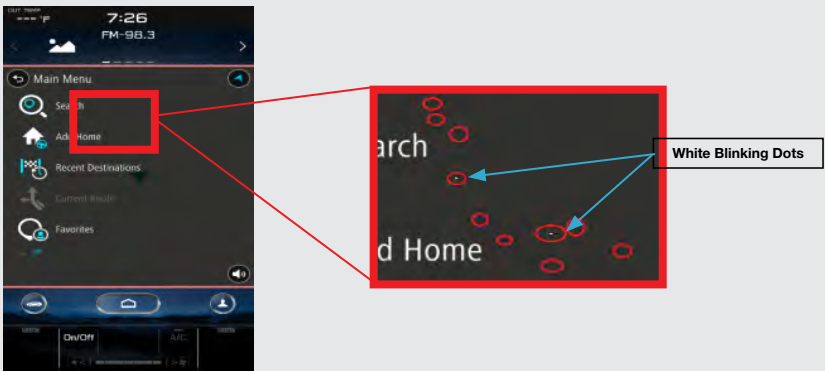
Symptom #	Description of Symptom:
1	Several minutes after Engine start, the Center Information Display (CID) reboots.
2	<p>After an extended period of usage, some white blinking dots appear on the display.</p>

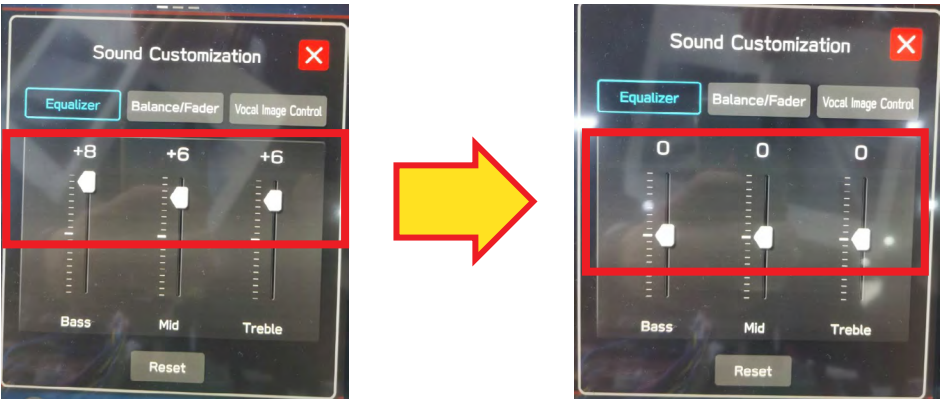
7	Customer-selected Equalizer settings are lost. Equalizer returns to the default settings after ignition switch is turned OFF and back ON.

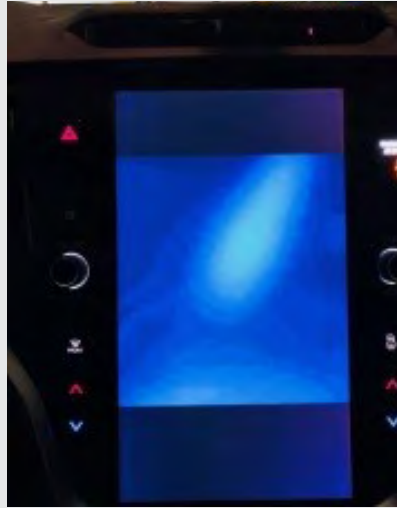
Symptom #	Description of Symptom:
13	CarPlay connection cannot be established. When connecting an iPhone via USB, "CarPlay Unavailable" is displayed and CarPlay does work.
14	The HOME screen goes blank. When the screen is switched from Camera mode to HOME, no icons are displayed as shown below.

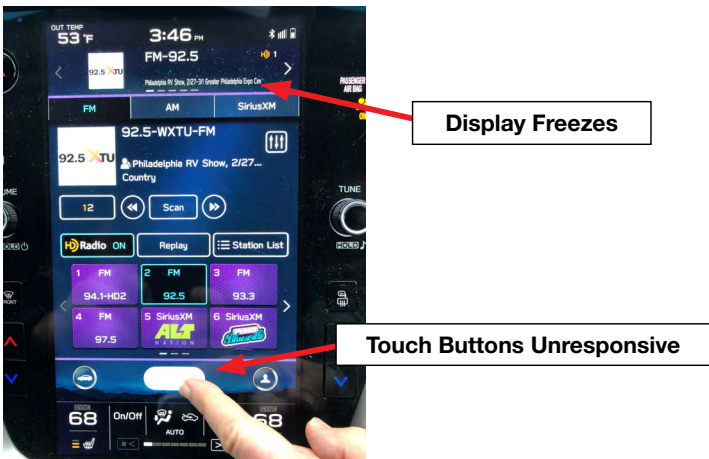
Symptom #	Description of Symptom:
1	<p>The CP1 display and/or center Combination Meter display freezes. No response from touch screen or voice guidance. After switching the ignition off and opening the driver’s door, the system does not recover**.</p>

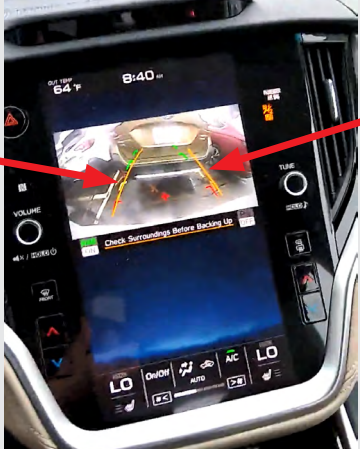
Symptom #	Description of Symptom:
2	<p>Delayed response of rear view camera guide lines. When the rear view camera is activated and the steering wheel is turned, there is a delay before the steering-responsive guide lines respond to the steering wheel input.</p>

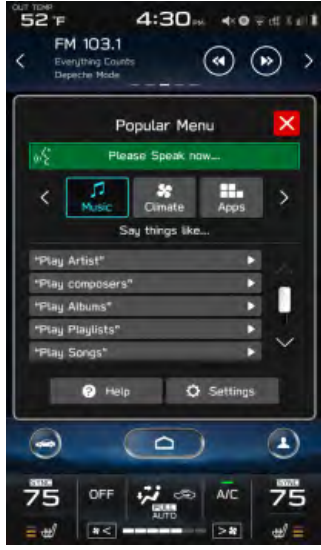
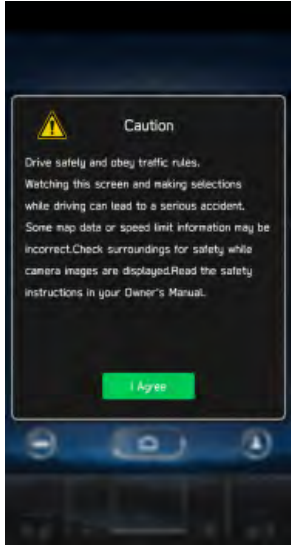
Symptom #	Description of Symptom:
5	<p>When using Voice Recognition to search for a 'Nearby POI' (Point of Interest) in Canada with FRENCH language selected, the CP1 display turns black and displays a Caution / disclaimer message.</p> <div style="display: flex; justify-content: space-around; align-items: center;">

</div> <div style="display: flex; justify-content: space-around; margin-top: 10px;"> <div style="border: 1px solid black; padding: 5px; text-align: center;">Voice Recognition</div> <div style="border: 1px solid black; padding: 5px; text-align: center;">Black Screen</div> <div style="border: 1px solid black; padding: 5px; text-align: center;">Caution / Disclaimer Message</div> </div>
