SERVICE BULLETIN

APPLICABILITY: 2022-24MY BRZ Models **NUMBER:** 15-297-22R
SUBJECT: Reprogramming File Availability for Optimization of Gen 4 Denso CP1 Infotainment Systems **DATE:** 07/01/22
REVISED: 10/02/24

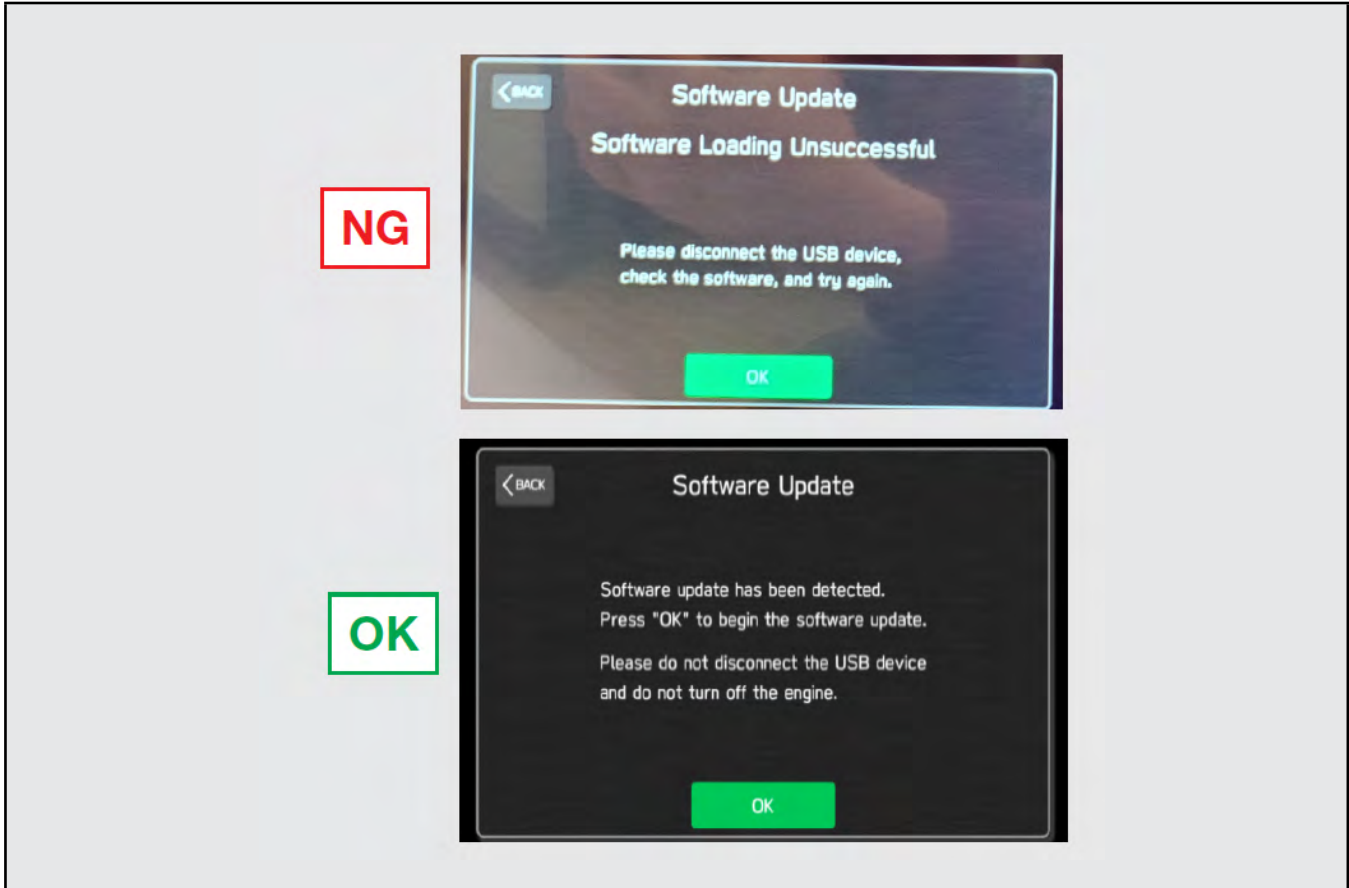
NOTE: If after plugging in the USB, the screen displays a **Software Loading Unsuccessful** message, confirm the USB device has been properly formatted and the the software on the device matches the system being reprogrammed and retry.

If you get the message Software Update Incomplete as shown below, please don't replace the hardware but retry updating the software according to the instructions in "Appendix B" on pg. 16.

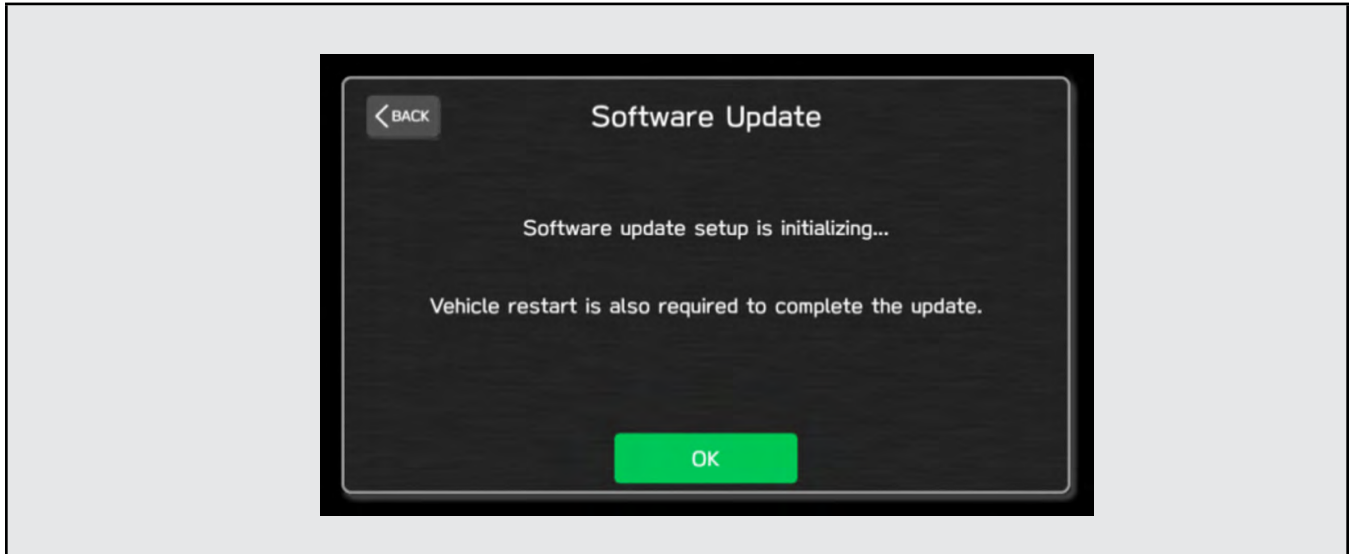
Follow this procedure in the RARE case of “Software update setup is initializing...” message is displayed:

- If the screen shown below appears, **WAIT** for approximately 30 minutes or as long as necessary (waiting for longer than 60 minutes might indicate system malfunction). In that case please perform recovery according to the instructions in “Appendix B ” to allow the Software update setup initialization process to complete.

1. Turn the ignition switch or the engine OFF, open the driver side door and close the door then wait for 3 minutes.
2. Open the driver side door then turn the ignition switch or the engine ON.
3. Go to Dealership Mode diagnostics then select Software Update as in STEP 4c.

IMPORTANT NOTE: If this procedure is required, contact Techline as additional action may be necessary.

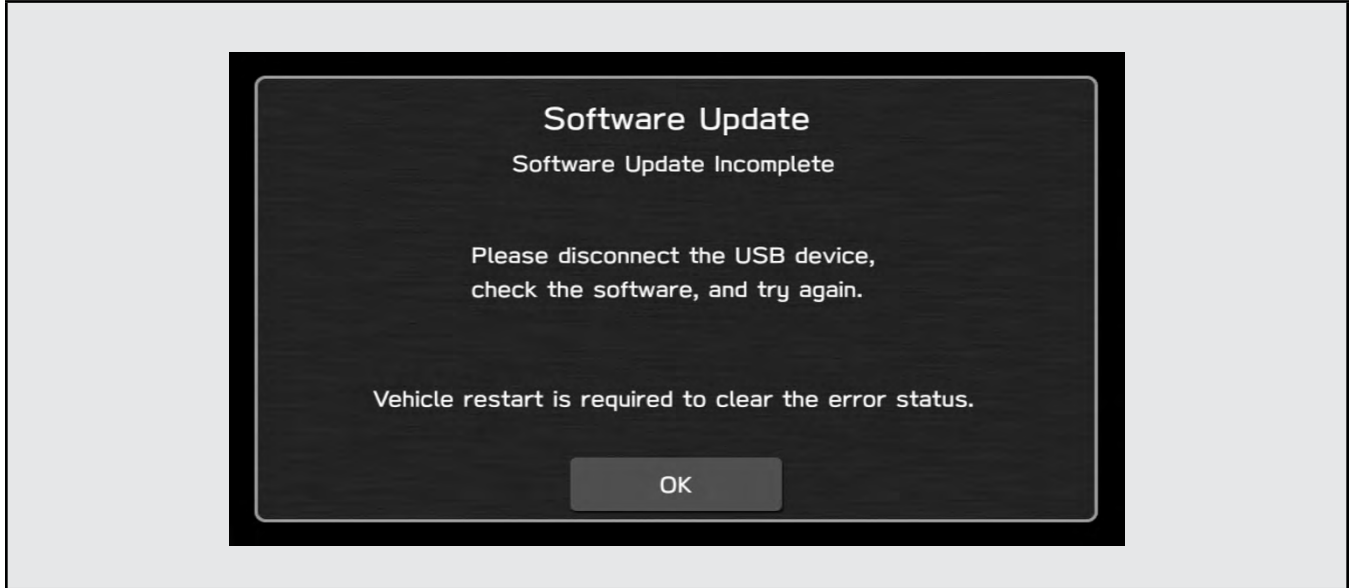
In case of retrying the software update after the first attempt of update fails.

- If the first attempt of update fails with the message below, please perform procedures 1-2 to 1-8 before retrying the software update.

1-1. Select OK in the screen below

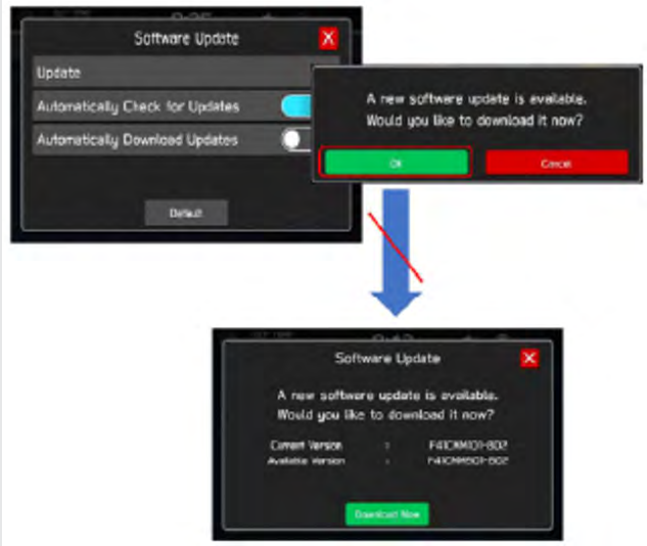
Number	Symptoms to be Improved:
22	<p>When using FOTA service to update the software by selecting “Setting” > “Software Update,” a message of “A new software update is available. Would you like to download it now?” is displayed but the downloading does not start after pressing “OK.” When this symptom occurs, it comes back to the “Software Update” screen. The downloading can be started by pressing the “Update” on the “Software Update” screen. (Temporary solution.)</p>

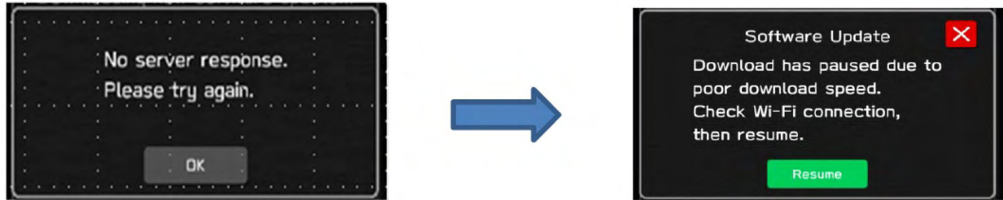
Number	New Functions and Enhancements:
1	Icons of home screen change to those of the US specifications even though the original specification is not of the US.
2	Two ways of MOTA operations, i.e., by connect CCM to Wi-Fi or by transferring the downloaded map data to CCM via smart phone are executed simultaneously by error.
3	<p>One of the Pop-up Error Messages displayed during the FOTA operation in case of weak Wi-Fi signal is not intuitive. Even if the customer tap “OK,” it does not transit to another screen.</p> <div style="text-align: center;">

</div> <p>As the improvement for this inconvenience, the message is changed so that the customer finds the reason why the FOTA operation has been paused. Also a “Resume” button is prepared so that the customer can do the rest of operations after necessary action (moving the vehicle to another place with better Wi-Fi connection**, or tethering the CP1 to a mobile phone, etc.)</p> <p>Note** The FOTA operation can be paused when the Wi-Fi indicator at the upper right corner of the CID is not in “Good” or “Excellent” as shown below.</p> <div style="text-align: center;">
