SERVICE BULLETIN

APPLICABILITY: 22-23MY WRX Models **NUMBER:** 15-301-22R
SUBJECT: Reprogramming File Availability for Optimization of Gen 4 Denso CP1 Infotainment Systems **DATE:** 09/09/22
REVISED: 10/02/24

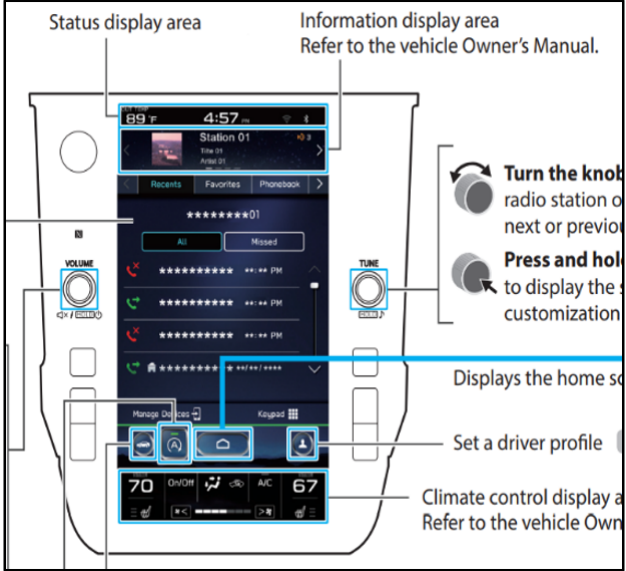
Number	Symptoms to be Improved:
1	While welcome animation on CID is displayed and the driver's door is left open, if turning ignition OFF/ON, the CID screen will be black screen.
2	After starting the engine, the loading animation remains and the screen does not transition remaining blank.
3	When the “All” tab is pressed on the Travellink Sports screen, a blank screen appears.
4	During Bluetooth audio playing, the CID screen turns into a black picture.
5	<p>The Information Display Area at the top of the CID screen displays a different information screen from the last time.</p>

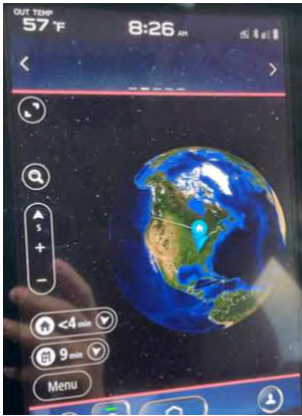
Number	Symptoms to be Improved:
7	Sound is lost when playing Bluetooth audio even though the screen is displayed without problem. It can occur when the audio source is switched repeatedly between the Bluetooth and others.
8	SXM radio output is lost after terminating a handsfree phone call.
9	No audio played back when using CarPlay.
10	Sound volume control does not work while using Android Auto.
11	Cyclic short noise like a drilling or vibration is heard from speakers.
12	After the engine is started, a message of “Loading Navigation...” continues to be displayed, but the map is not displayed.
13	Vehicle position on navigation map erroneously moves to zero degrees latitude and zero degrees longitude (0°N 0°E or west of Africa in the Atlantic ocean).
14	<p>Navigation map scale is changed to the lowest setting (globe is displayed).</p>

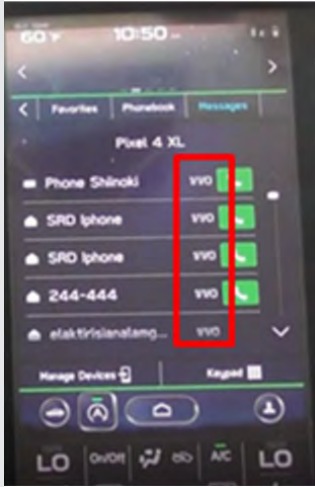
16	<p>When selecting “Phone->”Message,” message received time is displayed incorrectly as “1/1/0.”</p> <p>It can occur with an Android phone with a specific Android OS (Pixel 6, Pixel4a, Pixel4XL, Xperia etc.) in which time zone data is attached to the message receiving time.</p>

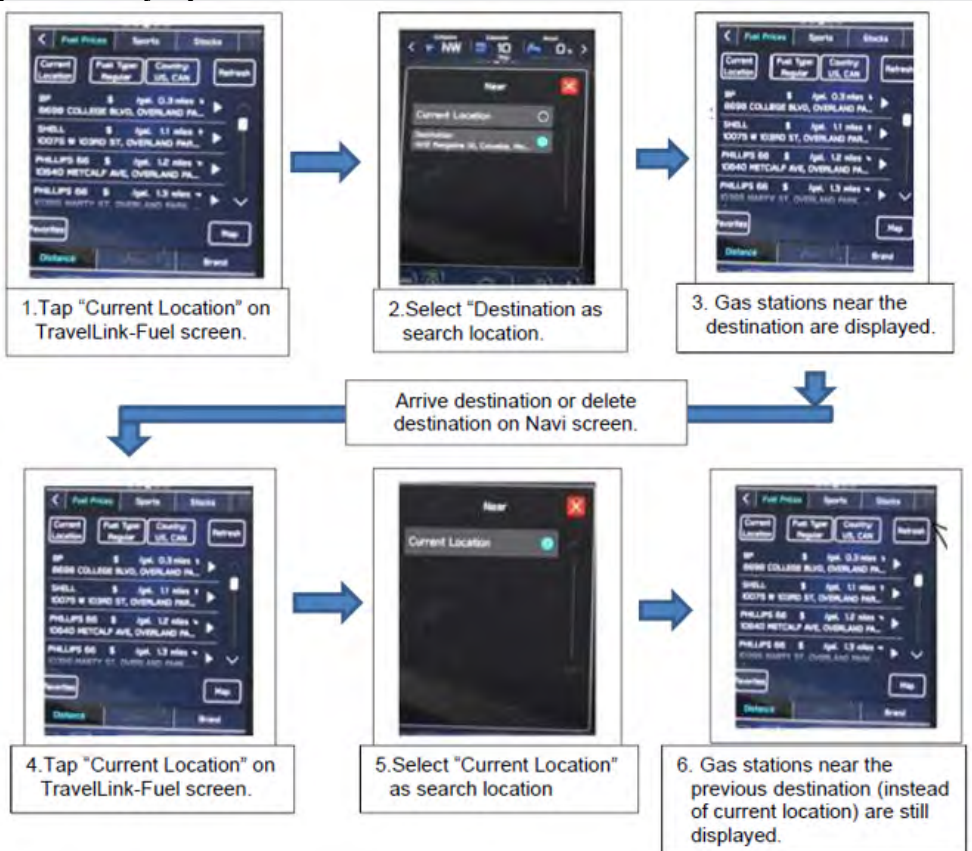
30	<p>A wrong search location is used on TravelLink function. Facilities around the previous destination are searched instead of those around the current destination.</p> <p>Example of the symptom.</p>

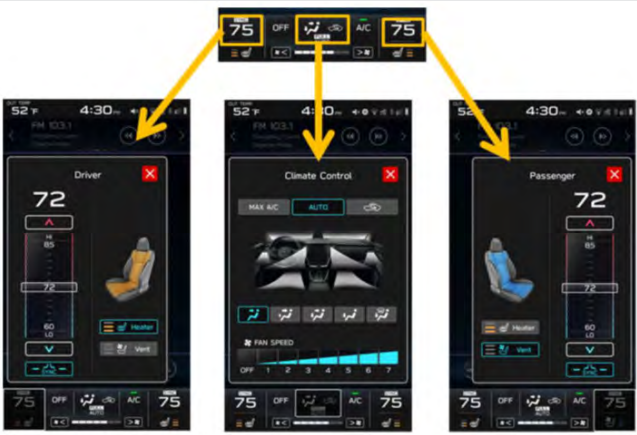
<p>2</p>	<p>Air conditioner control interface is changed to that of 23MY.</p> <p>Current (-22MY) screen transition:</p>

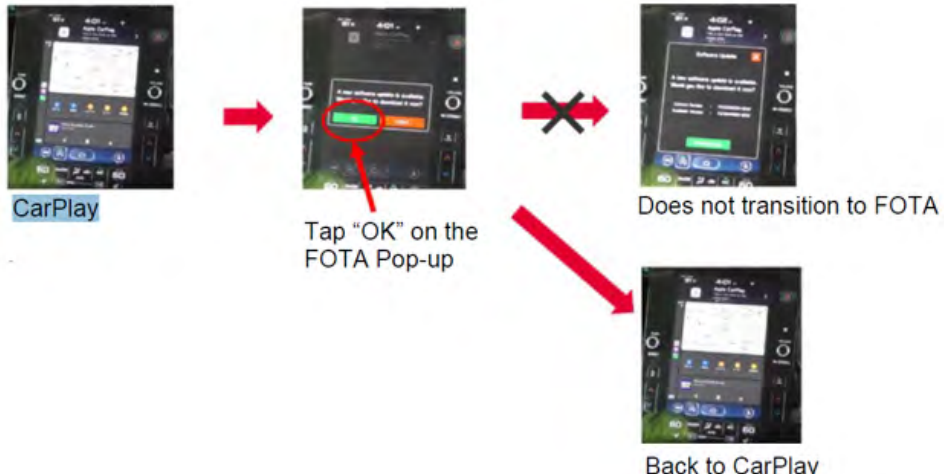
<p>Note* In case this USB update failure occurs, retry updating according to the instructions in “Appendix A”</p>
14	<p>When the FOTA pop-up (new software availability notification) is displayed while the CarPlay is being used, the display comes back to CarPlay screen even if the customer tries to get into the FOTA screen.</p>

<p>CarPlay Tap “OK” on the FOTA Pop-up Does not transition to FOTA Back to CarPlay</p>

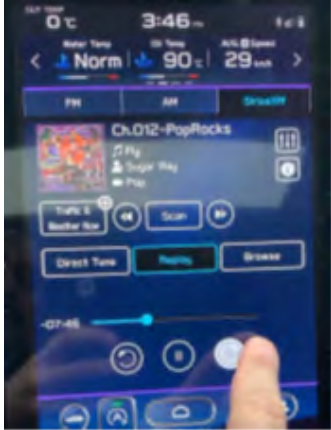
Number	Symptoms to be Improved:
29	<p>“Fast forward” does not work in SXM replay function. (Fast Rewind works.)</p>
