**SERVICE BULLETIN**

**APPLICABILITY:** 23-25MY Outback/Legacy Models (including Wilderness models)  
 23-24MY Ascent Models  
 24MY Impreza  
 24MY Crosstrek (including Wilderness models)  
 24MY WRX  
 25MY Forester

**NUMBER:** 15-305-22R  
**DATE:** 11/15/22  
**REVISED:** 10/02/24

**SUBJECT:** Reprogramming File Availability for Optimization of Gen 4.5 Denso CP1.5 Infotainment Systems

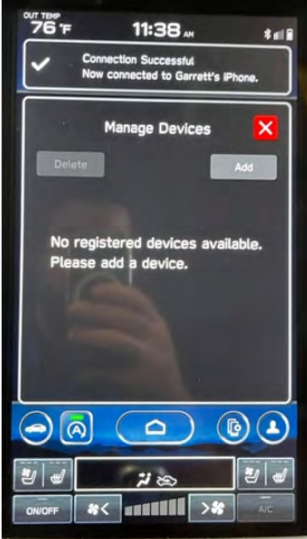
Number	Category	Symptoms to be Improved:
6	Display	<p>The registered mobile device information is not displayed on the Manage Devices screen.            (This occurs when the name or device ID of a mobile device contains a character code that cannot be displayed.)            (only applicable to HIGH and MID trim)</p>

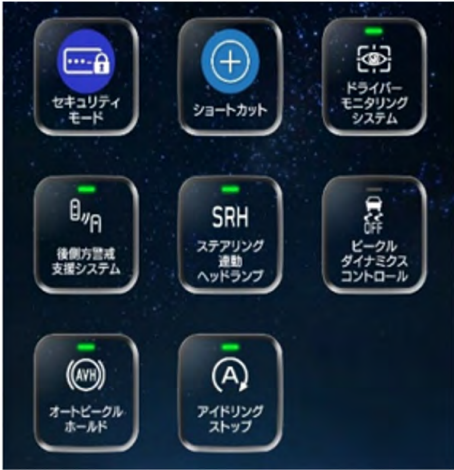
<p>The order of 1.First Name and 2.Family Name in the phone book is set to 1.→2. even if the order is set to 2.→1.</p>
		<p>The message function may become unavailable following repeated page scrolling up and down of the list on the phone's message list screen.            (only applicable to HIGH and MID trim)</p>
		<p>When transitioning to the maintenance screen and the setting value is set to AUTO, a popup prompting the user to sign a MySubaru contract is displayed and the setting is switched to Manual.            (only applicable to HIGH and MID trim)</p>
		<p>When turning off and on while two or more shortcuts of DMS/SRH/SRVD icons are set on the Home screen, the order of icons changes from DMS to SRVD, SRH, VDC, AVH, and ISS.</p>

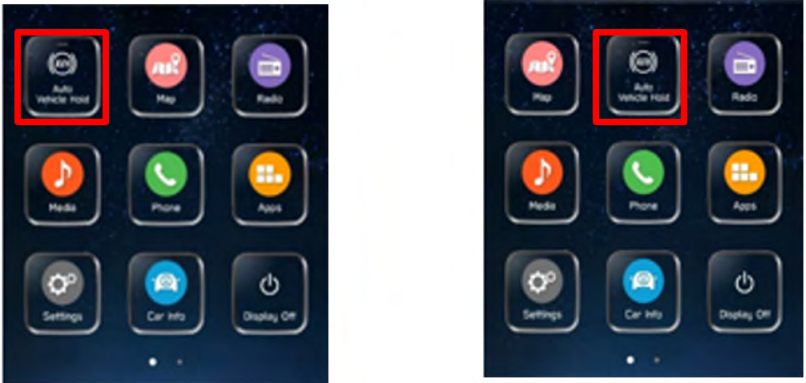
Number	Category	Symptoms to be Improved:
6	Display	<p>The AVH icons on the HOME screen are initially lined up next to the Valet-Mode icon. However, in some cases they are placed at the top (upper left corner of the first page) or next to the MAP icon. (only applicable to HIGH and MID trim)</p>

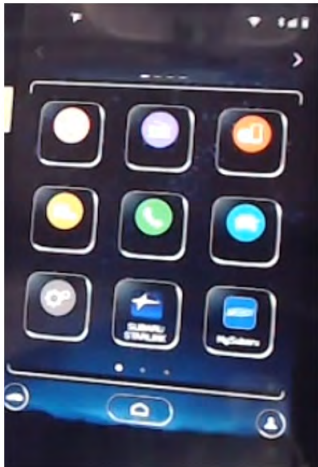
<p>After switching the clock function to AUTO, the CID screen display may become distorted. (only applicable to HIGH and MID trim)</p>

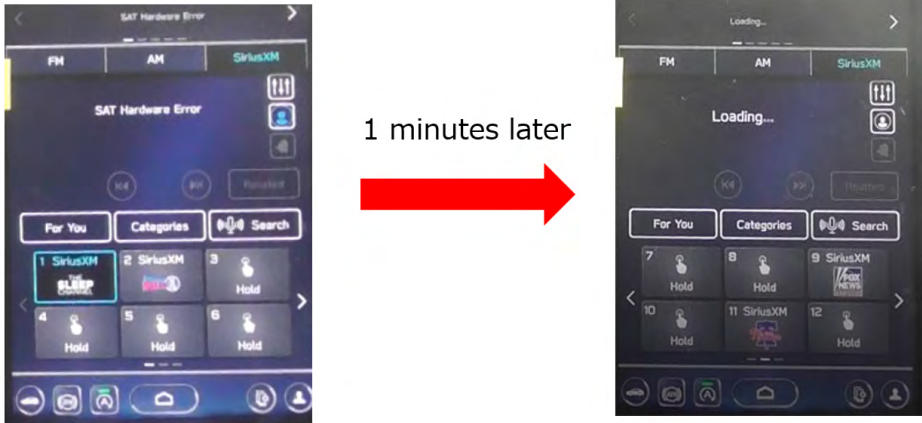
<p>It may take accessive time to start the CID screen after ignition on.</p>
7	SXM	<p>The first time ignition on after the CCU software update added the SXM360 functionality, the SXM playback screen may remain at “Loading...” after the CCU software update.</p>

<p>1 minutes later</p>

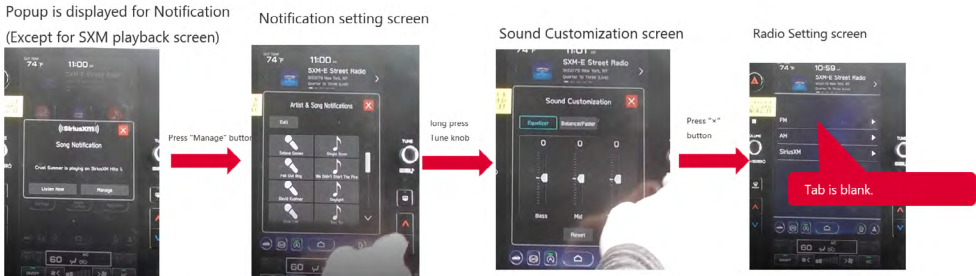
<p>The tab buttons for switching settings items may not be displayed. From the SXM Notification screen, press and hold the Tune knob button to enter the Sound Settings popup screen. Close the popup with the × button to transition to the Radio Settings screen.</p>

<p>Popup is displayed for Notification (Except for SXM playback screen)</p> <p>Notification setting screen</p> <p>Sound Customization screen</p> <p>Radio Setting screen</p> <p>Press "Manage" button</p> <p>long press Tune knob</p> <p>Press "x" button</p> <p>Tab is blank</p>

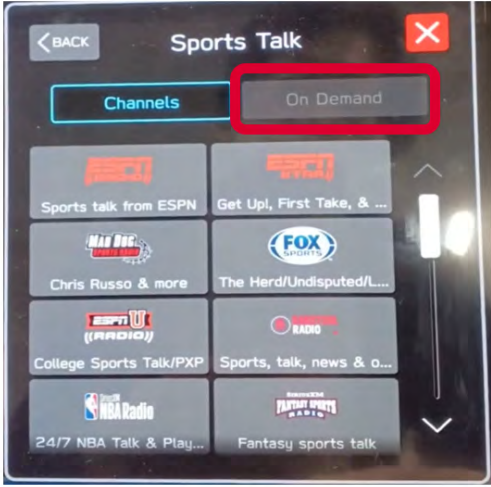
Number	Category	Symptoms to be Improved:
7	SXM	<p>In the SXM screen, the On Demand button in the upper right corner is grayed out and cannot be operated in the Sports→ Sports Talk screen. (only applicable to HIGH and MID trim)</p>

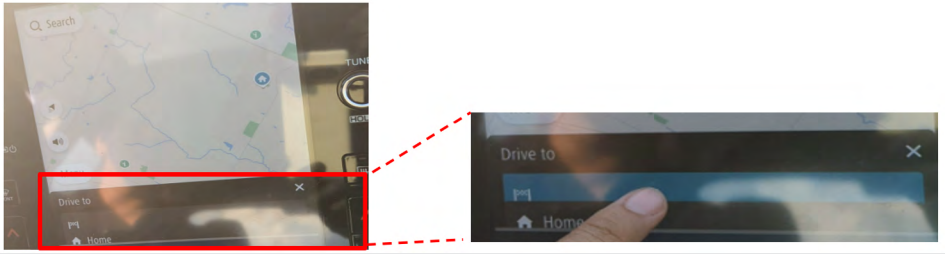
8	Navi	<p>After booting, the Map screen may not appear even if the Map icon on the Home screen is pressed. (only applicable to HIGH trim)</p> <p>Three destination suggestion displays in the navigation system are sometimes displayed overlapping each other. Originally, up to three destination suggestions are displayed at the bottom of the screen when the navigation system is started. (only applicable to HIGH trim)</p>

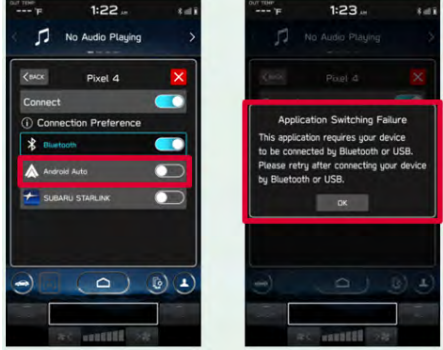
<p>- When you toggle on Android Auto from the Manage Device screen in CID while the Android device is not connected via USB, there may be a failure to start Wireless Android Auto (not applicable to BASE trim)</p>

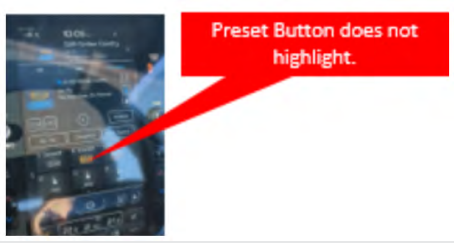
Number	Category	Symptoms to be Improved:
7	Bluetooth	<ul style="list-style-type: none"> <li>- Address vulnerabilities in the Bluetooth encryption mechanism (only applicable to BASE trim)</li> <li>- If the Bluetooth connection fails due to the loss of the link key in the phone, the following message should be changed to be displayed. Before: Connection unsuccessful Please try again later After: Connection unsuccessful Please try deleting and then re-pairing your device</li> </ul>
8	Radio	<ul style="list-style-type: none"> <li>- When pressing a preset button for a registered radio channel, you can play the channel. But the button you pressed does not highlight, and you cannot operate through presets using the steering wheel controls (not applicable to WRX)</li> </ul>

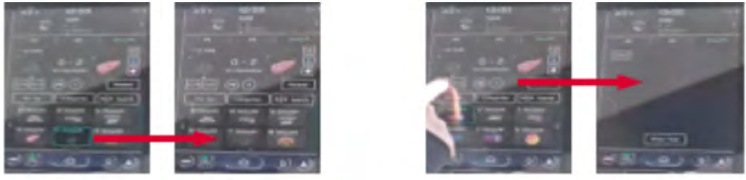
9	SXM	<ul style="list-style-type: none"> <li>- Following symptoms might be observed, when the SXM satellite channel and SXM IP channel are registered alternately in the radio preset registration and the preset channel selection is switched continuously using the steering switch (not applicable to BASE trim):</li> </ul> <ol style="list-style-type: none"> <li>1. The highlight of the radio preset disappears (It shifts from the currently selected preset)</li> <li>2. Information on the radio screen becomes blank</li> <li>3. SXM sound is interrupted</li> <li>4. The channel does not change even if the preset button is pressed</li> </ol>

<p>Preset button highlight disappears (shifts)      The information on the screen is blank.</p> <ul style="list-style-type: none"> <li>- The voice search feature in SXM has difficulty recognizing spoken voices due to low microphone input volume during voice search (not applicable to BASE trim)</li> </ul>

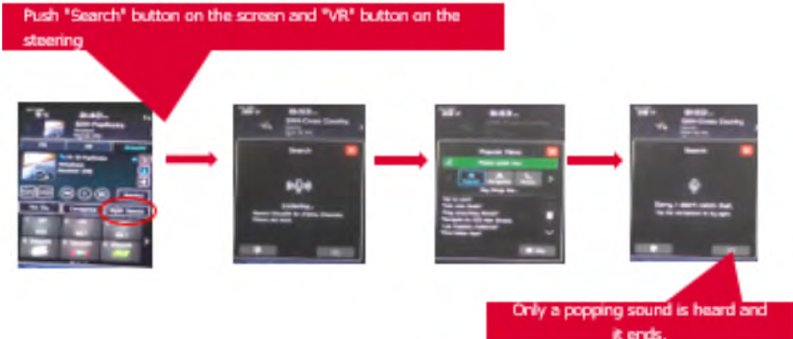
<p data-bbox="500 1430 1498 1541">- The voice recognition function encounters an error and ends, when initiating the SXM Search feature simultaneously with the activation of the CCU unit's voice recognition</p>

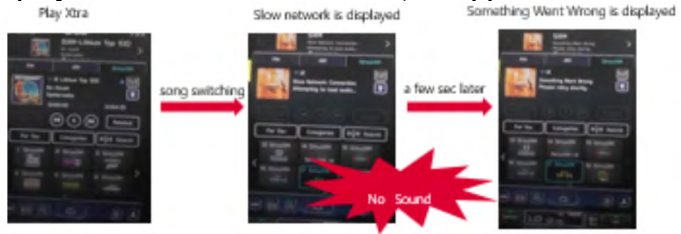
Number	Category	Symptoms to be Improved:
9	SXM	<p>- SXM sound stops sounding after conditions listed below:</p> <ol style="list-style-type: none"> <li>1. Register FM station A, an SXM sports channel that is not in the middle of a game, and FM station B in the order in which they are listed in the radio presets.</li> <li>2. Use the steering wheel switch to switch from FM station A to FM station B, skipping the SXM sports channel that is not in the middle of a game.</li> <li>3. Just before the playback of FM station B starts, operate the steering switch seek to return to the previous channel.</li> </ol> <p>- While playing SXM's Xtra channel, "Slow Network" --&gt; "Something Went Wrong" is displayed and no sound is heard (not applicable to BASE trim)</p>

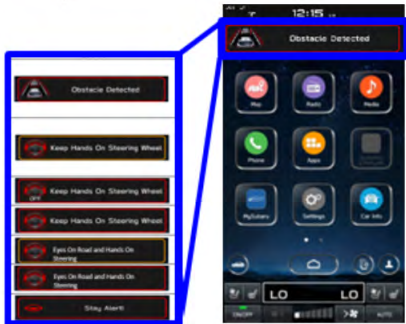
<p>- If the language setting of the CID is changed while an alarm message by the Driver Monitoring System(DMS) is displayed on the CID, the alarm will be hidden (not applicable to BASE trim)</p>

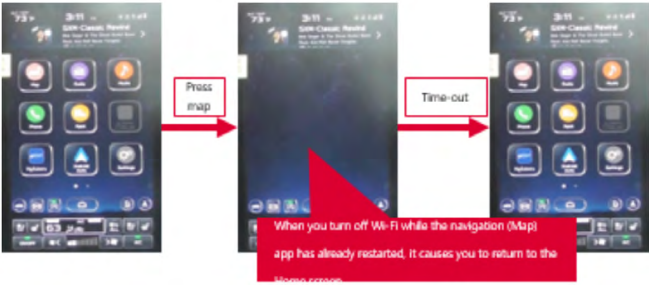
Number	Category	Symptoms to be Improved:
13	<b>Navi Operation</b>	<p>- During map data updates, if you switch off the Wi-Fi function from the Settings screen pressing the Map icon on the Home screen doesn't display the Map screen for a while (only applicable to HIGH trim)</p>

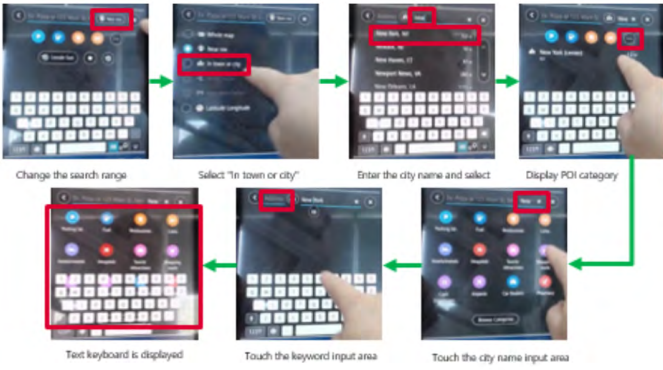
<p>- Even when pressing the Map icon the map does not appear and it remains stuck on the 'Loading Navigation' message. This issue occurs due to a corrupted file that stores settings and destination history (only applicable to HIGH trim).</p> <p>- The text keyboard which should not be displayed appears on top of the list of POI categories (only applicable to HIGH trim) when performing the steps below:</p> <ol style="list-style-type: none"> <li>1. Narrowing down the search range within a specific city in the navigation destination search.</li> <li>2. Move to the POI category screen.</li> <li>3. Touch the city name input area, then the keyword input area, in that order.</li> </ol>

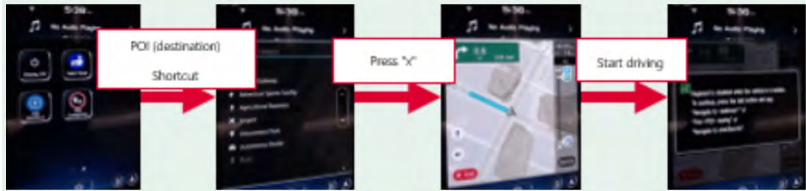
Number	Category	Symptoms to be Improved:
13	Navi Operation	<p>- "Keyboard is disable while the vehile is in motion"" is displayed on the screen when performing the steps below (only applicable to HIGH trim) :</p> <ol style="list-style-type: none"> <li>1. Press the POI (destination) Shortcut on the home screen to display the list of destinations.</li> <li>2. Press "x" to clear the list.</li> <li>3. Start driving with the Map screen displayed.</li> </ol>

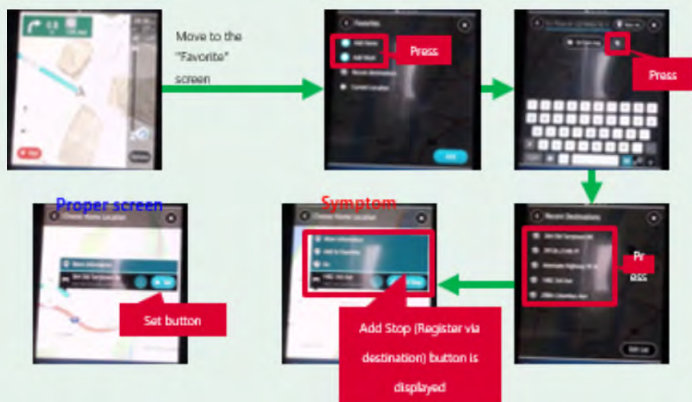
<p>- Add Stop (Register via destination) button is displayed instead of Set button and Favorite registration for Home/Work cannot be done after performing the steps below moving to the ""Favorite"" screen with the navigation destination set (only applicable to HIGH trim) :</p> <ol style="list-style-type: none"> <li>1. Press Add Home/Work</li> <li>2. Select a location from the Destination History screen</li> </ol>

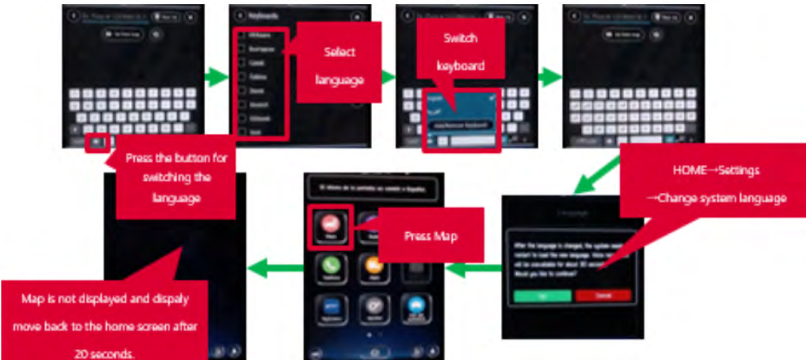
<p>- Map is not displayed when Map is pressed from the home screen if switching the language used for the text input keyboard on the search screen of the navigation application (only applicable to HIGH trim)</p>

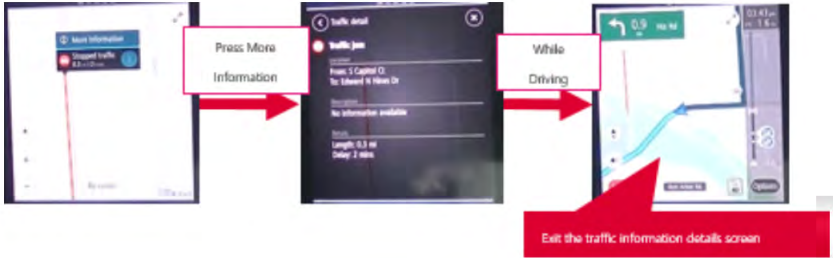
</div> </div> <p>- When using voice recognition to search for a destination based on a Point of Interest (POI) category name (such as "gas station"), the search results may display facilities that have names partially matching the POI category name in addition to the facilities within that specific category (only applicable to HIGH trim)</p> <p>- While parked or driving, touch the traffic information icon on the map or the traffic information icon on the route bar and display the traffic information details screen. If you start driving with this screen displayed, it will exit the traffic information details screen and transitions back to the map screen (only applicable to HIGH trim)</p> <div style="text-align: center;">

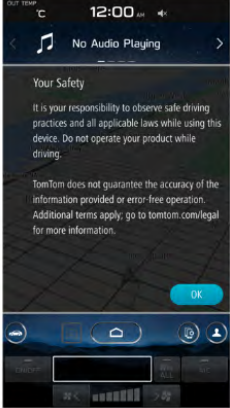
Number	Category	Symptoms to be Improved:
13	<b>Navi Operation</b>	<p>- The requirement to press ""OK"" on the Your Safety screen during the initial navigation launch sometimes wasn't displayed (only applicable to HIGH trim).</p> <p>Before the change: If the navigation app was launched for the first time from any icon other than the Map icon on the Home screen (e.g., through a rest suggestion feature) the Your Safety screen would not appear and navigation functionality could not be initiated.</p> <p>After the change: Even if the navigation app is launched for the first time from an icon other than the Map icon on the Home screen, the Your Safety screen will be displayed.</p>

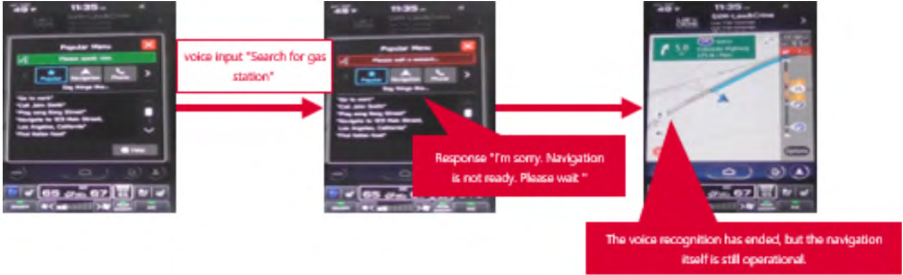
<p>- When searching for navigation POIs using voice recognition, the response is "Navigation is not ready" and POI search may not start (only applicable to HIGH trim)</p>

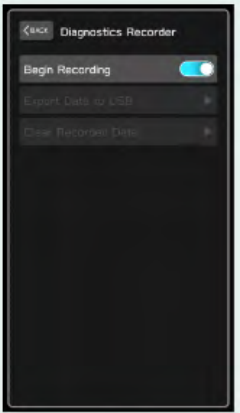
10	<p>Update against vulnerability in security of Bluetooth connection.</p>
11	<p>When getting CCU USB logs at the Diagnostics Recorder screen in the Dealership Mode, it was necessary to turn off "Begin Recording" to "Export Data to USB." And after the log acquisition, it was necessary to turn "Begin Recording" ON again. The system interface is improved so that "Begin Recording" is automatically switched ON after log acquisition has been accomplished.</p> <div data-bbox="786 1524 1024 1934" style="text-align: center;">

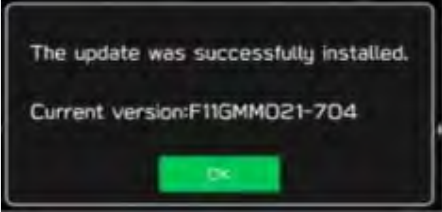
13	After the destination is set on Navi screen, voice recognition command of “Find <POI category> along route” is made, search results are not given in order of distance.
14	When “Call” button is pressed in “Confirm Destination” screen of Navigation system (to call the destination site,) the call can be made but the screen does not transit to phone call screen.
15	<p>Popup of “The update was successfully installed” is not displayed after reboot (IG-OFF and ON) operation of FOTA (Firmware Over The Air) update.</p>

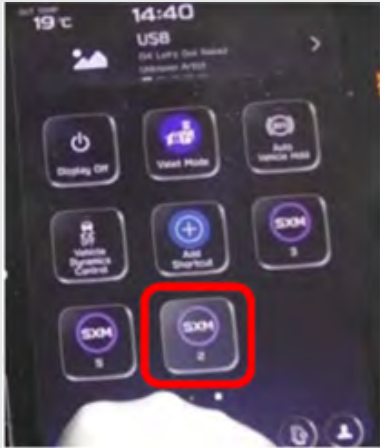
Number	Symptoms to be Improved:
6	<p>SXM station shortcut created by the customer does not work when the SXM has not been used as audio source after the Ignition Switch was turned on in the ignition cycle.</p>

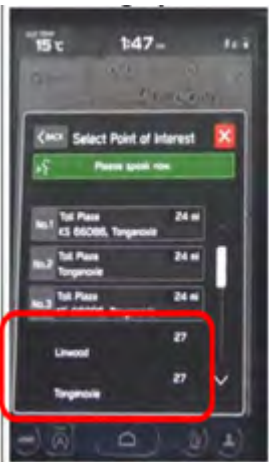
8	<p>Cannot connect to CarPlay via wireless connection. This symptom possibly occurs after the Ignition Switch was turned Off and On abruptly.</p>
9	<p>POI Search Result shows only city names and distances (without unit) when voice recognition POI search with Category name like “Find toll gate” is used.</p>
