SERVICE BULLETIN

APPLICABILITY: 2020-2022MY Outback & Legacy
 2022-2023MY BRZ
 2022-2023MY WRX

NUMBER: 15-270-20R

SUBJECT: FOTA (Firmware Over-The-Air) Reprogramming for DENSO Gen 4 Audio / Navigation Infotainment Systems

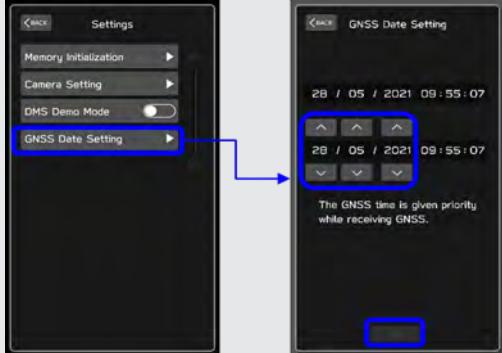
No.	Conditions/Symptoms to be improved
4	<p>When the clock was set to "AUTO," the date and time are shifted to a date approximately 20 years in the future due to anomalous values received from GPS or other reasons. If it occurs, the date and time cannot be corrected manually and have to be reset by disconnecting the battery terminal. As a countermeasure, a setting screen to manually adjust the clock display in the "AUTO" setting is to be added to the Dealership Mode (Dealership Mode->Settings->GNSS Data Setting).</p>

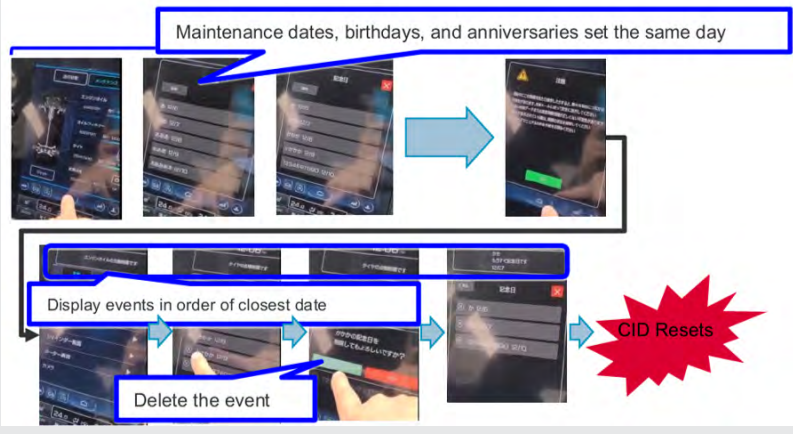
No.	Conditions/Symptoms to be improved
5	Touch operation of the CID screen does not work. The screen is displayed and sound is played, but the touch-screen operations are not available.
6	Operation of the CID screen and reaction may become slow while using Bluetooth audio.
7	The CID screen resets immediately or within 3 minutes after engine start.
8	<p>If a same date is set to maintenance date, birthday, and anniversary date, pop-ups will appear in sequence on the top of the CID after engine is started when the day comes. Under this condition, if an operation is performed to delete the maintenance date, birthday or anniversary date registration within a few seconds immediately before the pop-up display, the CID screen will reset.</p>

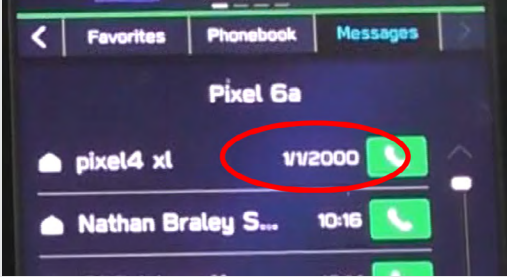
No.	Conditions/Symptoms to be improved
25	After canceling the phonebook transfer that appears automatically when connecting via Bluetooth, attempting to transfer a phonebook by manual operation fails to initiate the transfer.
26	<p>The date of receipt of a received message is displayed as “2000/1/1.” This occurs on some models of phones with Android OS 13 or later.</p>

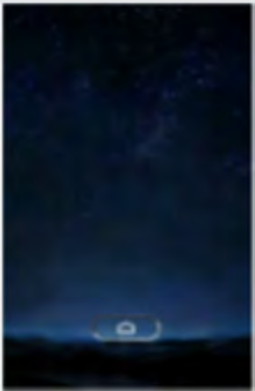
No.	Conditions/Symptoms to be improved
1	Unexpected CP1 system reboot resulting from an inter reset to sync internal communication with Bluetooth module.
2	CID restarts itself right after engine is started.
3	CID resets and reboots.
4	4 Right after starting up, the CID is blank only displaying the background without icons.

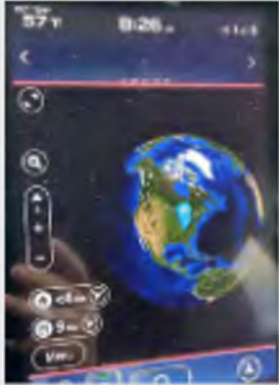
No.	Conditions/Symptoms to be improved
5	Loss of audio output for AM/FM
6	Loss of audio output from all sources. Voice from telematics, meter buzzer or beep sound are not affected
7	Sound is lost when playing Bluetooth audio even though the screen is displayed without problem. It can occur when the audio source is switched repeatedly between the Bluetooth and others.
8	SXM radio output is lost after terminating a handsfree phone call.
9	No audio played back when using CarPlay.
10	Sound volume control does not work while using Android Auto.
11	Cyclic short noise like a drilling or vibration is heard from speakers.
12	After the engine is started, a message of “Loading Navigation...” continues to be displayed, but the map is not displayed.
13	Vehicle position on navigation map erroneously moves to zero degrees latitude and zero degrees longitude (0°N 0°E or west of Africa in the Atlantic ocean)
14	Navigation map scale is changed to the lowest setting (globe is displayed).

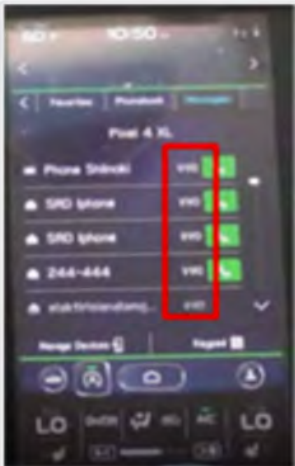
15	When “Call” button is pressed in “Confirm Destination” screen of Navigation system (to call the destination site,) the call can be made but the screen does not transit to phone call screen.
16	When selecting “Phone->”Message,” message received time is displayed incorrectly as “1/1/0.” It can occur with an Android phone with a specific Android OS (Pixel 6, Pixel4a, Pixel4XL, Xperia etc.) in which time zone data is attached to the message receiving time.

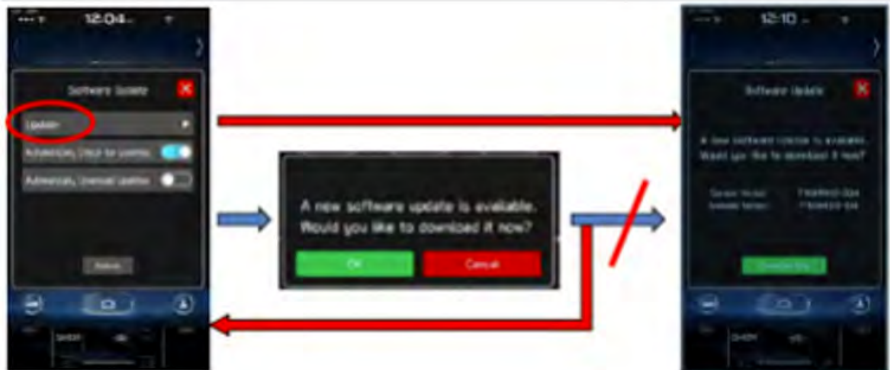
No.	Conditions/Symptoms to be improved
24	<p>When using FOTA service to update the software by selecting “Setting” > “Software Update,” a message of “A new software update is available. Would you like to download it now?” is displayed but the downloading does not start after pressing “OK.” When this symptom occurs, it comes back to the “Software Update” screen. The downloading can be started by pressing the “Update” on the “Software Update” screen. (Temporary solution.)</p>

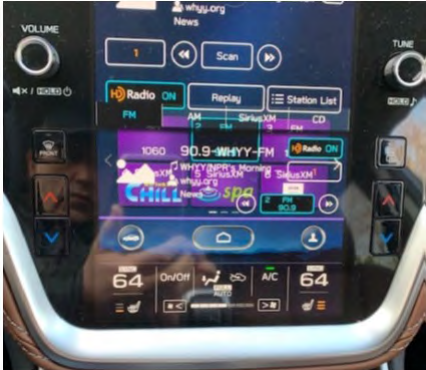
No.	Conditions/Symptoms to be improved
9	CarPlay stopped working after hanging up a hands-free phone call
10	Screen is no changed to Composer or Album screen, iPhone /iPod connected as iPod mode
11	<p>CID shows multiple images simultaneously</p>

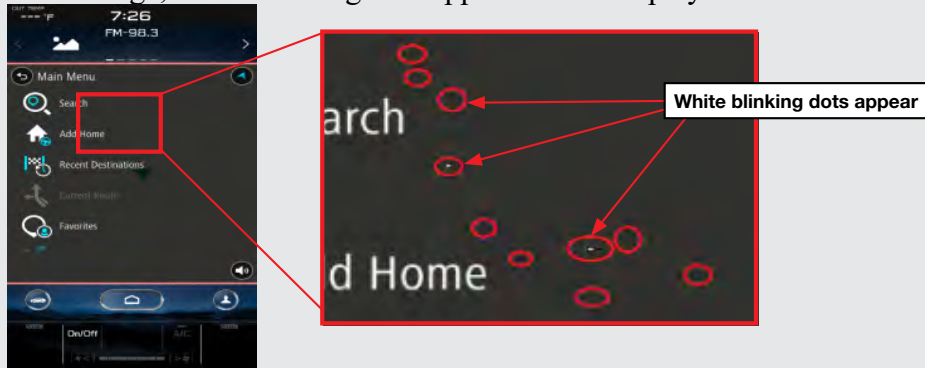
No.	Symptom to be improved	FOTA
1	Several minutes after Engine start, Center Information Display (CID) reboots itself	Yes
2	<p>After extended usage, white blinking dots appear on the display.</p>

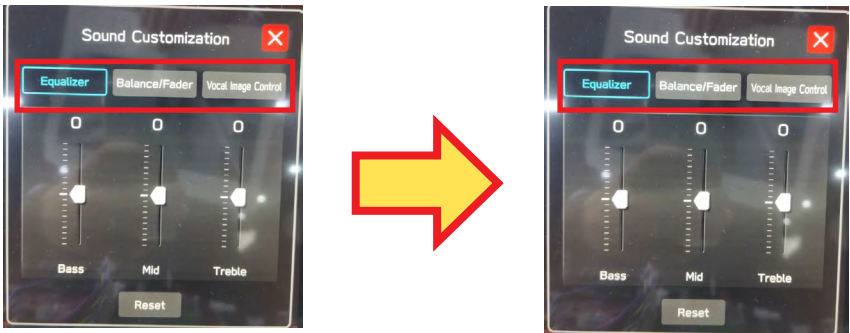
7	<p>Equalizer setting returns to default setting. After ignition switch is turned Off and ON, the equalizer returns to default setting.</p>

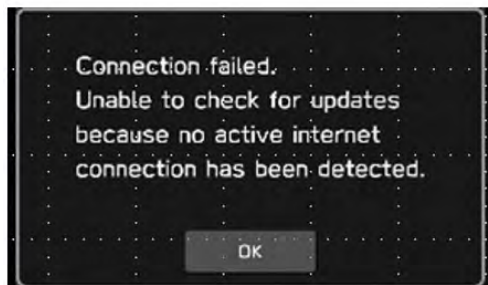
2. If you receive one of the following two messages during the update process:

- a. Check the internet connection to ensure it is active and shows full signal strength.
 - i. Select General tab under “Setting” screen and change the “Wi-Fi” to Off once then turn it back to On again.

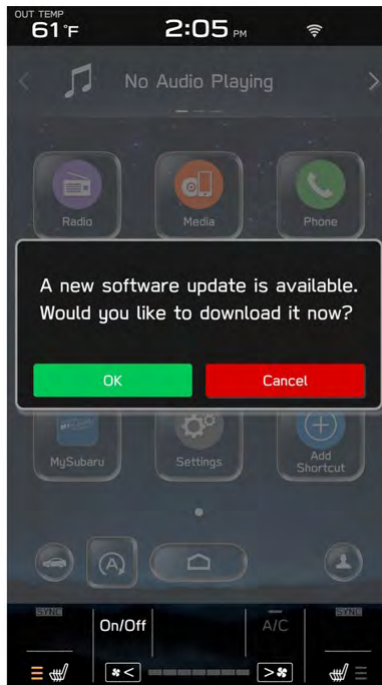
4. If the "OK" button does not respond when I begin the update process:

- a. If CarPlay application is running at the time the pop-up screen comes up, the screen is being disabled for OK operation. Please press the home button on the display, go to Settings, Software Updates, Update, and begin again.
