Technical Service Bulletin

93 e-tron GE electric drive motor leak P0AA600

93 24 22 2073858/2 October 8, 2024. Supersedes Technical Service Bulletin Group 93 number 24-82 dated July 27, 2024 for reasons listed below.

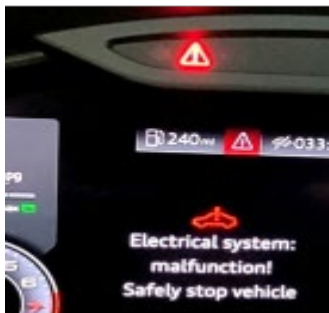
- A Drive System/Electrical System Malfunction message (Figure 1) appears in the in the instrument cluster; the warning may not be present at the time of inspection.

Figure 1. Warning lamp associated with message.
