# 42-080 ABS Wheel Speed Fault Code Correction for MBSP Equipped Vehicles

## TSB-42-080-FTL

► New Cascadia

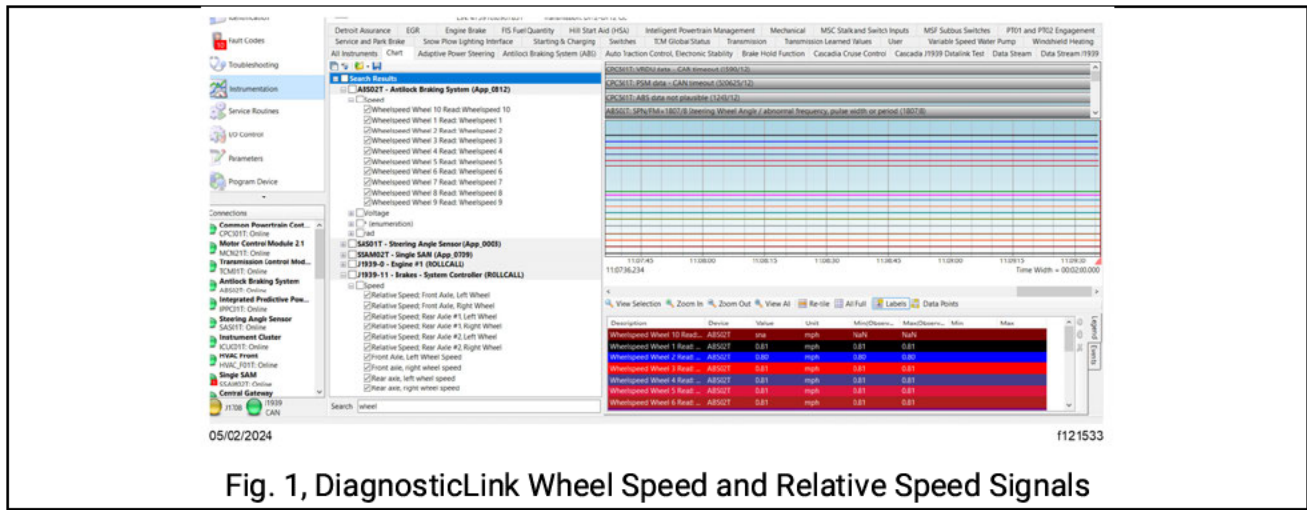
Fig. 1, DiagnosticLink Wheel Speed and Relative Speed Signals

13.  During the test drive, monitor the wheel speeds using DiagnosticLink and ensure that the ABS module and all J1939 connections are active. Do the wheel speeds appear erratic, spike up, or show readings when the vehicle is stationary? It is recommended to refer to the chart instead of the ABS tab/panel. See Table [Wheel Speed Chart Signals 4](#) and Fig. 1 for the charting selections in DiagnosticLink.
