Driver Assistance System Module Sensor Misalignment - DTC C14A4 - MY 2023 and 2024 Chrysler Pacifica (RU) / Jeep Compass (MP) and Dodge Durango (WD)

WARRANTY OPERATIONS NEWSLETTER

VOLUME 10, ISSUE 10

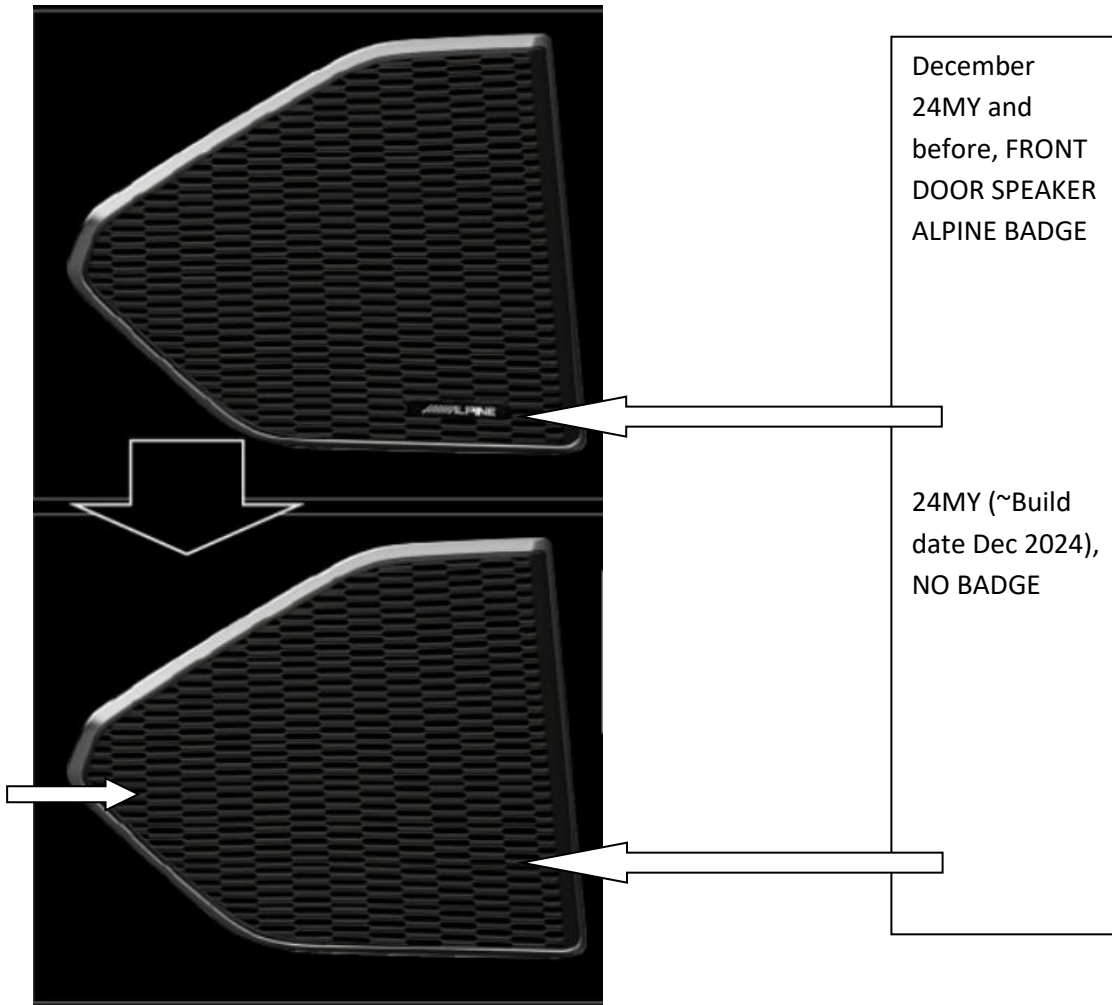
Please note that the "ALPINE" front Speaker badge will be removed on WL74/75 vehicles starting in December of 2024. When ordering Front Doors for service, please make sure that Vehicles with the Alpine Badge are replaced with the same. If front Door has no Alpine badge it needs to be replaced with the same. Rear doors are not affected as they never had the Alpine Badge.

- Verify speaker grille PN and visually check if speaker is with badge or without.
 - Check PN on back of part being replaced.
 - Order Service PN for the part being replaced
- Please refer to DTC specific repair procedures found in Dealer Connect.
