## **Driver Assistance System Module Sensor Misalignment - DTC C14A4 - MY 2023 and 2024 Chrysler Pacifica (RU) / Jeep Compass (MP) and Dodge Durango (WD)**

# FCA CARIBBEAN WARRANTY OPERATIONS NEWSLETTER

## VOLUME 10, ISSUE 10

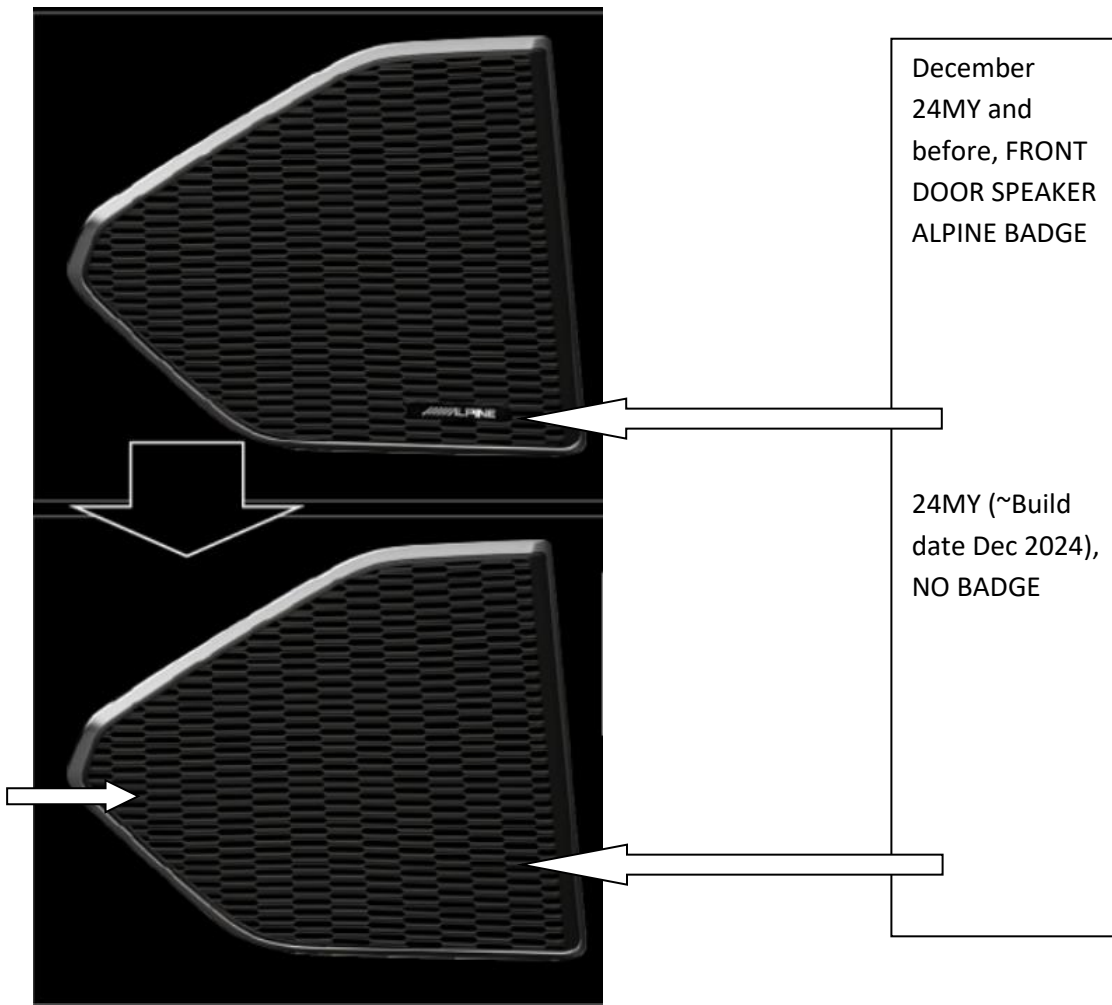
Please note that the "ALPINE" front Speaker badge will be removed on WL74/75 vehicles starting in December of 2024. When ordering Front Doors for service, please make sure that Vehicles with the Alpine Badge are replaced with the same. If front Door has no Alpine badge it needs to be replaced with the same. Rear doors are not affected as they never had the Alpine Badge.

- Verify speaker grille PN and visually check if speaker is with badge or without.
  - Check PN on back of part being replaced.
  - Order Service PN for the part being replaced
- Please refer to DTC specific repair procedures found in Dealer Connect.
