Service Bulletin

Bulletin No.: 21-NA-192

Subject: Top Not Secure DIC Message, DTC B19E4 SYM64 May be Stored in History in Convertibles

Brand:	Model:	Model Year:		Date Breakpoint:		Engine:	Transmission:
		from	to	from	to		
Chevrolet	Corvette Convertible	2020	2025	—	—	All	All

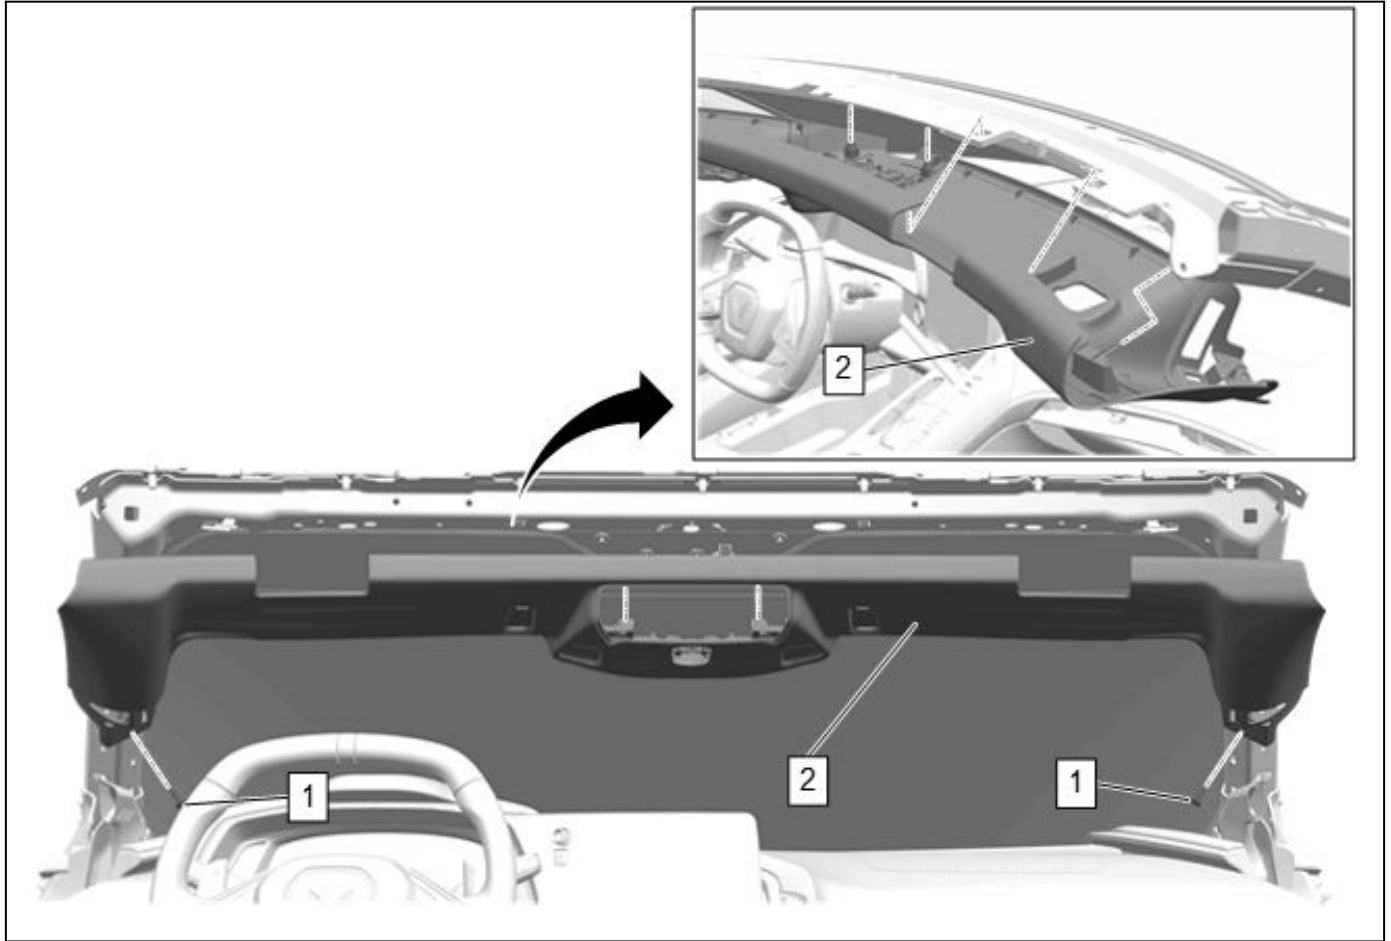
5389192

1. Remove the windshield upper garnish molding (2). Refer to *Windshield Upper Garnish Molding Replacement (Convertible)* in SI.
