GROUP	MODEL
Subsequent Repair Action	2014-2016MY Optima (TF HEV) w/2.4L MPI
NUMBER	DATE
PI2104Y/Z (Rev 1, 11/07/2024)	July 2023

ENGINE REPLACEMENT INSTRUCTIONS FOR DTC P1326 (PI2104Y/Z)

This bulletin provides information related to the Technical Service Bulletin previously published in (PI2104) titled "Knock Sensor Detection System - ECU Logic Improvement" for 2014-2016MY Optima (TF HEV) vehicles equipped with Theta 2.4L MPI engine, produced from December 11, 2013 through July 22, 2015. Specifically, this bulletin provides instructions on which procedures to follow if, after installation of the KSDS, any one of the subject vehicles below return to the dealer with Diagnostic Trouble Code (DTC) P1326 (Knock Signal Range/Performance).

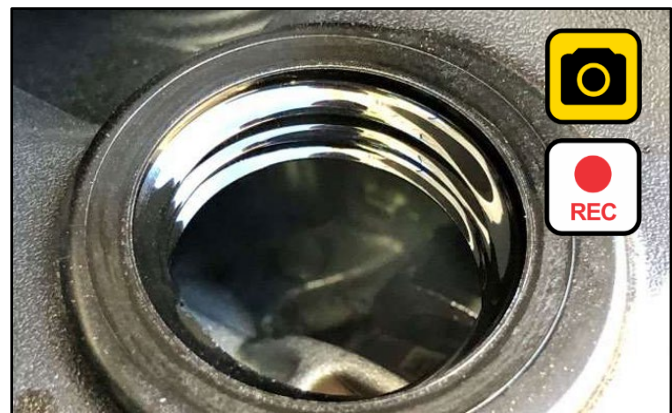
Record/Note findings: No oil, oil sludge, varnish, burnt oil smell condition(s) found.

If NO oil is registered on the dipstick, or oil lacquering, oil sludge and/or oil varnish is present (NG), then the engine is therefore suspect to maintenance neglect. Review of the vehicle's maintenance history is required.

If suspect, proceed to the 'Oil Level Measurement' instructions below and submit with the Techline case.
