GROUP	MODEL
Subsequent Repair Action	2017-19MY Soul (PS) w/Nu 2.0L GDI
NUMBER	DATE
PI2107Y/Z (Rev 1, 11/07/2024)	May 2022

ENGINE REPLACEMENT INSTRUCTIONS FOR DTC P1326 (PI2107Y/Z)

This bulletin provides information related to the Technical Service Bulletin previously published (PI2107) titled "Nu 2.0L GDI - Knock Sensor Detection System ECU Logic Improvement". Specifically, this bulletin provides instructions on which procedures to follow if, after installation of the KSDS, any one of the subject vehicles below return to the dealer with Diagnostic Trouble Code (DTC) P1326 (Knock Signal Range/Performance).

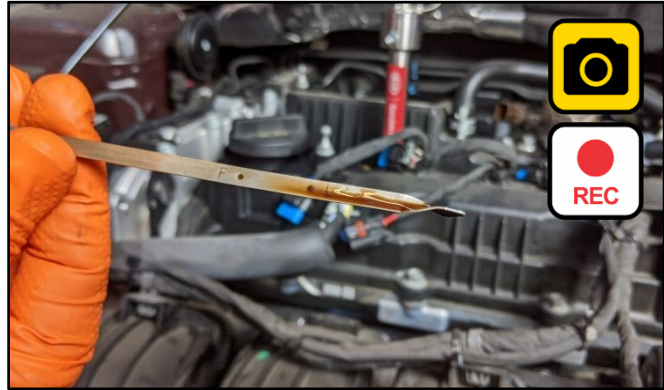
1. Start video showing vehicle and move in towards the dash VIN tag.
2. Measure and record oil dip stick level.
3. Note oil dip stick reading on the RO.
4. Take a picture of the oil reading on dipstick.

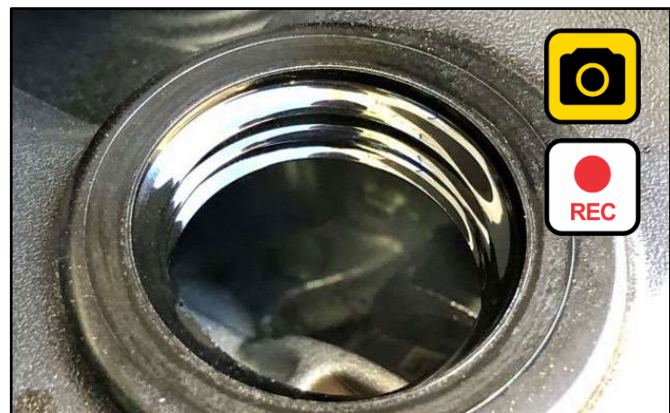
Record/Note findings: No oil, oil sludge, varnish, burnt oil smell condition(s) found.

If NO oil is registered on the dipstick, or oil lacquering, oil sludge and/or oil varnish is present (NG), then the engine is therefore suspect to maintenance neglect. Review of the vehicle's maintenance history is required.

If suspect, proceed to the 'Oil Level Measurement' instructions below and submit with the Techline case.

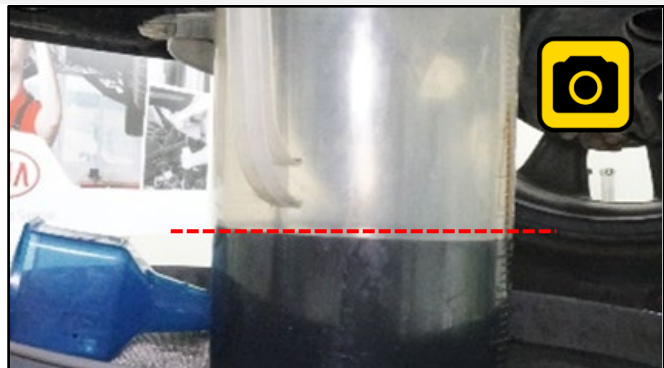
**Oil Level Measurement: (Main Flowchart → PWA Request) NO OIL READING ON DIPSTICK**

1. Remove oil filler cap, remove oil drain plug and drain oil into the measuring container SST067BUCK and check oil level.
2. Record oil level reading on the RO.
3. Take photo of the drained oil container using KDS and attach to warranty claim PWA request.

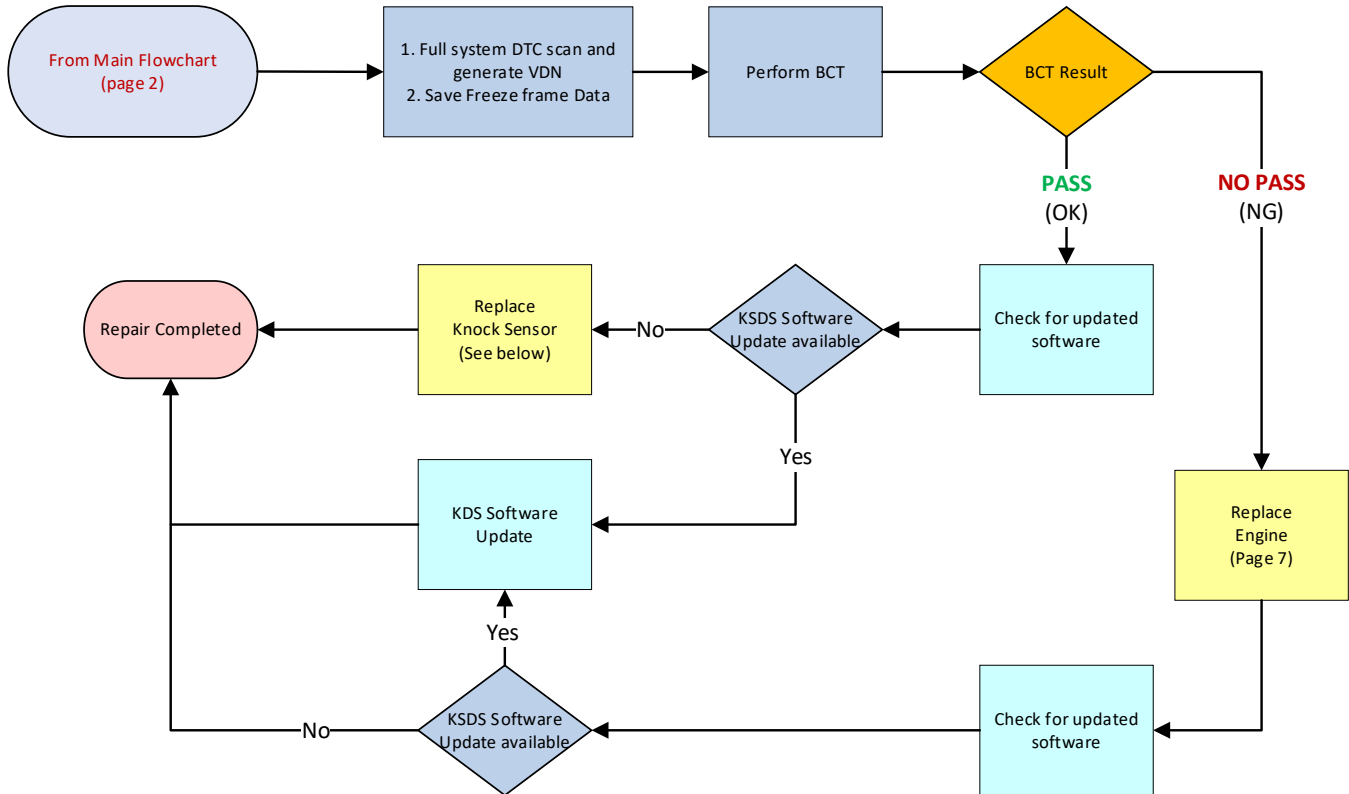
A. DTC P1326 Stored

Create PI2107Y Claim - No Techline PWA Required

Knock Sensor Replacement Procedure:

1. Replace the knock sensor by referring to the "Engine Control / Fuel System → Engine Control System → Knock Sensor → Repair procedures" chapter in the applicable Shop Manual on KGIS.

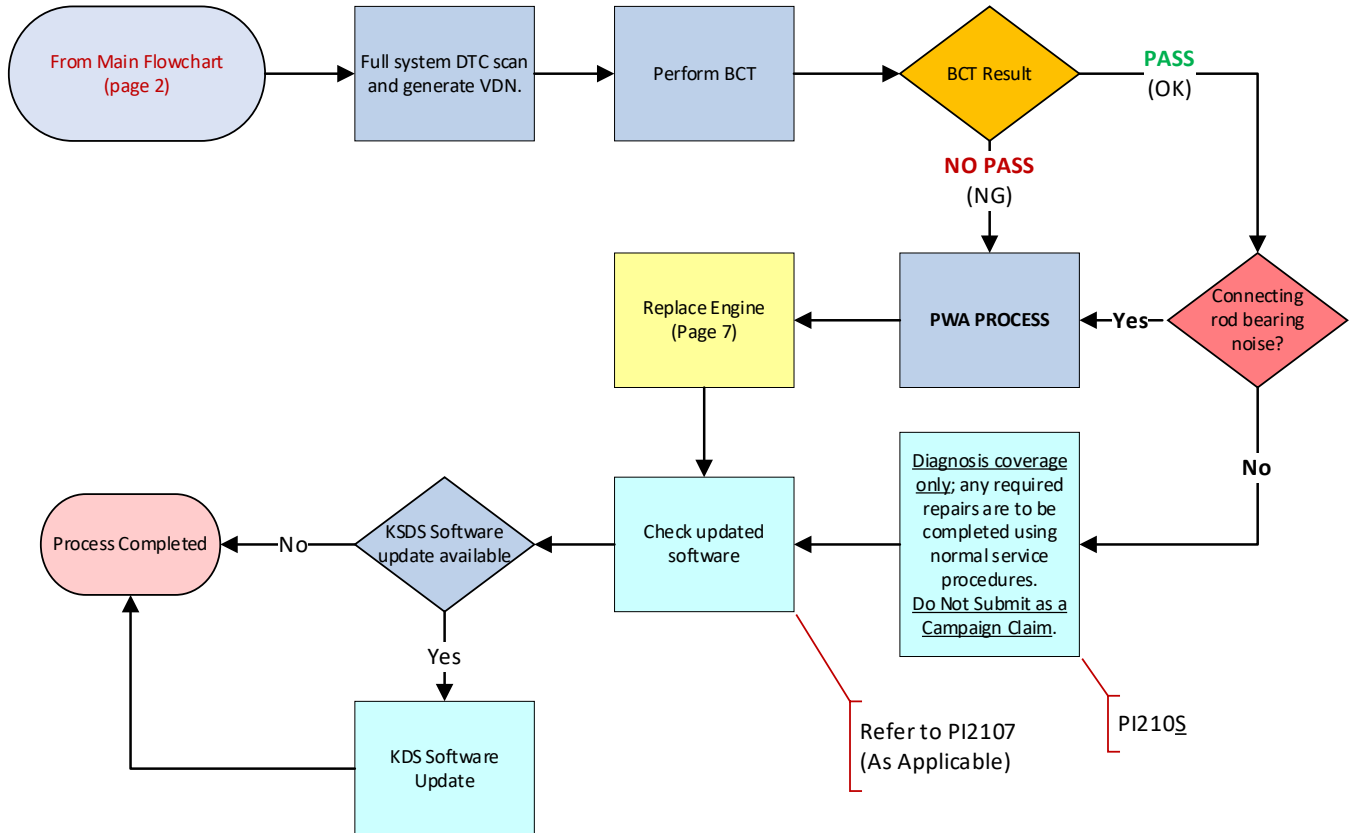
B. Engine Noise

Techline PWA Required; Diagnosis Only Campaign Possible

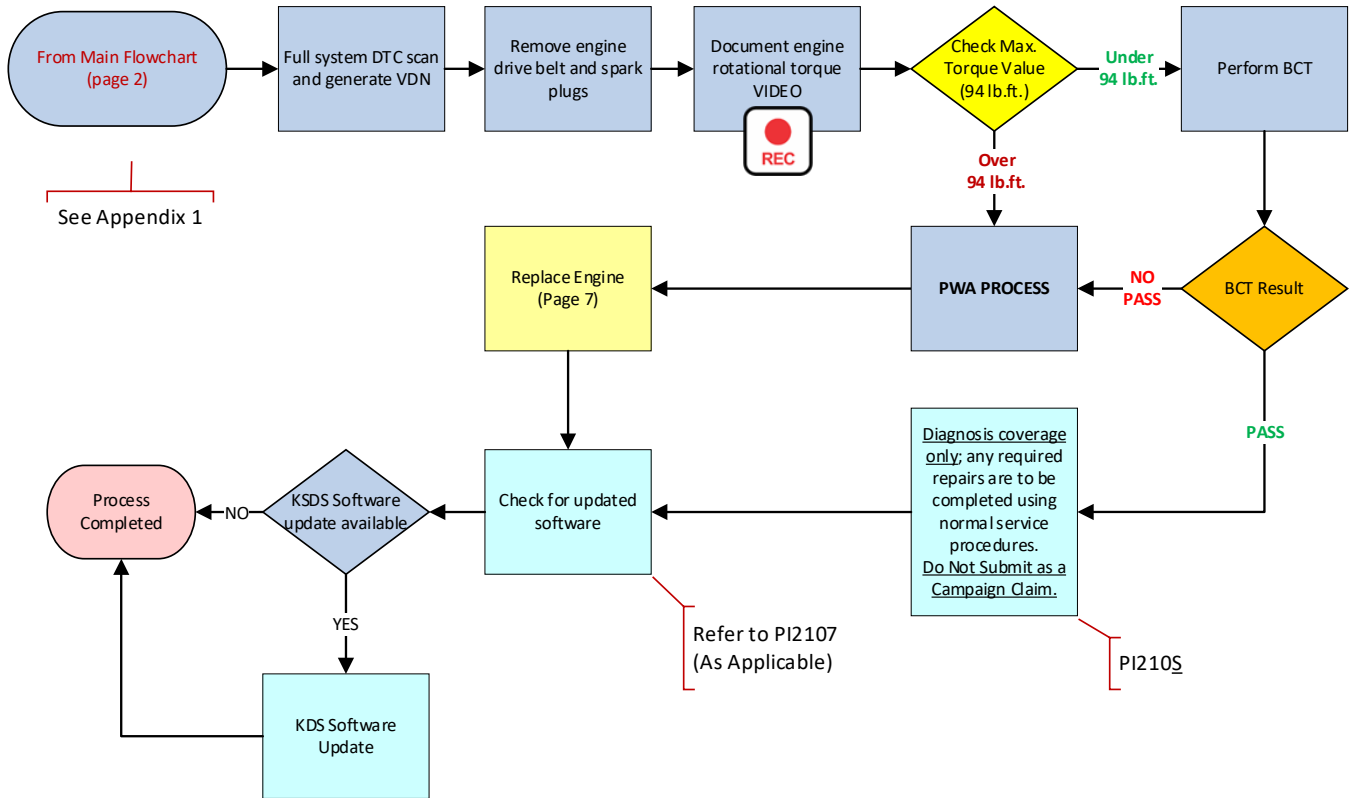
C. Engine No Crank

Techline PWA Required; Diagnosis Only Campaign Possible
