Service Bulletin

Bulletin No.: 17-NA-357

Subject: Noise or Malfunction of Trim Door on Broken Quarter Upper Trim Panel, Possible Convertible Top Inoperative

Brand:	Model:	Model Year:		VIN:		Engine:	Transmission:
		from	to	from	to		
Chevrolet	Camaro Convertible	2016	2024	—	—	All	All

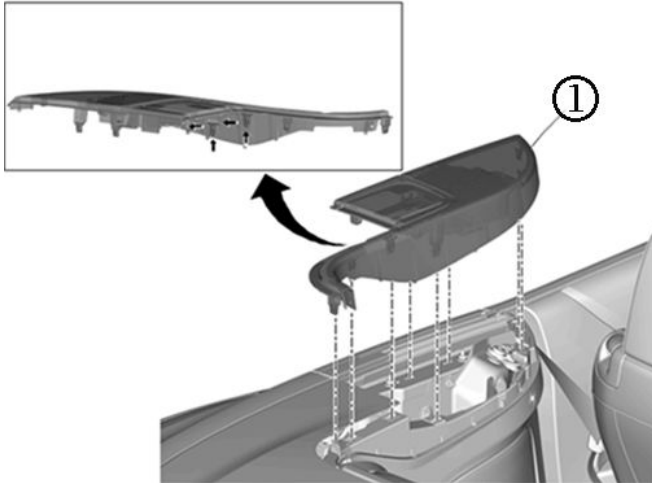
4889569

Important: Under no circumstances should the 3rd clip be removed from the quarter upper trim panel.

Note: For vehicles built prior to February 14, 2017, it will also be necessary to replace the window regulator in addition to the quarter upper trim panel to accommodate the added 3rd clip design.
