MAS004445 RU 24-42

Rapid Update 765

Maserati Grecale – Front Wiring Repositioning

DATE: November 21, 2024

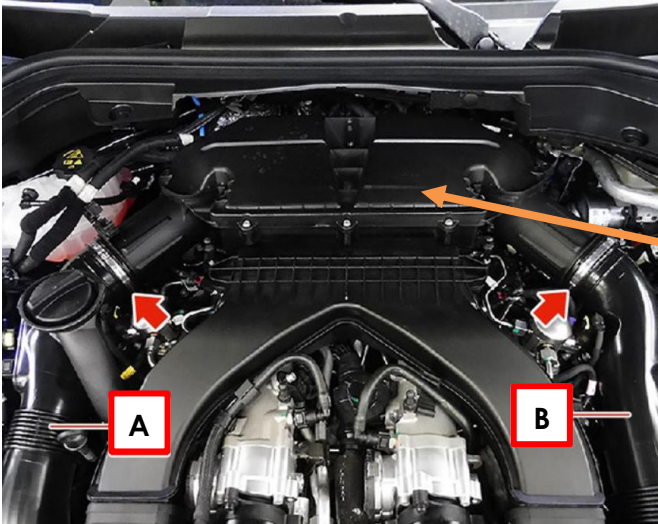
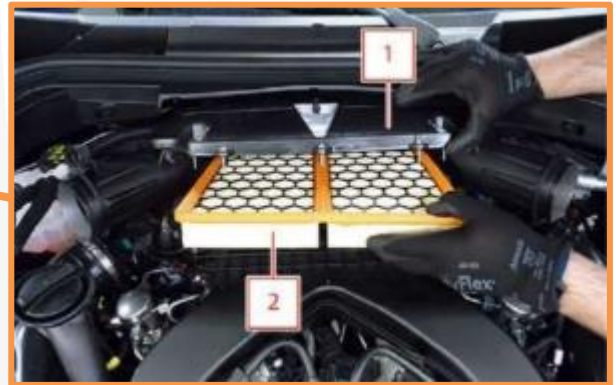
1. Always check ModisCS+ to see if the vehicle is involved in this action and if it has not been previously performed.
2. Disconnect the battery according to the instructions in the workshop manual:
 - **08.20.001 - BATTERY - Connecting/disconnecting the power supply**
3. Open the front hood and remove the engine compartment cover following the procedure given in the workshop manual: **09.15.001 ENGINE COMPARTMENT COVER.**
4. Remove the suspension strut connecting cross cross-member assembly following the instructions in the workshop manual: **9.03.055 SUSPENSION UPRIGHT CONNECTION CROSSBEAM ASSEMBLY.**
5. Remove the air filter following the procedure in the workshop manual by completely removing the top cover (1) but **avoiding** removing the side collars and moving the A/B ducts: **1.41.001 AIR FILTER.**
