SERVICE BULLETIN

APPLICABILITY: 23-25MY Outback/Legacy Models (including Wilderness models)
 23-24MY Ascent Models
 24MY Impreza
 24MY Crosstrek (including Wilderness models)
 24MY WRX
 25MY Forester

NUMBER: 15-305-22R
DATE: 11/15/22
REVISED: 11/07/24

SUBJECT: Reprogramming File Availability for Optimization of Gen 4.5 Denso CP1.5 Infotainment Systems

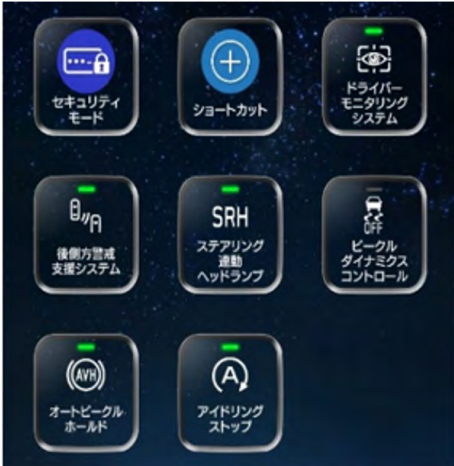
<p>The order of 1.First Name and 2.Family Name in the phone book is set to 1.→2. even if the order is set to 2.→1.</p>
		<p>The message function may become unavailable following repeated page scrolling up and down of the list on the phone's message list screen. (only applicable to HIGH and MID trim)</p>
		<p>When transitioning to the maintenance screen and the setting value is set to AUTO, a popup prompting the user to sign a MySubaru contract is displayed and the setting is switched to Manual. (only applicable to HIGH and MID trim)</p>
		<p>When turning off and on while two or more shortcuts of DMS/SRH/SRVD icons are set on the Home screen, the order of icons changes from DMS to SRVD, SRH, VDC, AVH, and ISS.</p>

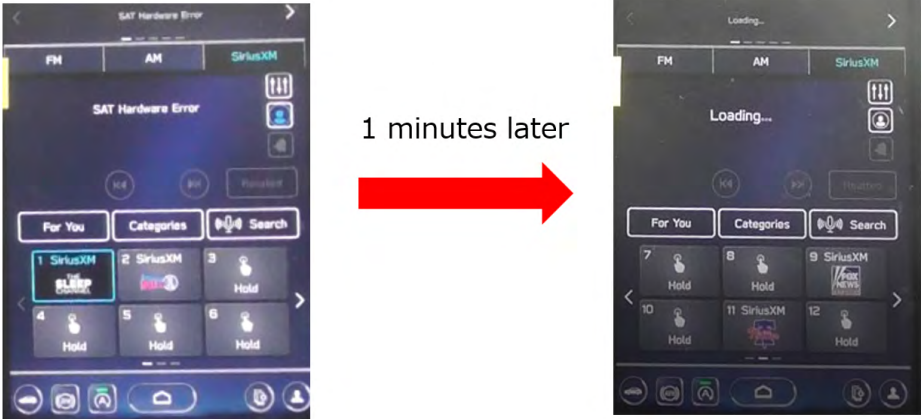
<p>It may take accessive time to start the CID screen after ignition on.</p>
7	SXM	<p>The first time ignition on after the CCU software update added the SXM360 functionality, the SXM playback screen may remain at “Loading...” after the CCU software update.</p>

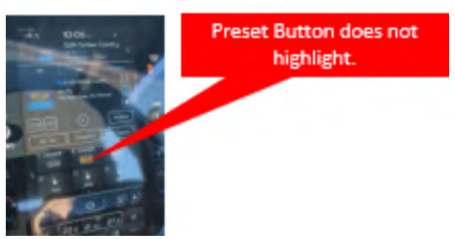
Number	Category	Symptoms to be Improved:
7	Bluetooth	<p>- Address vulnerabilities in the Bluetooth encryption mechanism (only applicable to BASE trim)</p> <p>- If the Bluetooth connection fails due to the loss of the link key in the phone, the following message should be changed to be displayed.</p> <p>Before: Connection unsuccessful Please try again later</p> <p>After: Connection unsuccessful Please try deleting and then re-pairing your device</p>
8	Radio	<p>- When pressing a preset button for a registered radio channel, you can play the channel. But the button you pressed does not highlight, and you cannot operate through presets using the steering wheel controls (not applicable to WRX)</p> <div data-bbox="776 695 1227 932" style="text-align: center;">

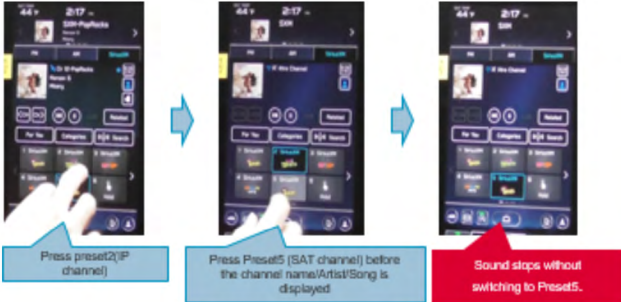
Number	Category	Symptoms to be Improved:
9	SXM	<p>- When switching to the SAT channel (satellite channel) immediately after selecting the IP channel (Internet channel) on the SXM360, song information is not displayed and audio playback stops (not applicable to BASE trim)</p>

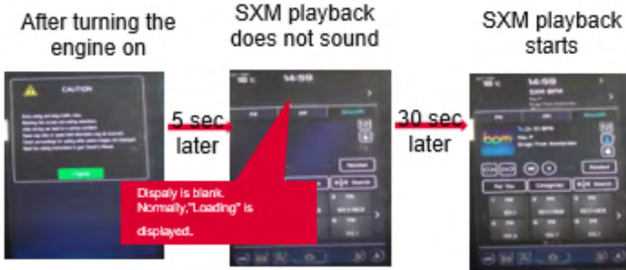
<p>- Registering a channel with blank information in presets results in a preset button with a blank label, and the channel logo is not displayed. Additionally, pressing the preset button with the blank label does not initiate playback of the channel.</p> <p>- After turning the engine on, "Loading" should appear on the channel information screen until SXM playback starts, but it does not appear and remains blank</p>

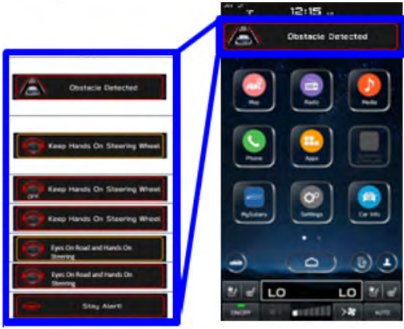
<p>- If the language setting of the CID is changed while an alarm message by the Driver Monitoring System(DMS) is displayed on the CID, the alarm will be hidden (not applicable to BASE trim)</p>

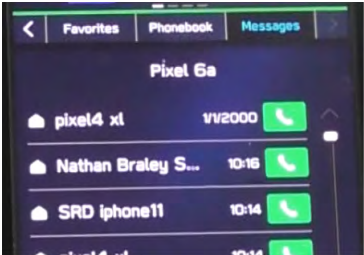
<ul style="list-style-type: none"> - The date for the message is displayed as 1/1/2000 instead of the correct date. This occurs on some models of phones with Android OS 13 or later. <div style="text-align: center;">

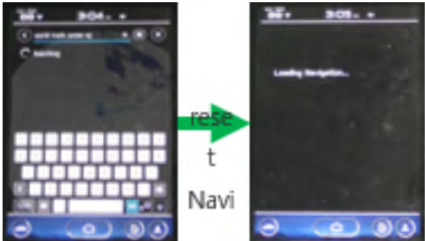
</div>
12	Touch Operation	<ul style="list-style-type: none"> - Suddenly, the touch screen on the CID (Central Information Display) becomes unresponsive, even though the screen display remains normal. (not applicable to WRX) - CID doesn't respond to touch (The screen is displayed and sound is played, but only the operations are not available)
13	Navi Operation	<ul style="list-style-type: none"> - When repeatedly entering text on the destination search screen, the screen may freeze, and the navigation application restarts (only applicable to HIGH trim) <div style="text-align: center;">

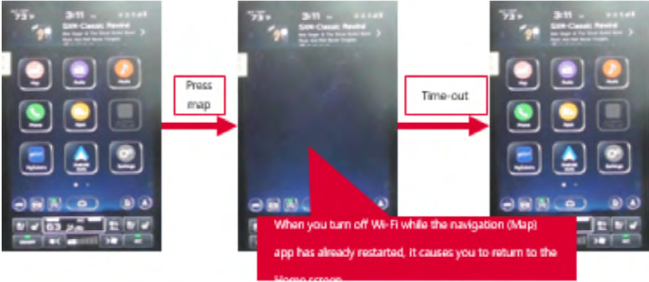
Number	Category	Symptoms to be Improved:
13	Navi Operation	<p>- During map data updates, if you switch off the Wi-Fi function from the Settings screen pressing the Map icon on the Home screen doesn't display the Map screen for a while (only applicable to HIGH trim)</p> <div data-bbox="678 296 1323 575" style="text-align: center;">

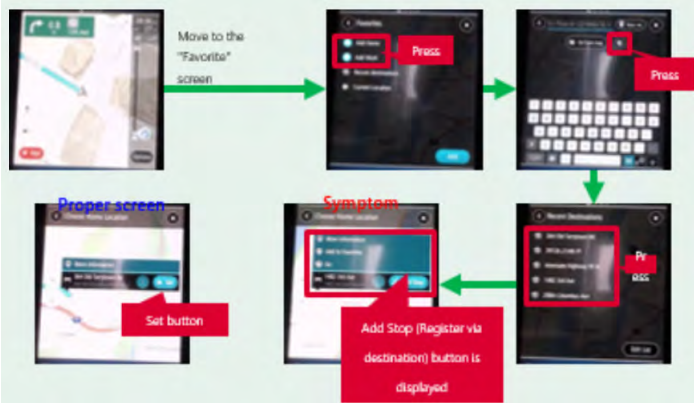
<p>- Add Stop (Register via destination) button is displayed instead of Set button and Favoirte registration for Home/Work cannot be done after performig the steps below moving to the ""Favorite"" screen with the navigation destination set (only applicable to HIGH trim) :</p> <ol style="list-style-type: none"> 1. Press Add Home/Work 2. Select a location from the Destination History screen

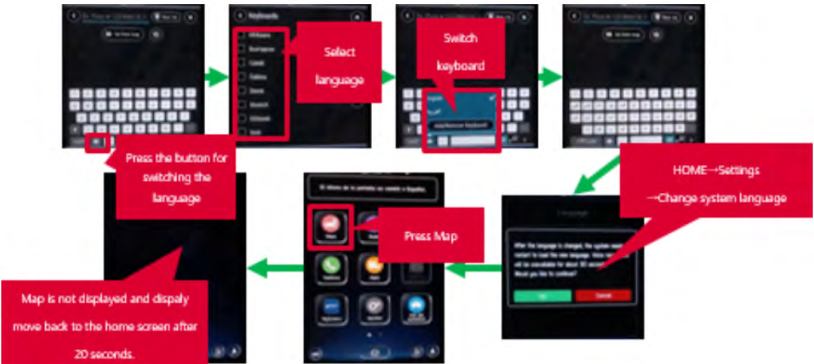
<p>- Map is not displayed when Map is pressed from the home screen if switch- ing the language used for the text input keyboard on the search screen of the navigation application (only applicable to HIGH trim)</p>

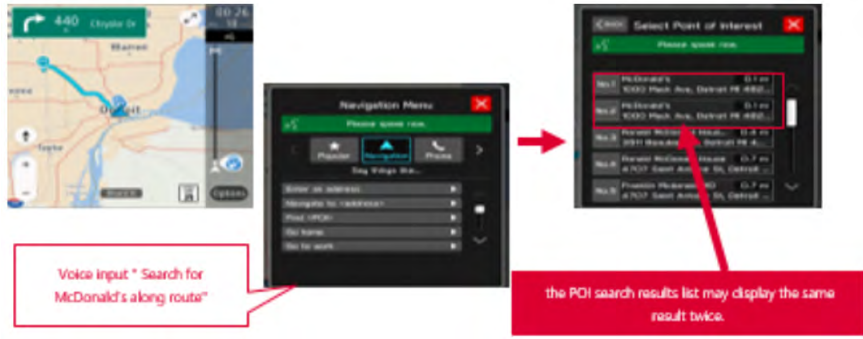
Number	Category	Symptoms to be Improved:
13	Navi Operation	<p>- When using voice recognition during navigation to say 'Search for **** along route,' the POI search results list may display the same result twice (only applicable to HIGH trim)</p>

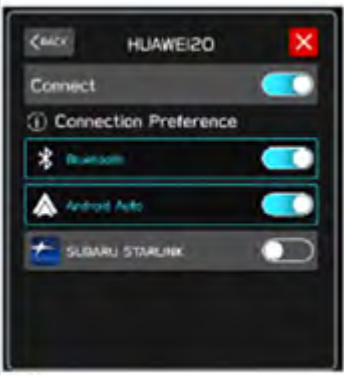
2	<p>On the “Manage Devices” screen Bluetooth cannot be selected as connection preference.</p>
