**SERVICE BULLETIN**

**APPLICABILITY:** 2020-2022MY Outback & Legacy  
 2022-2023MY BRZ  
 2022-2023MY WRX

**NUMBER:** 15-270-20R

**SUBJECT:** FOTA (Firmware Over-The-Air) Reprogramming for DENSO Gen 4 Audio / Navigation Infotainment Systems

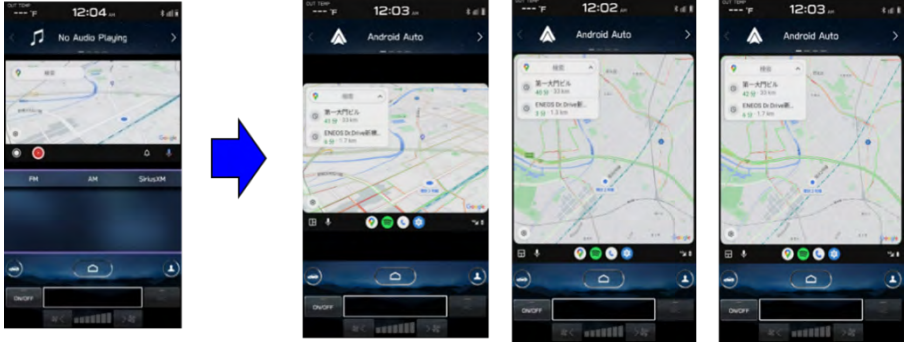
No.	Conditions/Symptoms to be improved
1	<p>CCU Support vertical screen displays for Android Auto, but the actual display screen size differs depending on the Android device's OS version.</p>

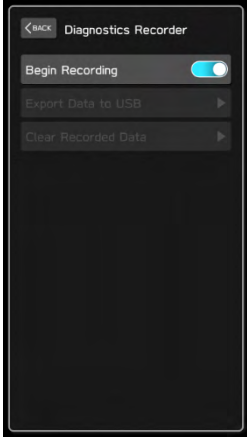
2	<p>Update against vulnerability in security of Bluetooth connection.</p>
3	<p>When getting CCU USB logs at the Diagnostics Recorder screen in the Dealership Mode, it was necessary to turn off "Begin Recording" to "Export Data to USB." And after the log acquisition, it was necessary to turn ""Begin Recording"" ON again. The system interface is improved so that "Begin Recording" is automatically switched ON after log acquisition has been accomplished.</p>

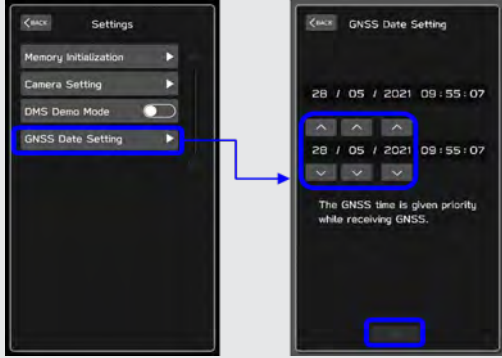
No.	Conditions/Symptoms to be improved
4	<p>When the clock was set to "AUTO," the date and time are shifted to a date approximately 20 years in the future due to anomalous values received from GPS or other reasons. If it occurs, the date and time cannot be corrected manually and have to be reset by disconnecting the battery terminal. As a countermeasure, a setting screen to manually adjust the clock display in the "AUTO" setting is to be added to the Dealership Mode (Dealership Mode-&gt;Settings-&gt;GNSS Data Setting).</p>

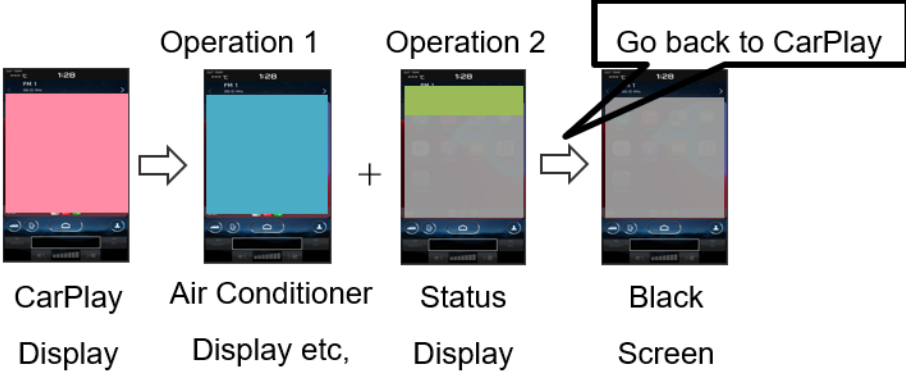
No.	Conditions/Symptoms to be improved
13	<p>After performing operations 1 and 2 below from the CarPlay screen, returning to the CarPlay screen causes the CarPlay screen to be black screen.</p> <p><b>Operation 1:</b> Switching to a pop-up screen such as the air conditioner screen</p> <p><b>Operation 2:</b> Interrupt pop-up screen display due to volume operation, etc.</p>

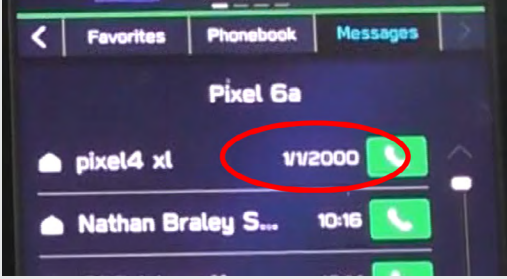
No.	Conditions/Symptoms to be improved
25	After canceling the phonebook transfer that appears automatically when connecting via Bluetooth, attempting to transfer a phonebook by manual operation fails to initiate the transfer.
26	<p>The date of receipt of a received message is displayed as “2000/1/1.” This occurs on some models of phones with Android OS 13 or later.</p>

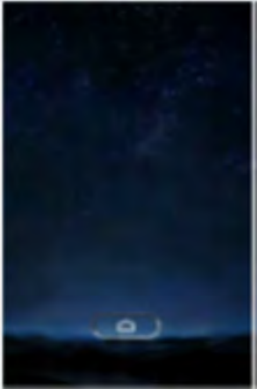
No.	Conditions/Symptoms to be improved
1	Unexpected CP1 system reboot resulting from an inter reset to sync internal communication with Bluetooth module.
2	CID restarts itself right after engine is started.
3	CID resets and reboots.
4	4 Right after starting up, the CID is blank only displaying the background without icons.

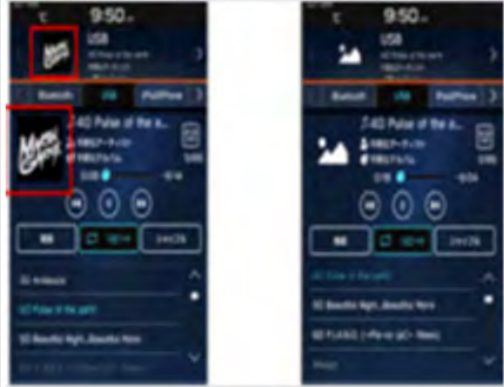
No.	Conditions/Symptoms to be improved
17	Even when using the same mobile device that was paired previously, a message of “Are you sure you want to activate this profile?” is prompted and confirmation is needed to activate the device.
18	<p>Cover art of previous music is displayed when playing music without cover art in USB audio. It can occur when music with and without cover art is mixed and stored together a single USB.</p>

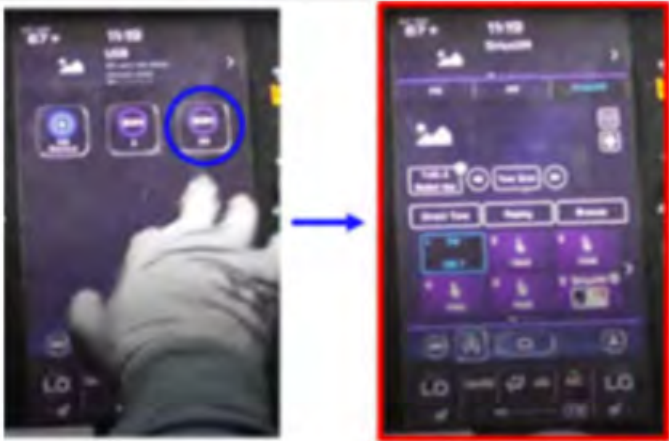
21	<p>In USB music mode, some music is skipped and the music in the next folder is started. Under following condition</p> <ol style="list-style-type: none"> <li>1. Play USB music in “Folder” mode with repeat mode setting “Repeat All.”</li> <li>2. Turn Ignition Switch off then open/close door and keep it locked for more than 5 minutes.</li> <li>3. Turn Ignition Switch on and operate “Track Up/Down” on the audio system.</li> </ol>
22	The mode does not switch to Media, after “Media” icon is selected.
23	<p>When selecting shortcut for SXM channel on “Home” screen, the screen is changed to SXM but no sound is coming or no channel name is displayed.</p>

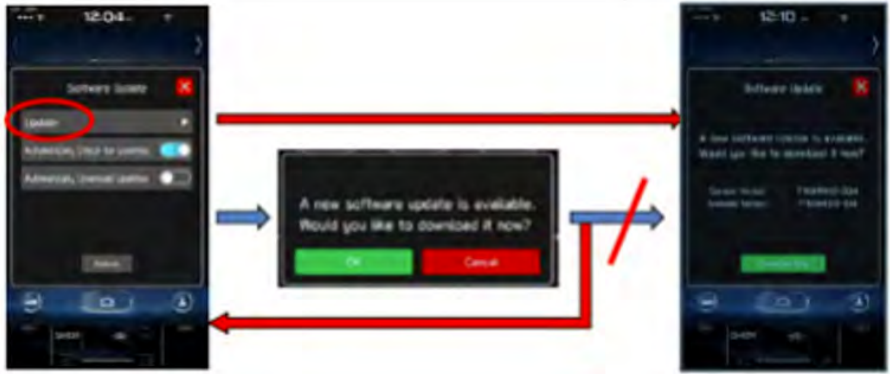
No.	Conditions/Symptoms to be improved
24	<p>When using FOTA service to update the software by selecting “Setting” &gt; “Software Update,” a message of “A new software update is available. Would you like to download it now?” is displayed but the downloading does not start after pressing “OK.” When this symptom occurs, it comes back to the “Software Update” screen. The downloading can be started by pressing the “Update” on the “Software Update” screen. (Temporary solution.)</p>

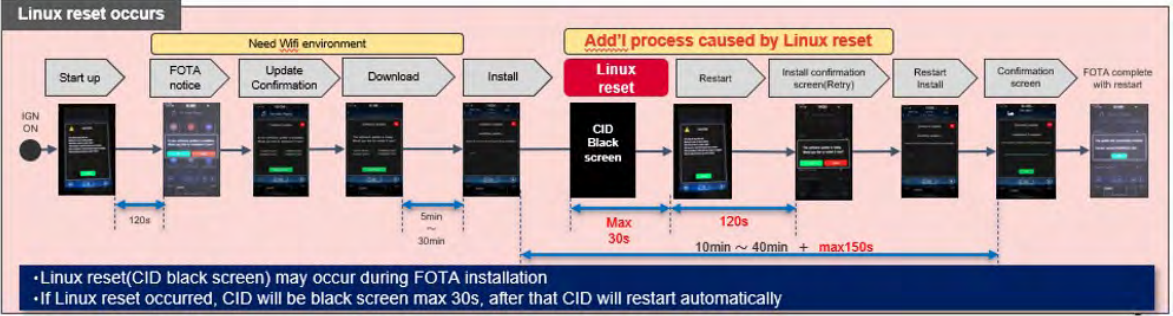
<p>The flowchart titled "Linux reset occurs" shows the same process as above but includes a "Linux reset" step. This step is represented by a red box labeled "Linux reset" and a black box labeled "CID Black screen" (Max 30s). This is followed by a "Restart" (120s) and "Install confirmation screen(Retry)" (10min ~ 40min + max150s) step. The final steps are "Restart install", "Confirmation screen", and "FOTA complete with restart". A blue box at the bottom contains the text: "•Linux reset(CID black screen) may occur during FOTA installation" and "•If Linux reset occurred, CID will be black screen max 30s, after that CID will restart automatically".</p> <p><b>Note*)</b> Even if this symptom occurs, after approximately 2 minutes, the system resumes, and the CID comes back to the below screen. Customer can then push the “Install Now” to proceed with the installation.</p>

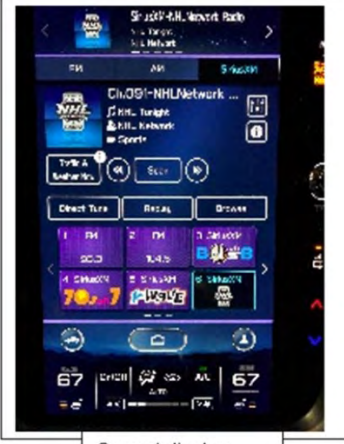
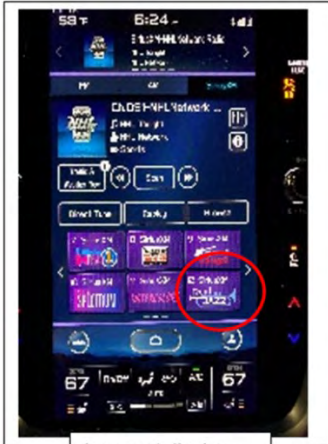
No.	Conditions/Symptoms to be improved
36	<Home> cannot be selected
37	Radio station moves unexpectedly due to momentary flick or brush of the touch screen
38	Temperature setting cannot be controlled by Voice Recognition in Canadian (C*) specification
39	Preset outline is not shown following station selection using steering switch <div style="display: flex; justify-content: space-around; align-items: center;">

</div> <div style="display: flex; justify-content: space-around; margin-top: 5px;"> <span data-bbox="560 808 755 829">Correct display</span> <span data-bbox="990 808 1185 829">Incorrect display</span> </div>
40	When restart Engine, while downloading map data through Wi-Fi, <Major Update>and/or <Up to Date> button is not displayed
41	If destination set by voice recognition, after restart Engine, Navigation screen not displayed
42	Steering switch button doesn't work to select preset station or control music playback

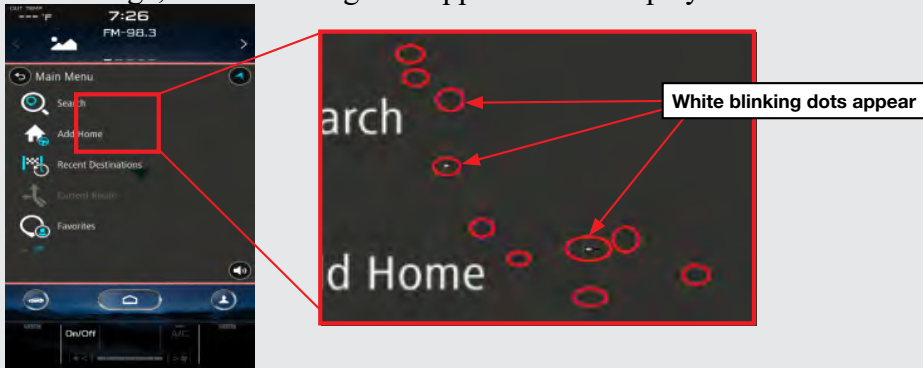
No.	Symptom to be improved	FOTA
1	Several minutes after Engine start, Center Information Display (CID) reboots itself	Yes
2	<p>After extended usage, white blinking dots appear on the display.</p>

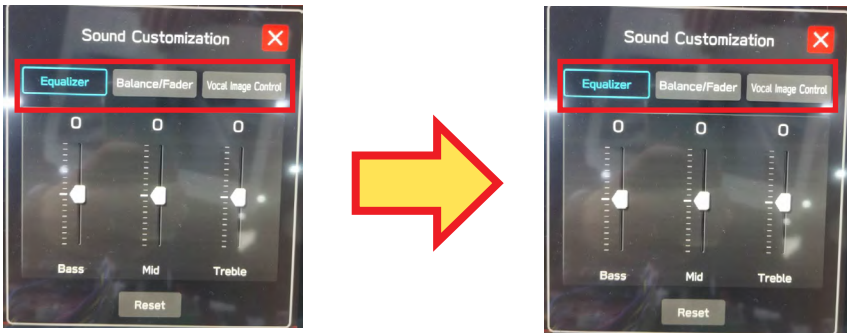
7	<p>Equalizer setting returns to default setting. After ignition switch is turned Off and ON, the equalizer returns to default setting.</p>

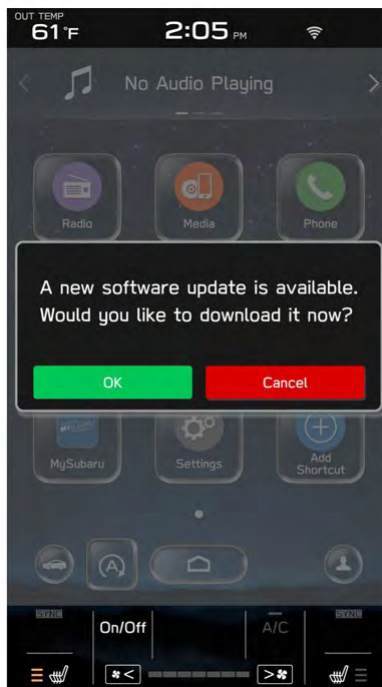
- a. If current software version is the latest, you don't need an update and no action is necessary.
- b. If the software version is not the latest, you are likely not eligible for FOTA update at this time. Please proceed with USB update following TSB 15-261-20.
4. If the "OK" button does not respond when I begin the update process:

- a. If CarPlay application is running at the time the pop-up screen comes up, the screen is being disabled for OK operation. Please press the home button on the display, go to Settings, Software Updates, Update, and begin again.

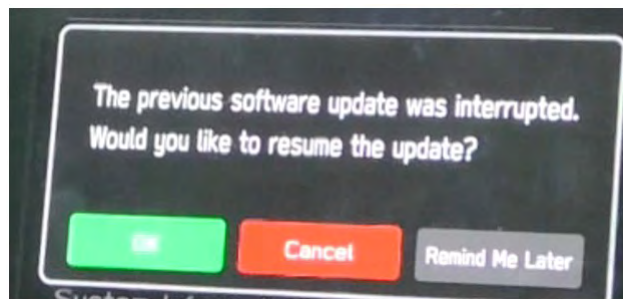
**7. If you receive the following message during the update:**

- a. The above message will display if the vehicle is turned off during the software update process. Select “OK” to resume the process.

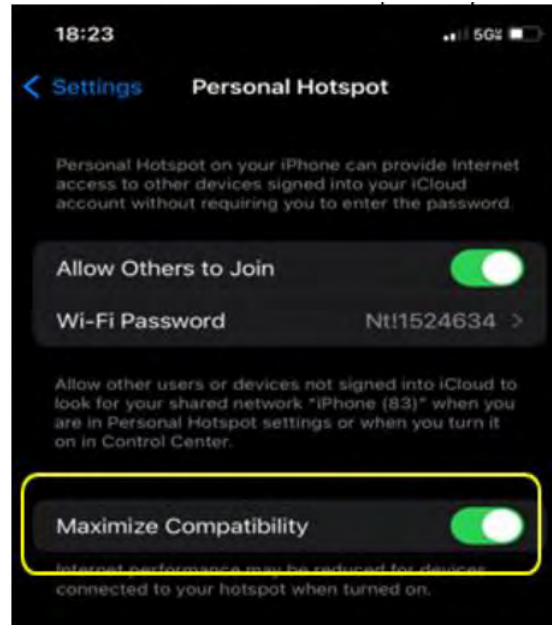
**8. CP1 connectivity issues observed when tethered via iPhone hotspot (Phone as Modem/ Wi-Fi Hotspot).**

- Navigate to Settings > Personal Hotspot.
- Enable Maximize Compatibility.

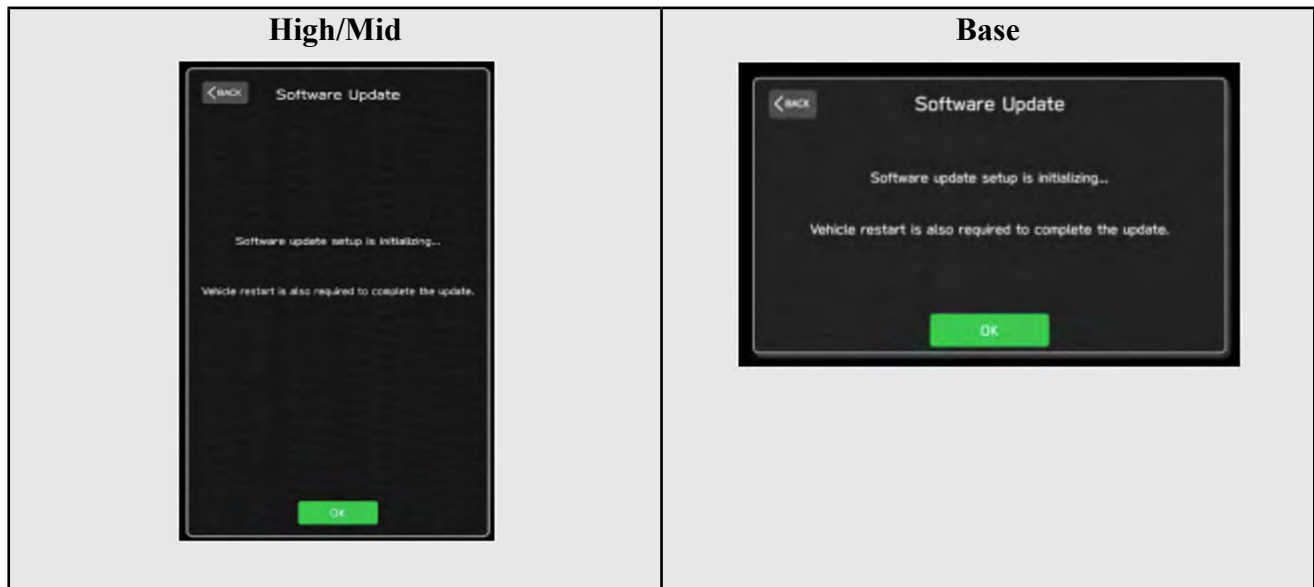
Follow this procedure in the RARE case of “Software update setup is initializing...” message is displayed: • If the screen shown below appears, WAIT for approximately 30 minutes or as long as necessary (waiting for longer than 60 minutes might indicate system malfunction).

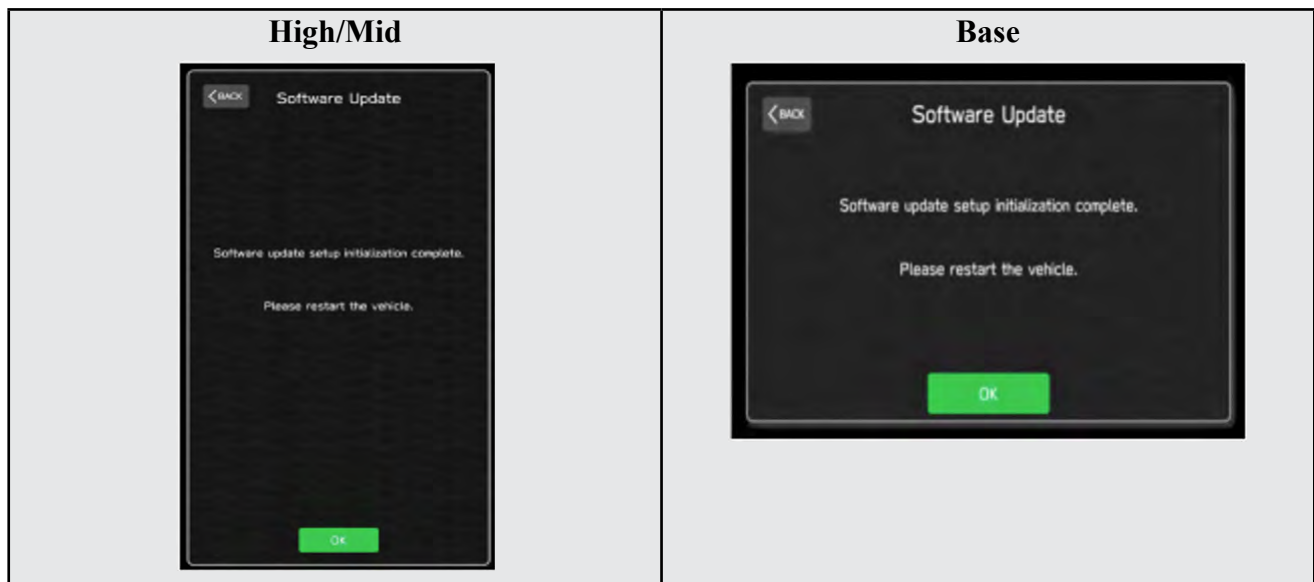
The screens shown below will be displayed when the process completes.

1. Turn the ignition OFF, open the driver's door, close the driver's door and **WAIT** for 3 or more minutes before proceeding further.
2. Open the driver's door again and either turn the ignition ON (if a charger is connected) or start the engine.
3. Please proceed with USB Update following TSB 15-261-20.

**IMPORTANT NOTE:** If this procedure is required, contact Techline as additional action may be necessary
