## SERVICE BULLETIN

**APPLICABILITY:** 2019-23MY Impreza  
 2019-23MY Crosstrek (Including Hybrid Model)  
 2019-24MY Forester  
 2019MY Legacy/ Outback  
 2019-21MY WRX  
 2019-21MY WRX STI  
 2019-21MY BRZ- Navigation -equipped ONLY  
 2019-22MY Ascent

**NUMBER:** 15-236-18R

**SUBJECT:** Reprogramming File Availability for Optimization of Harman Gen 3.1  
 and Gen 3.1α Audio and Navigation Head Units

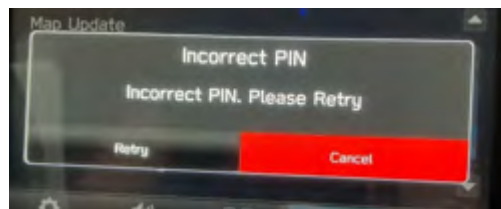
- 8) Repair Facility POI icons are now shown on the NAVI map display. See **NOTE 4** below.
- 9) Activation Code Not Accepted by Navigation System when updating Map Data

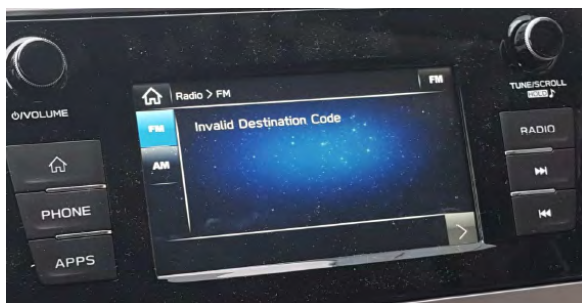
- 3) US State names corrected when using voice guidance.
- 4) Correction made for Pop / Crackling-type sound when using AM radio.
- 5) Navigation system freezes during loading / start-up.
- 6) Music skips/cuts out while using Apple CarPlay.
- 7) Hands-free feature freezes intermittently while loading.
- 8) Navigation system freezes after entering a particular address using Voice Recognition.  
**NOTE:** All other functions are not affected.
- 9) The voice guidance volume no longer changes After Ignition Off/On. Once the Voice Guidance has been muted, the system retains that setting even after switching the ignition Off/On.
- 10) Invalid Destination Code message appears on the display while listening to the radio.
