SERVICE BULLETIN

APPLICABILITY: 22-23MY WRX Models **NUMBER:** 15-301-22R
SUBJECT: Reprogramming File Availability for Optimization of Gen 4 Denso CP1 Infotainment Systems **DATE:** 09/09/22
REVISED: 11/26/24

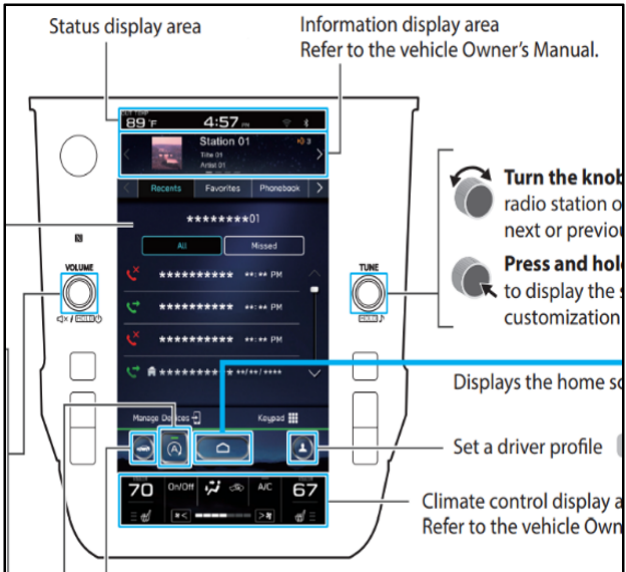
Number	Symptoms to be Improved:
1	While welcome animation on CID is displayed and the driver's door is left open, if turning ignition OFF/ON, the CID screen will be black screen.
2	After starting the engine, the loading animation remains and the screen does not transition remaining blank.
3	When the “All” tab is pressed on the TravelLink Sports screen, a blank screen appears.
4	During Bluetooth audio playing, the CID screen turns into a black picture.
5	<p>The Information Display Area at the top of the CID screen displays a different information screen from the last time.</p>

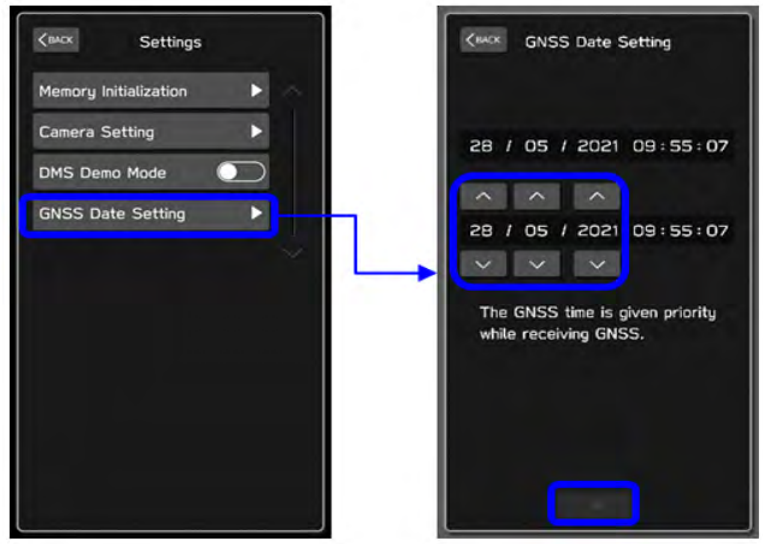
Number	Symptoms to be Improved:
37	<p>When a language other than English is set, the distance to the destination displayed in the navigation destination is abnormal.</p> <p>When the distance is greater than 1.0, the decimal point is rounded down.</p> <p>When the distance is less than 1.0, the value becomes 0.1.</p>
38	<p>When the clock was set to "AUTO," the date and time are shifted to a date approximately 20 years in the future due to anomalous values received from GPS or other reasons. If it occurs, the date and time cannot be corrected manually and have to be reset by disconnecting the battery terminal. As a countermeasure, a setting screen to manually adjust the clock display in the "AUTO" setting is to be added to the Dealership Mode (Dealership Mode->Settings->GNSS Data Setting).</p>

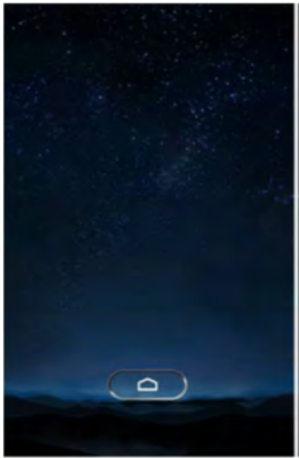
Number	Symptoms to be Improved:
1	Unexpexted CP1 system reboot resulting from an inter reset to sync internal communication with Bluetooth module.
2	CID restarts itself right after engine is started.
3	CID resets and reboots.
4	<p>Right after starting up, the CID is blank only displaying the background without icons.</p>

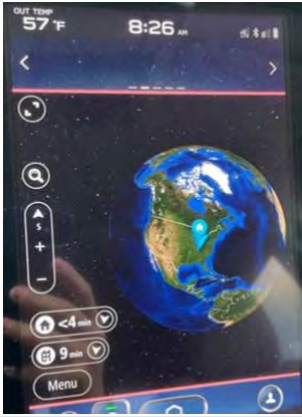
Number	Symptoms to be Improved:
7	Sound is lost when playing Bluetooth audio even though the screen is displayed without problem. It can occur when the audio source is switched repeatedly between the Bluetooth and others.
8	SXM radio output is lost after terminating a handsfree phone call.
9	No audio played back when using CarPlay.
10	Sound volume control does not work while using Android Auto.
11	Cyclic short noise like a drilling or vibration is heard from speakers.
12	After the engine is started, a message of “Loading Navigation...” continues to be displayed, but the map is not displayed.
13	Vehicle position on navigation map erroneously moves to zero degrees latitude and zero degrees longitude (0°N 0°E or west of Africa in the Atlantic ocean).
14	<p>Navigation map scale is changed to the lowest setting (globe is displayed).</p>

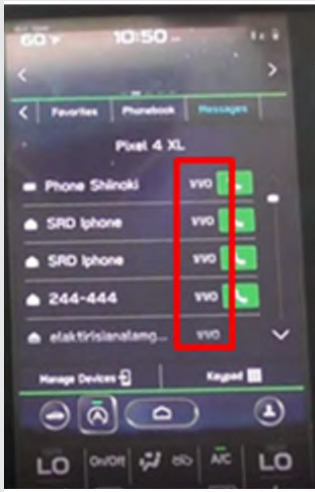
16	<p>When selecting “Phone->”Message,” message received time is displayed incorrectly as “1/1/0.”</p> <p>It can occur with an Android phone with a specific Android OS (Pixel 6, Pixel4a, Pixel4XL, Xperia etc.) in which time zone data is attached to the message receiving time.</p>

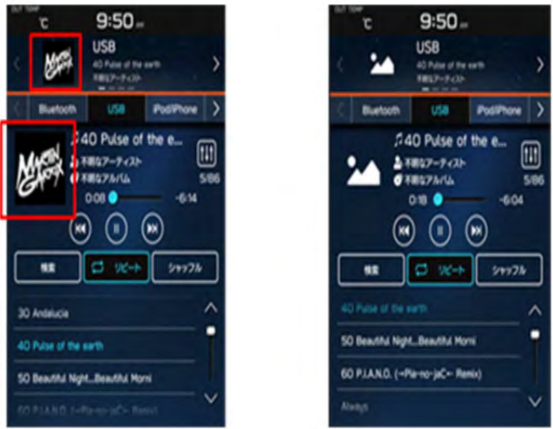
Number	Symptoms to be Improved:
17	Even when using the same mobile device that was paired previously, a message of “Are you sure you want to activate this profile?” is prompted and confirmation is needed to activate the device.
18	<p>Cover art of previous music is displayed when playing music without cover art in USB audio. It can occur when music with and without cover art is mixed and stored together a single USB.</p>

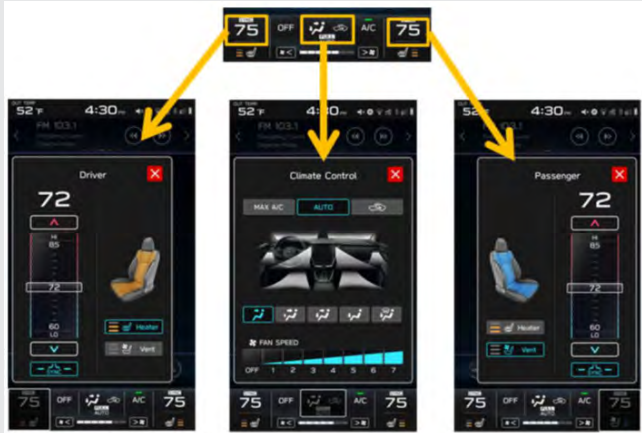
2	<p>Air conditioner control interface is changed to that of 23MY.</p> <p>Current (-22MY) screen transition:</p>

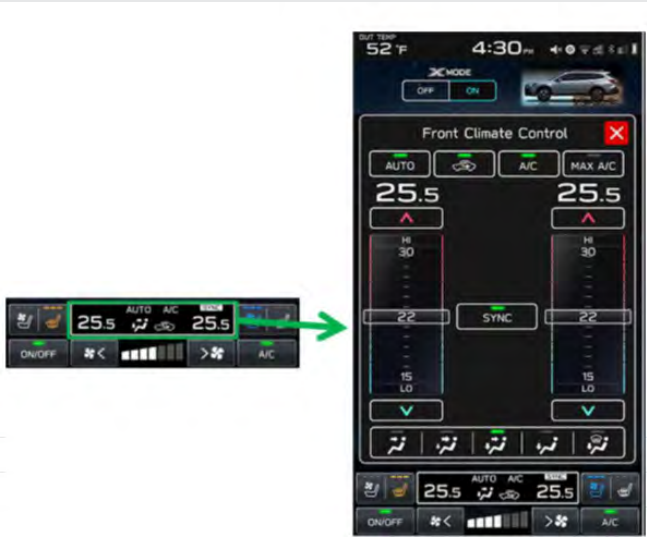
<p>23MY screen transition:</p>

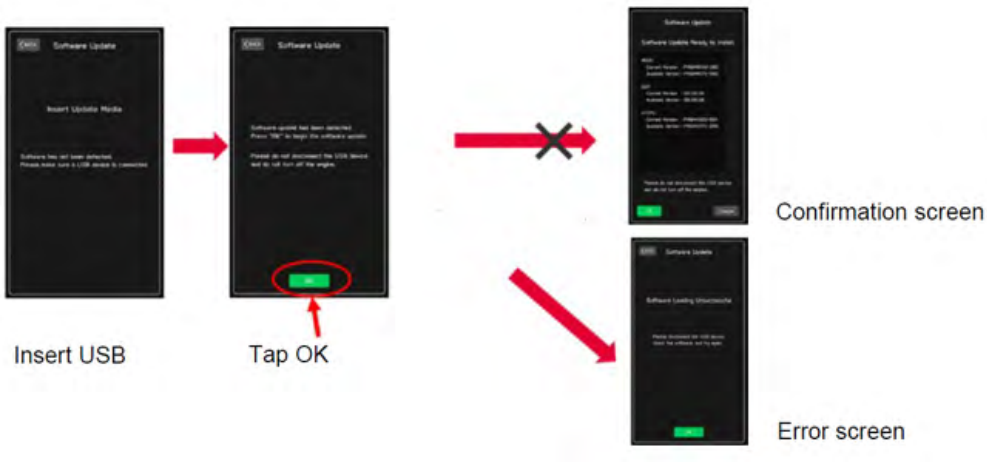
Number	Symptoms to be Improved:
12	<p>When conducting USB reprogramming, the screen transition to error screen instead of confirmation screen.</p>

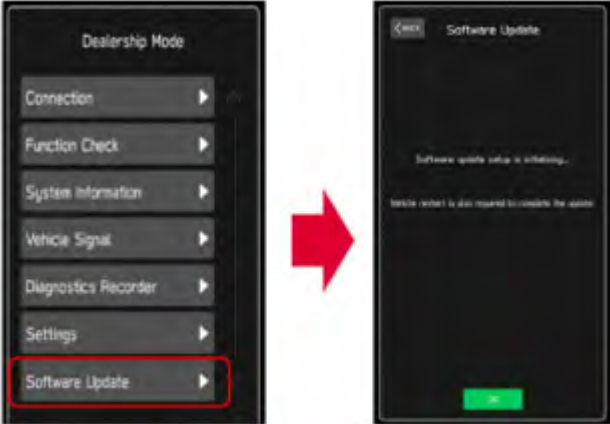
<p>The diagram illustrates the intended flow and a common failure point. It shows three stages: 1. 'Insert USB' screen. 2. A screen with a green 'OK' button circled in red, with a red arrow pointing to it and the text 'Tap OK'. 3. A split path: one path leads to a 'Confirmation screen' (indicated by a red arrow with a large 'X' over it), and another path leads to an 'Error screen' (indicated by a red arrow).</p>
13	<p>When “Software Update” is selected in the Dealership Mode, the following initialization process does not end more than 20 minutes. *</p>

<p>The diagram shows two screens. The first is 'Dealership Mode' with a list of options: Connection, Function Check, System Information, Vehicle Signal, Diagnostics Recorder, Settings, and Software Update. The 'Software Update' option is highlighted with a red box. A red arrow points to the second screen, 'Software Update', which displays 'Software update status is initializing...' and 'Vehicle restart is also required to complete the update'.</p> <p>Note* In case this USB update failure occurs, retry updating according to the instructions in “Appendix A”</p>

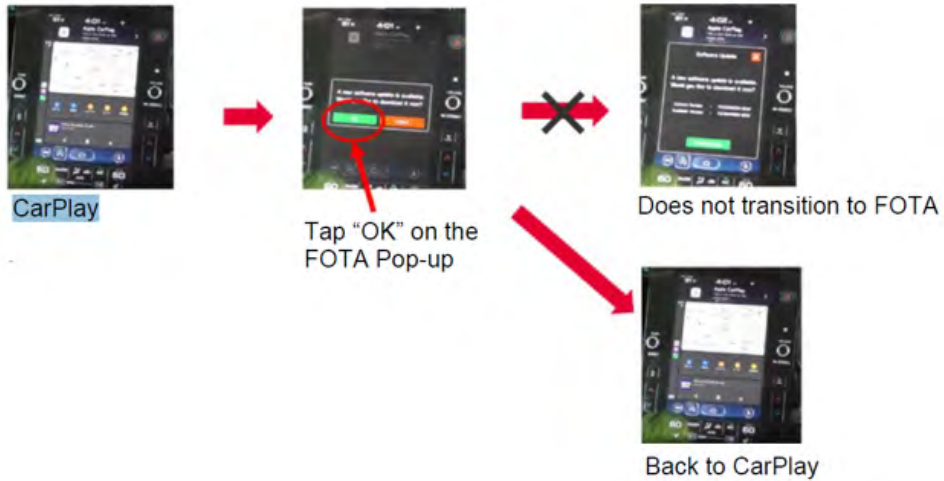
14	<p>When the FOTA pop-up (new software availability notification) is displayed while the CarPlay is being used, the display comes back to CarPlay screen even if the customer tries to get into the FOTA screen.</p>

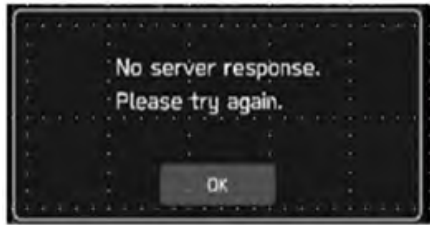
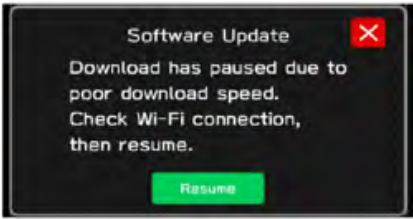
Number	New Function or Enhancement:
1	Icons of home screen change to those of the US specifications even though the original specification is not of the US.
2	Two ways of MOTA operations, i.e., by connect CCM to Wi-Fi or by transferring the downloaded map data to CCM via smart phone are executed simultaneously by error.
3	<p>One of the Pop-up Error Messages displayed during the FOTA operation in case of weak Wi-Fi signal is not intuitive. Even if the customer tap “OK,” it does not transit to another screen.</p> <div style="display: flex; align-items: center; justify-content: center;">

</div> <p>As the improvement for this inconvenience, the message is changed so that the customer finds the reason why the FOTA operation has been paused. Also a “Resume” button is prepared so that the customer can do the rest of operations after necessary action (moving the vehicle to another place with better Wi-Fi connection**, or tethering the CP1 to a mobile phone, etc.)</p> <p>Note** The FOTA operation can be paused when the Wi-Fi indicator at the upper right corner of the CID is not in “Good” or “Excellent” as shown below.</p> <div style="text-align: center;">
