WARRANTY BULLETIN

NO: D-23-04

SUBJECT: 2018 - 2024 (Current) Jeep
Wrangler (JL) and 2020 - 2024 (Current)
Jeep Gladiator (JT) - Corrosion Warranty
Claim Simplification (Rev. G)

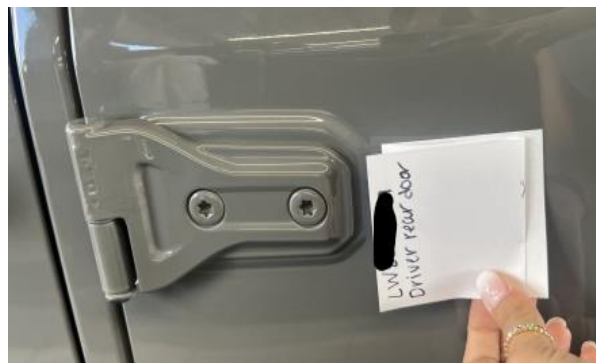
VIN Example (Fig. 3)

Dealers will need to take photos of the affected areas identified during the inspection to support the repair. A clear photo of the corrosion is needed and **MUST** include the VIN and affected body panel. The VIN and affected body panel can be included on a sticky note, written with a grease pen, a copy of the RO in the photo, masking tape, etc. (Figure 3)
