FCA CARIBBEAN WARRANTY BULLETIN

NO: ID-23-03

SUBJECT: 2018 - 2024 (Current) Jeep
Wrangler (JL) and 2020 - 2024 (Current)
Jeep Gladiator (JT) - Corrosion Warranty
Claim Simplification (Rev. H)

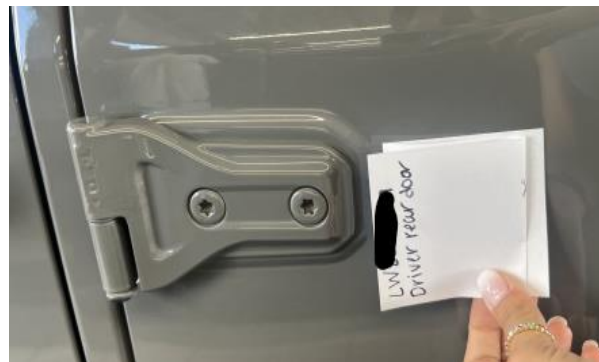
VIN Example (Fig. 3)

Dealers will need to take photos of the affected areas identified during the inspection to support the repair. A clear photo of the corrosion is needed and **MUST** include the VIN and affected body panel. The VIN and affected body panel can be included on a sticky note, written with a grease pen, a copy of the RO in the photo, masking tape, etc. (Figure 3)
