GROUP	MODEL
ELE	2025MY K4 (CL4)
NUMBER	DATE
363	December 2024

## TECHNICAL SERVICE BULLETIN

### SERVICE ACTION: SUNROOF OPERATION SOFTWARE LOGIC IMPROVEMENT (SA595)

This issue number is SA595.

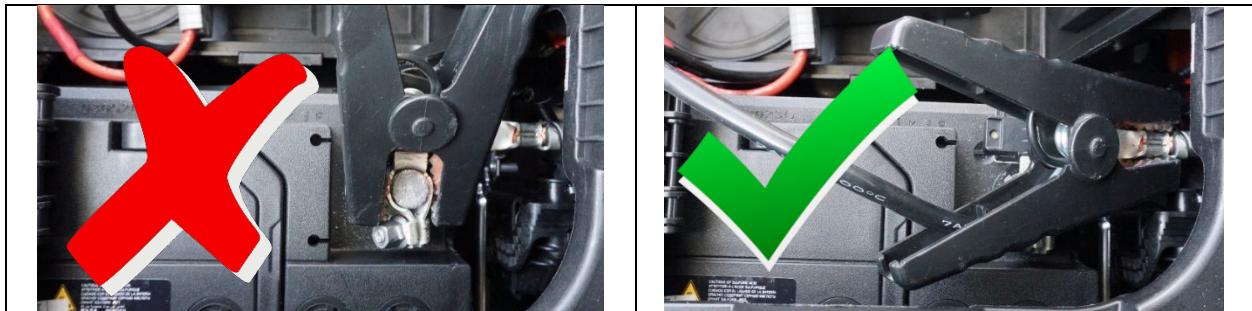
[Connect the negative \(-\) terminal to the battery as shown below.](#)
