Service Bulletin

Bulletin No.: 24-NA-025

Subject: Check Engine Light or Malfunction Indicator Lamp Illuminated with DTCs U0401 and/or U1611 Set

Brand:	Model:	Model Year:		VIN:		Engine:	Transmission:
		from	to	from	to		
Chevrolet	Corvette Z06	2024	2025	—	—	5.5L (LT6)	M1M

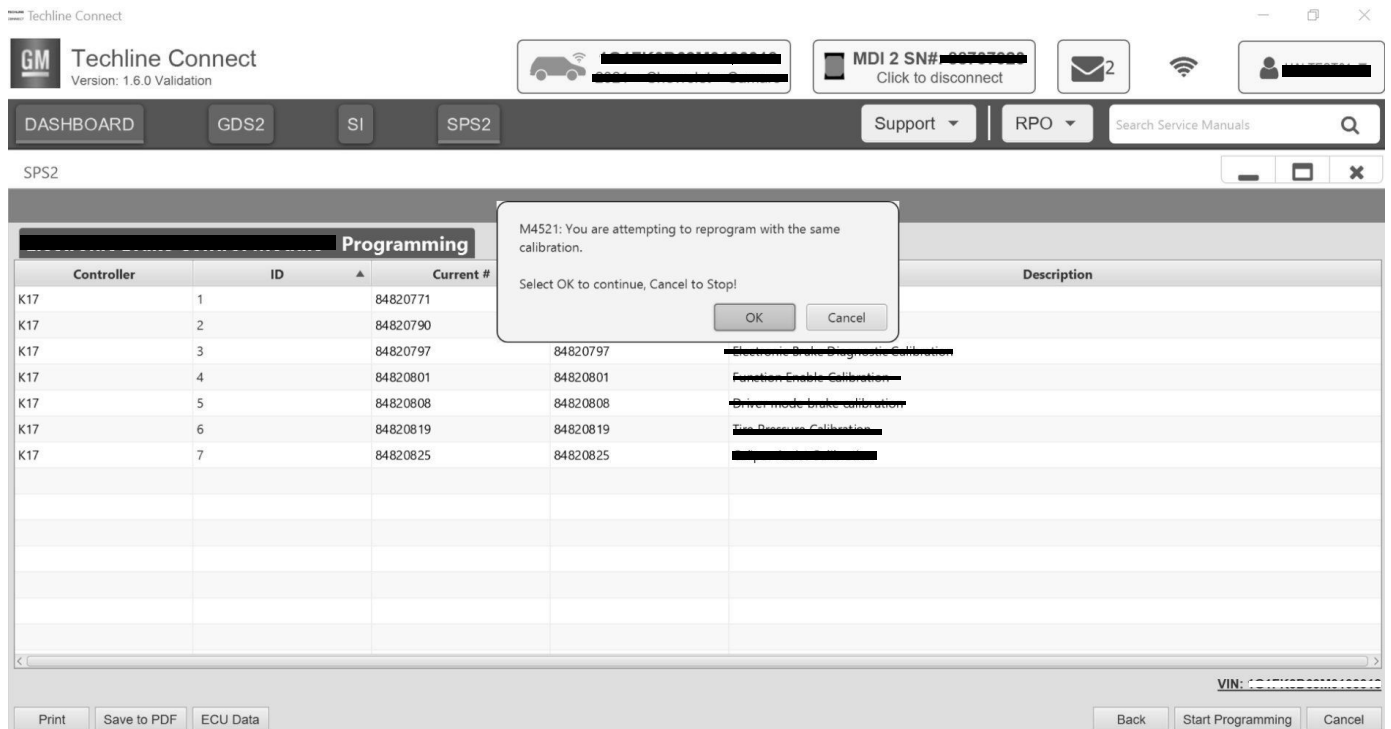
5644477

Important: Techline Connect screen shown above.

Important: If the same calibration/software warning is noted on the TLC Summary screen, select OK and follow screen instructions. After a successful programming event, the WCC is located in the Service Programming System dialogue box of the SPS Summary screen. Record the WCC on the job card. No further action is required. Refer to the Warranty Information section of the bulletin.
