## Fuse Replacements WITHOUT Wiring Repairs

## Coolant Leak & Engine Overheating Issue - MY 2021 - 2025 - Jeep Wrangler (JL), Jeep Grand Cherokee (WL), Jeep Compass (MP), Dodge Hornet (GG)/ Alfa Romeo Tonale (GC)

## 2023 - 2025 MY (VF) - Brake Pedal Switch Stuck Condition

## Ram 1500 (DT) - Front Lower Control Arm to Knuckle Balljoint Removal Process

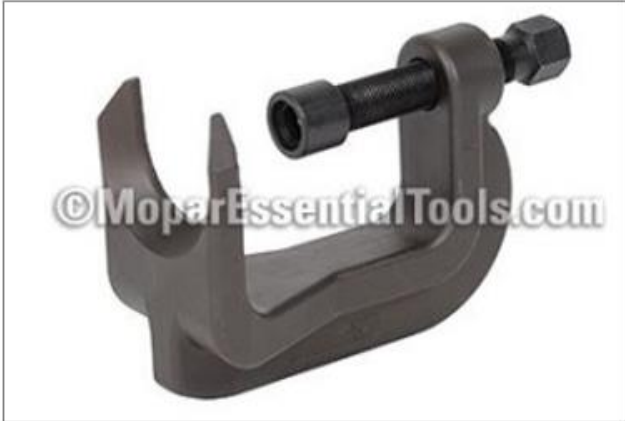
When removing the front lower control arm balljoint from the front steering knuckle, do not hammer any of the components. This includes the knuckle (1), the balljoint stud (2), or the lower control arm (3). This can damage the stud and crack the knuckle.

1 - Lower Ball Joint Stud  
2 - Ball Joint Remover

Picture of tool properly installed and used to remove the balljoint from the knuckle

Remover, Ball Joint  
Item Number: 8677A
