Fuse Replacements WITHOUT Wiring Repairs

Coolant Leak & Engine Overheating Issue - MY 2021 - 2025 - Jeep Wrangler (JL), Jeep Grand Cherokee (WL), Jeep Compass (MP), Dodge Hornet (GG)/ Alfa Romeo Tonale (GC)

Exterior Mirrors (Especially Ram Trucks 1500-5500 (DS, DT, DJ, D2, DD, DP))

MY 2023 - 2024 Compass (MP) - Technical Service Bulletin Guidelines (Expectations)

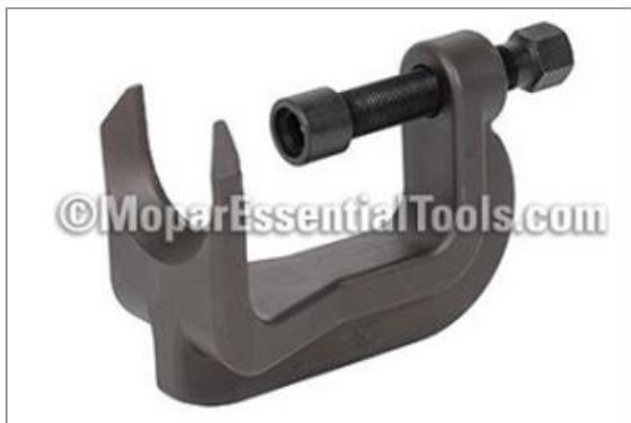
1 - Lower Ball Joint Stud
2 - Ball Joint Remover

Picture of tool properly installed and used to remove the balljoint from the knuckle

When removing the front lower control arm balljoint from the front steering knuckle, do not hammer any of the components. This includes the knuckle (1), the balljoint stud (2), or the lower control arm (3). This can damage the stud and crack the knuckle.
