SIB 01 11 24

F30 G12 I12 PHEV I01 BEV HV BATT CELL MOD TEMP SENSORS EXT LTD WTY (ELW) 15/150

Service Information Bulletin

B01 11 24

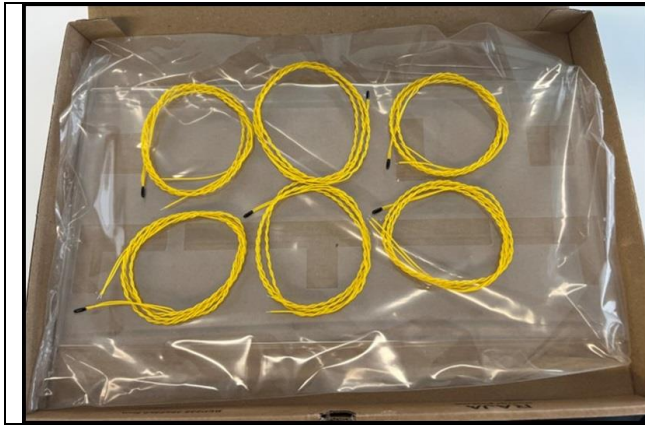
For the eligible vehicles, BMW of North America, LLC (BMW NA) is extending the limited warranty for the vehicle's **the High-Voltage (HV) Battery Assembly's Cell Module Temperature Sensors (Internal NTC repair kit) (F30 Shown)** to:

Over time, the temperature sensors may fail, this can cause the measured values of one or more of the temperature sensors to deviate from specification. The vehicle's monitoring system may interpret these deviating temperature sensor values as either implausible or impermissible.

If there are failed cell module temperature sensors, the test plan will instruct you to replace the applicable HV cell module's internal temperature sensors (NTC repair kit), one repair kit per cell module.
