WRS1 - Checking High-Voltage Battery and Replacing Cell Block Module if necessary (Workshop Campaign)

Model Line: **Taycan (Y1A / Y1B / Y1C)**

Model Year: **As of 2020 up to 2024**

Concerns: **High-voltage battery**

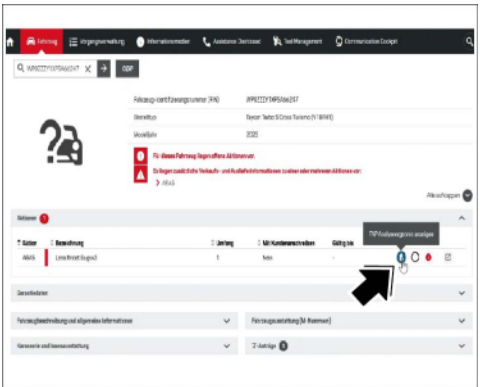
<p><i>Pop-up display window</i></p>

- The data analysis yields a **positive result** (green PCSS display): The vehicle can then be handed over to the customer. Continue to Warranty Processing, Scope 1.
- The data analysis yields a **negative result** (red PCSS display): In rare cases, it may be necessary to replace the cell block module. If this is the case, the VIN in the ARB5 campaign is transferred to one of the accompanying campaigns.
- VAL faulty/insufficient (yellow or grey PCSS display): In very rare cases, additional VALs may be required.
