TECH TALK - VOLUME 283 NOVEMBER/DECEMBER 2024

SPARE PART INFORMATION: Steering Wheel Remote Control Switch

TECHNICAL INFORMATION: Electrical System Service Required Warning is on

TECHNICAL INFORMATION: Fuel - Hard to fill concerns

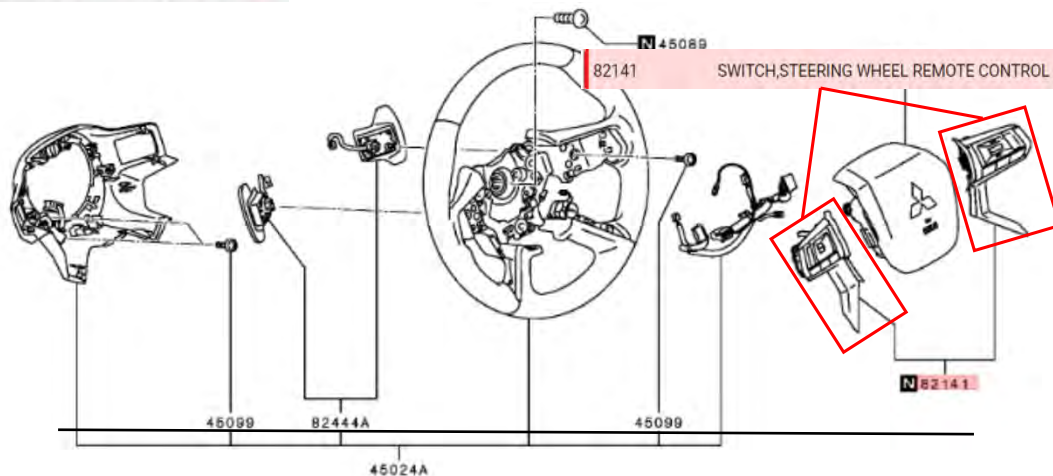
37-010 STEERING WHEEL / -/-

Customers expressed concern that the Steering Switch did not have a press/click feeling or the switch would not return to its original position. Therefore, the internal structure and durability of the Steering Switch has been revised.

Please refer to the table below for the old and new part numbers.

Part Name	Old Part Number	New Part Number
SWITCH, STEERING WHEEL REMOTE CONTROL	8616A121	8616A201
	8616A122	8616A204
	8616A123	8616A205
	8616A124	8616A206
	8616A134	8616A203
