# KARMA Technical Service Bulletin

TB-25-76-01

MODEL: Karma Revero GT and GTS, GS-6 and 2025 Karma Revero

## TITLE: Front Door Glass Fitment Inspection and Adjustment

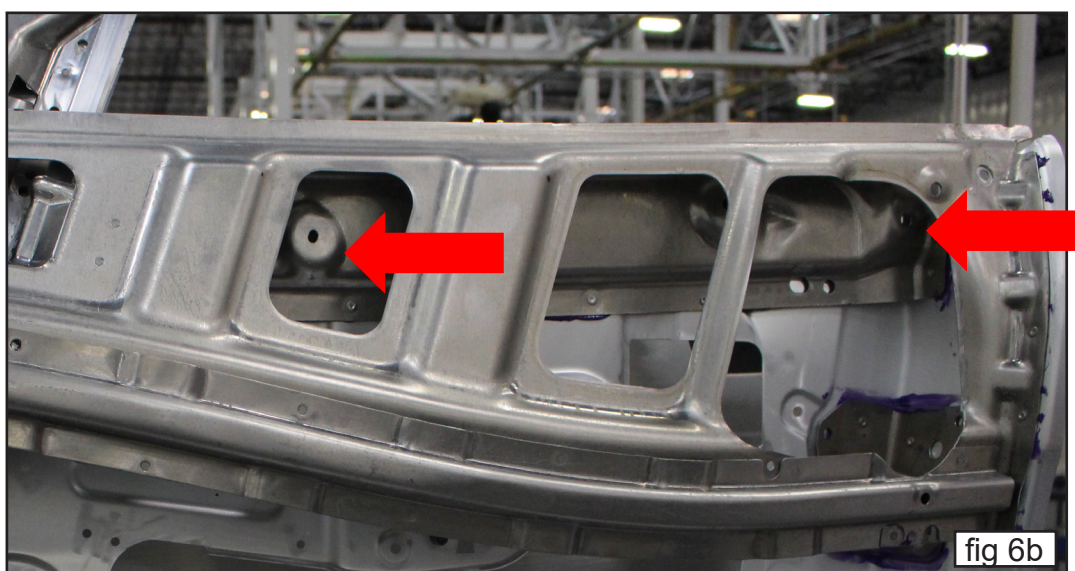
A bare door assembly shown here to better identify the regulator mount position (fig 6b).

- 5) Check the upper regulator mounts for shims- if required remove shims to check adjustment this may be sufficient (fig 6a). However verify that glass movement speed, up and down in the channel is not affected, as the glass may now contact the seal and create some drag. You may find one (1) or (2) shims in each position, trial should first be done removing 1 shim and checking glass to B pillar flushness and for satisfactory glass speed, if this is still unsatisfactory remove the second shim and recheck.
