MAS004045 RU 25-01

Rapid Update 769 MC20 – Door Compartment Carpet Check

DATE: January 9, 2025

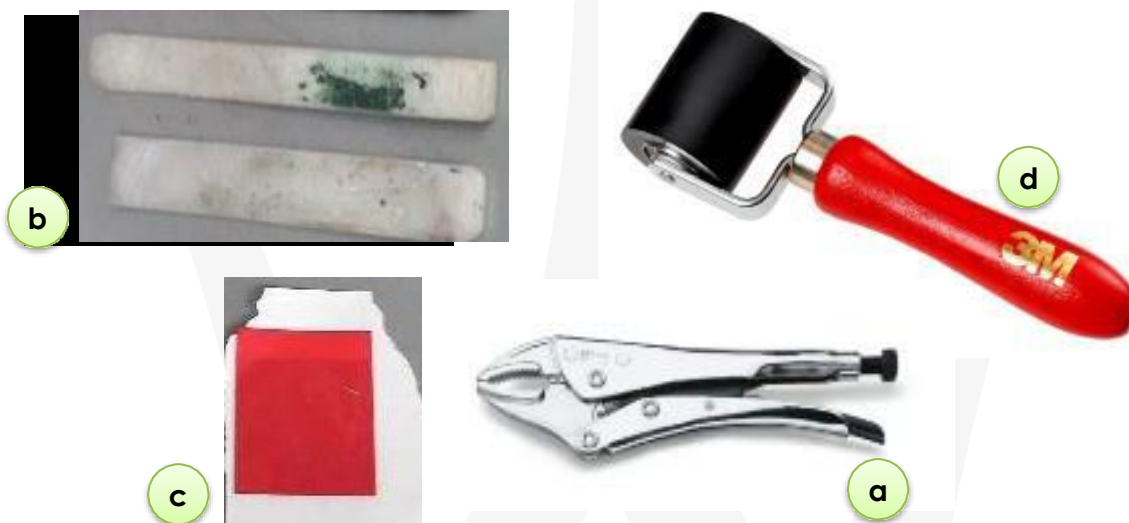
- Snap-on pliers or equivalent tools
- Teflon Bars
- Double-sided adhesive 45x45 mm
- Pressure roller or equivalent tools
- Solvent wipes type Heptane

- To facilitate the restoration of the carpets, move the door seal following the instructions in the workshop manual.
