### Problem Details:

# 13-007 Air Compressor Discharge Line Blocked by Ice in Cold Weather

## TSB-13-007-FTL

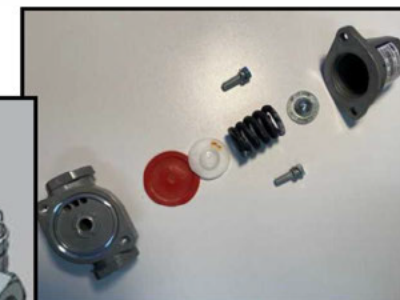
- Air compressor stops building air due to ice blockage at discharge line overflow valve.
- When discharge line becomes blocked, air compressor relieves pressure through relief valve on housing and sprays compressor oil
- Occurs in high-humidity near (+/-) freezing environmental conditions

- Moisture accumulates in spring chamber of overflow valve, then freezes, disabling valve
- Original theory was ice blockage in the air stream but this has been proven untrue

- Splash cover will be added in production mid-2025

- Service Bulletin TSB-13-007-FTL with instructions for thawing valve and installing insulation
- Service Bulletin will be revised when splash cover becomes available.
