# SS 776-WST X-Series intermittent no-start and CPC not configured message

X-Series vehicles with Detroit powertrain

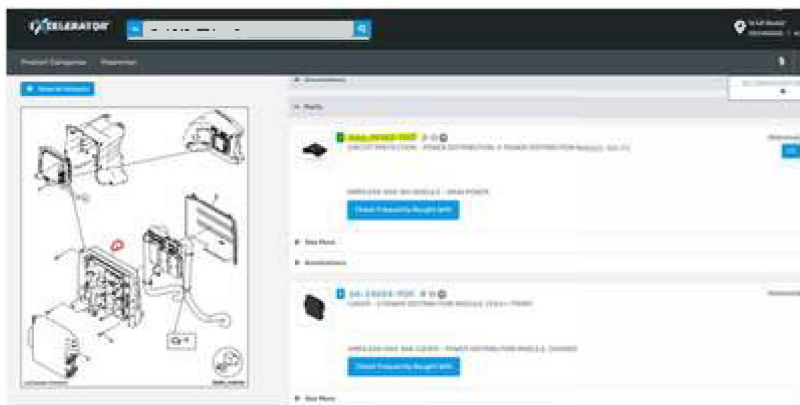
Use the VPDM part number to locate the correct Wall Chart

Once the correct wall chart is located search for either fuse F49 or F67 as this is the ignition power for all Powertrain modules, this will show us the correct relay that powers the ignition circuit for all Powertrain modules (Typically either R22 or R24 in the VPDM).
