# Service Bulletin

Bulletin No.: 21-NA-049

**Subject: Diagnostic Aid – PicoScope Information and Setup for Transmission Related Concerns**

Brand:	Model:	Model Year:		VIN:		Engine:	Transmission :
		from	to	from	to		
Chevrolet	Corvette	2020	2025	—	—	All	All

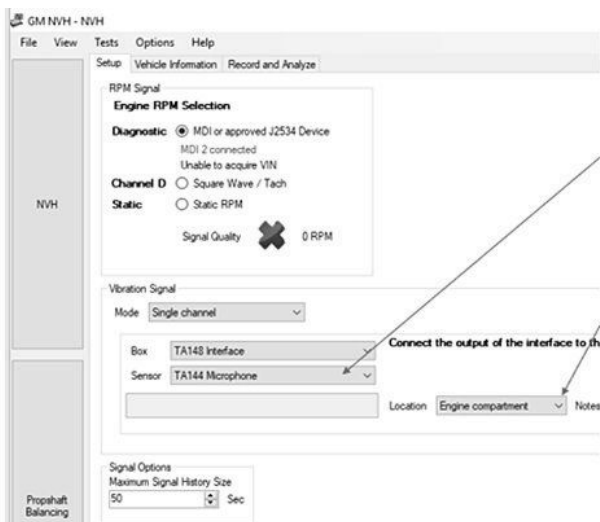
5751818

3. After completing the wizard, go back into the setup tab under Vibration Signal and select Single Channel. Select TA148 Interface in the "Box" dropdown and TA144 Microphone for the "Sensor" Drop down. Select the Location as Engine Compartment. Set the Diff Ratio to 3.55. **Failure to change location to engine compartment will result in you being asked to correct that setting and resend the data.**
