Service Bulletin

Bulletin No.: 24-NA-166

Subject: DTC C1171 C1172 C1173 C1174 Tire Pressure Monitor Sensor Unable to Relearn Ethernet Cable Overlay for TCP OnStar Module

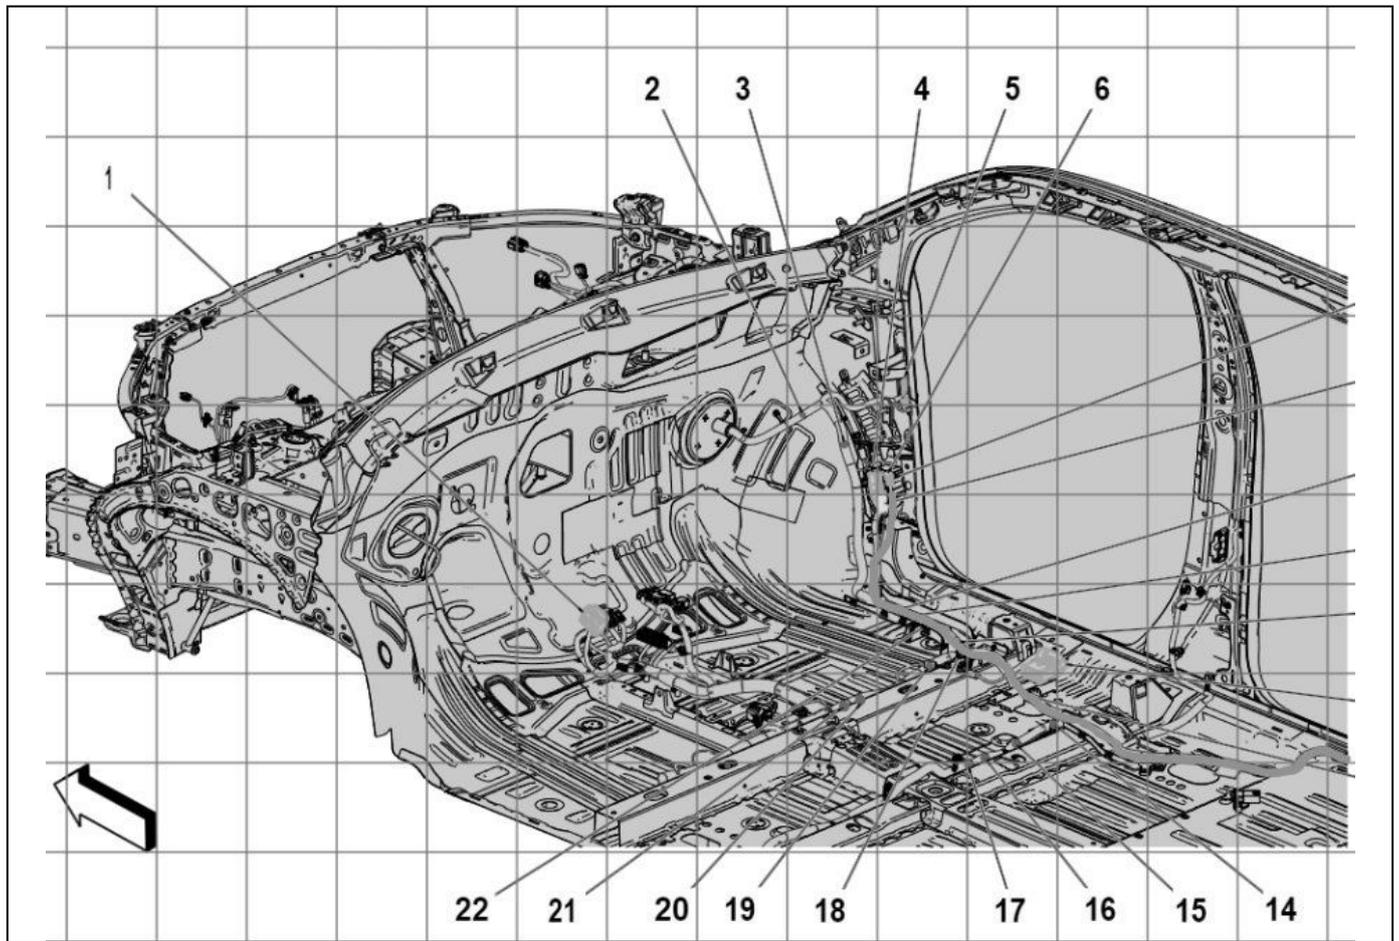
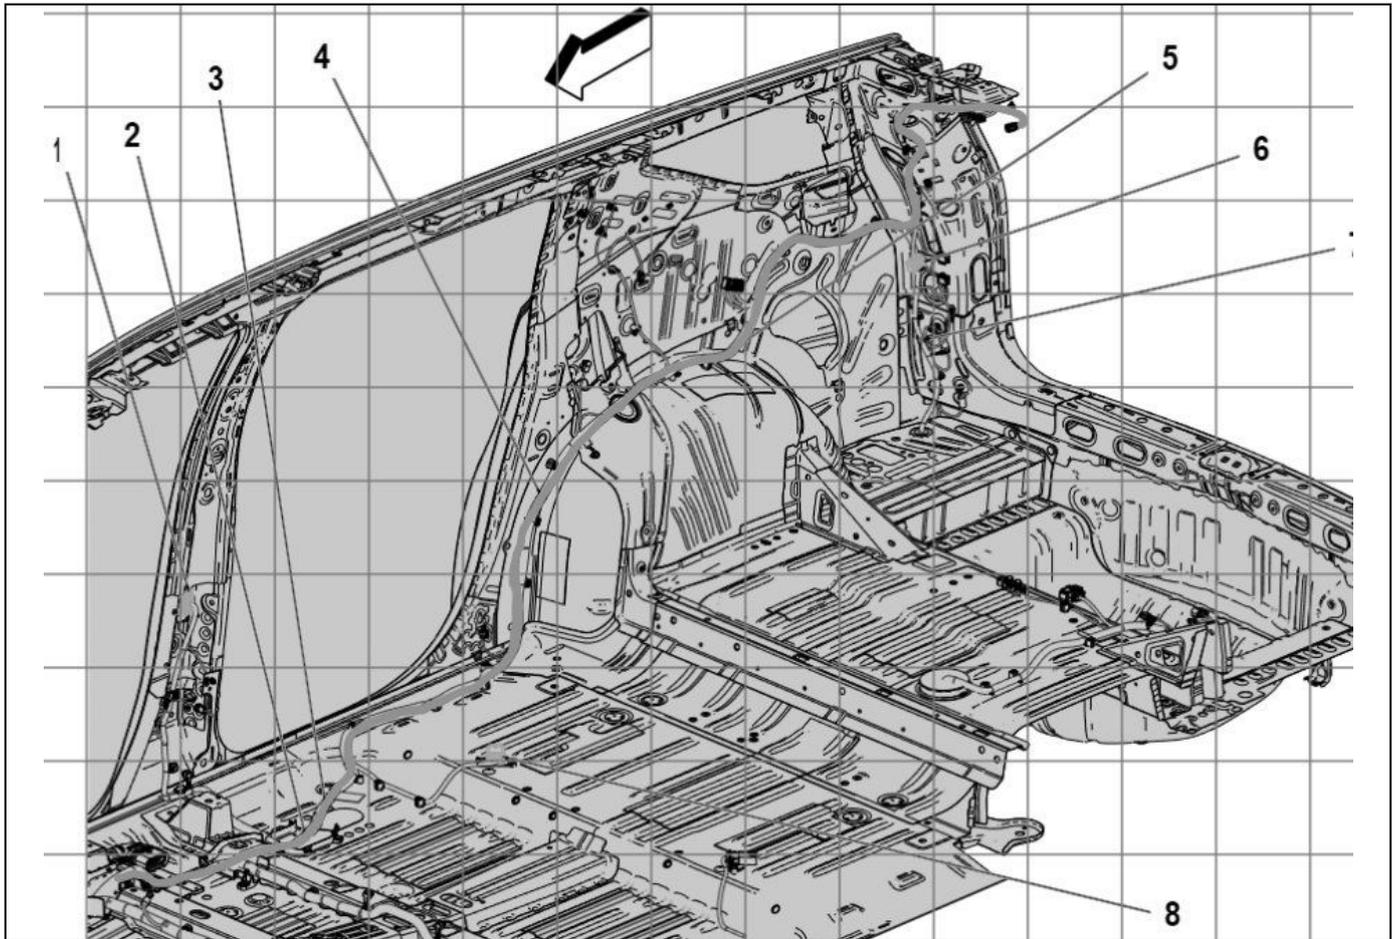
6706066

Note: Replacement Ethernet Cable routing shown in Green.

18. Begin to route the new Service cable starting at X205 and following the Body Wiring Harness running back towards the Telematic Control Module. Use the diagrams above to reference cable routing.
