PROTERRA

ISSUE DATE:	3-23-2022
SERVICE BULLETIN SUBJECT:	Steering Gearbox Bolt Torque Stripe and Re-torque Fleet Check
VINs or MODELS AFFECTED:	Service Specified Buses with Non-TPI Bodies
COMPLETE BY:	Next Service Opportunity
SERVICE BULLETIN #:	FC-22-46
Labor Operation Code:	N/A

STEERING GEARBOX TORQUE STRIPE AND RE-TORQUE FLEET CHECK

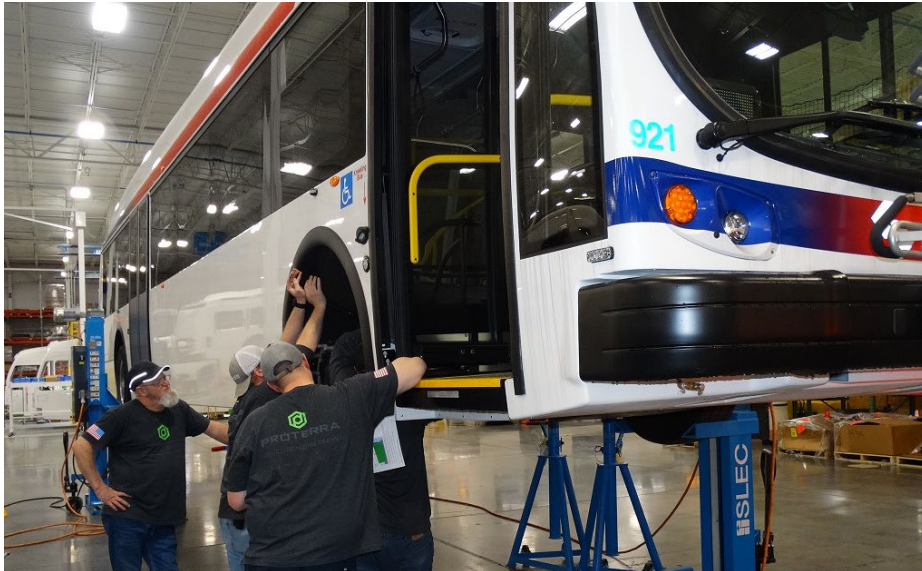
1. Complete the Proterra approved Lockout/Tagout procedure to make the bus safe for work.
2. Using four Wheel Lifts, raise the bus into the air. Using four Jack Stands, support the bus for safety.
